**Appendix B:  
Tree Inventory**

Tree Inventory and Construction Guidelines  
Lot at S. Grimmer Boulevard and Fremont Boulevard  
Fremont, CA

Submitted to:  
Lennar  
c/o: Chad Kiltz  
6111 Bollinger Canyon Road, #550  
San Ramon, CA 94583

Prepared by:  
Samuel Oakley  
ISA Certified Arborist WE-9474A  
ASCA Registered Consulting Arborist #556

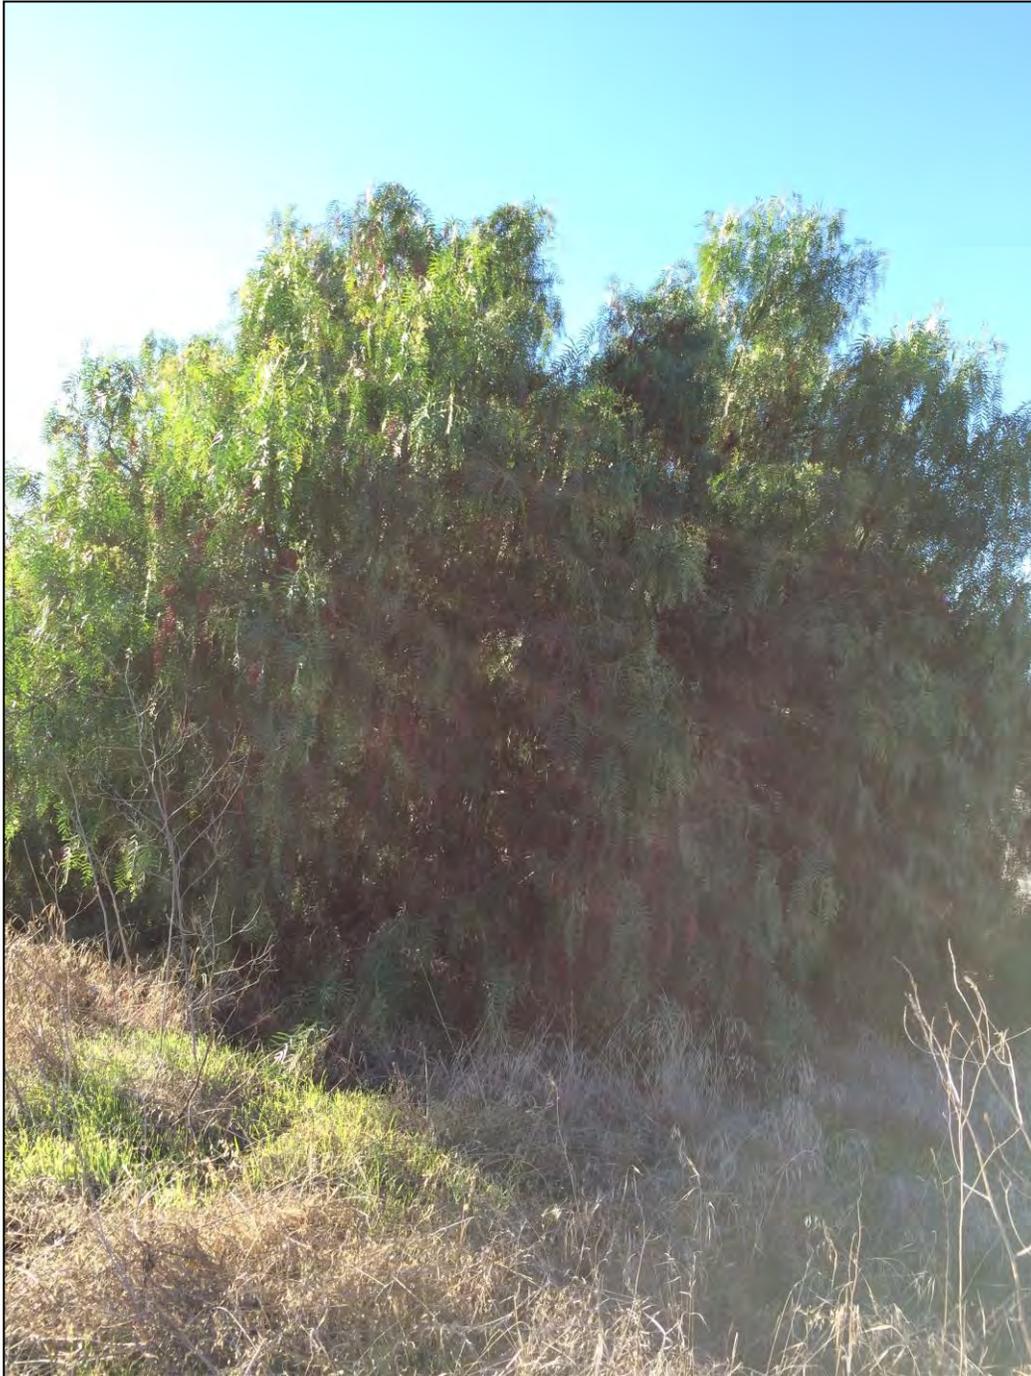
Figure 3: Tree #1

Tag	Common Name	Species	Diameter (inches)	Height (feet)	Canopy (feet)	Overall Condition	Comments
1	Peruvian Pepper Tree	<i>Schinus molle</i>	7, 5, 5, 4, 3	15	20	Good	Volunteer; Multiple Stems
2	Eucalyptus	<i>Eucalyptus spp.</i>	7 (x3), 6, 5 (x5), 3, 2, 1	35	35	Moderate	Resprout from stump; Volunteer
3	Eucalyptus	<i>Eucalyptus spp.</i>	8, 8, 7, 6, 5, 5, 3, 1	40	30	Moderate	Resprout from stump; Volunteer
4	Chinese Pistache	<i>Pistachia chinensis</i>	17	35	40	Moderate	Overarching branches towards road
5	Eucalyptus	<i>Eucalyptus spp.</i>	32	70	500	Moderate	Major trunk wound; Foliar end weight
6	Eucalyptus	<i>Eucalyptus spp.</i>	20	50	30	Moderate	Foliar End weight
7	Honey Locust	<i>Gleditsia triacanthos</i>	9	20	15	Very Poor	Mostly Dead
8	Honey Locust	<i>Gleditsia triacanthos</i>	7	10	10	Very Poor	Mostly Dead
9	Honey Locust	<i>Gleditsia triacanthos</i>	7	15	15	Very Poor	Mostly Dead
10	Fruiting Olive	<i>Olea europaea</i>	6	15	10	Poor	Leaning; Poor pruning cuts

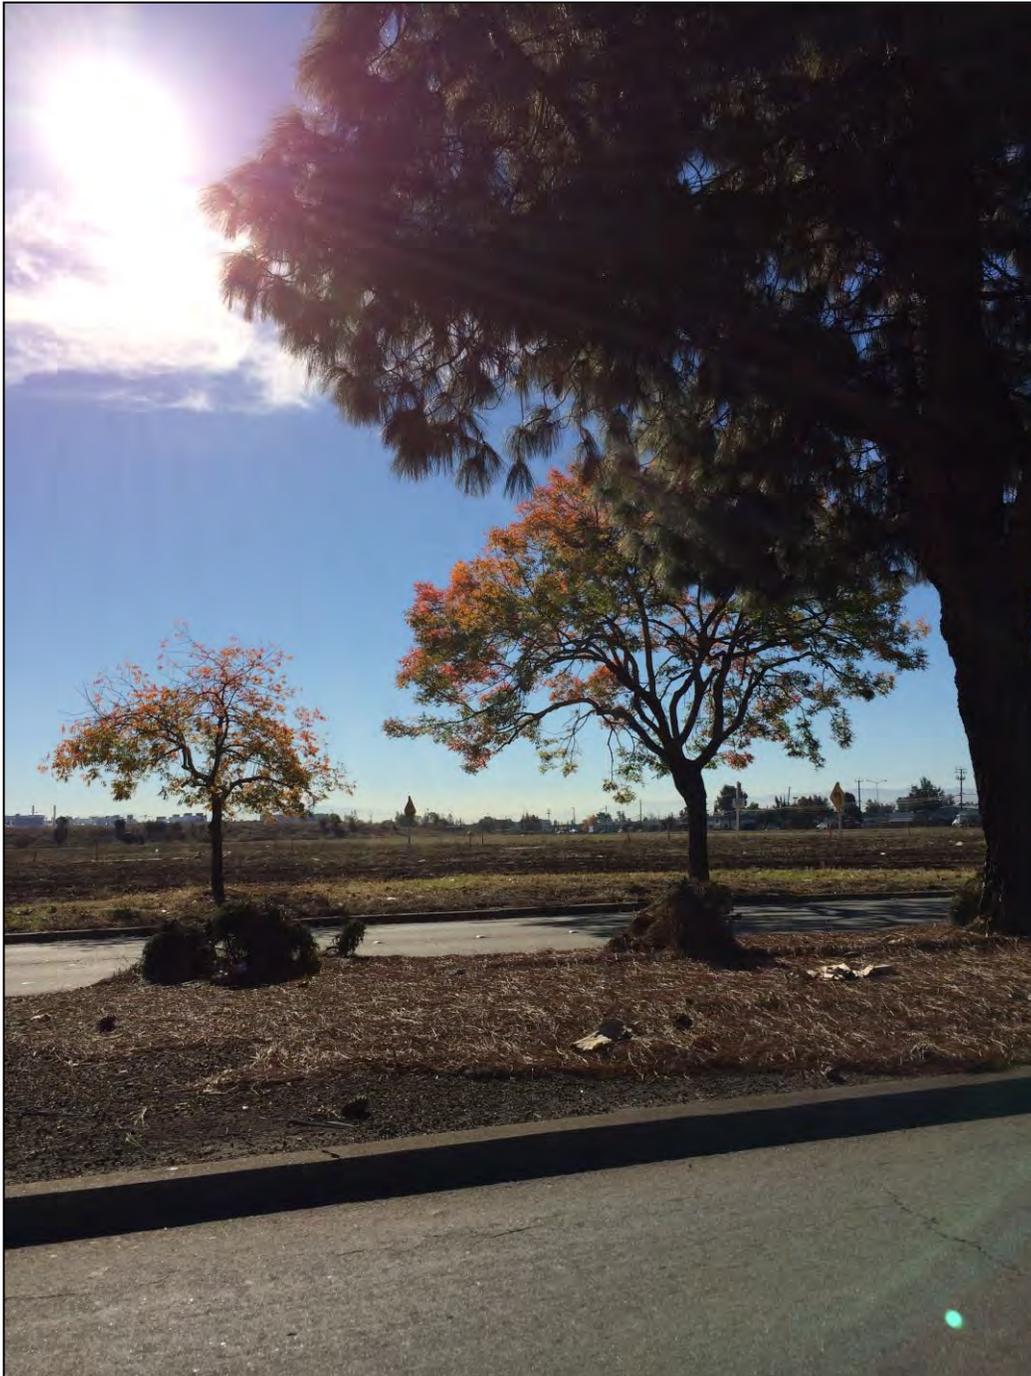
Figure 10: Trees #11 and #12

11	Chinese Pistache	<i>Pistachia chinensis</i>	7	15	20	Poor	Branch failure; Poor pruning cuts
12	Chinese Pistache	<i>Pistachia chinensis</i>	15	30	30	Poor	Poor structure
13	Chinese Pistache	<i>Pistachia chinensis</i>	14	30	25	Poor	Poor structure
14	Coast Live Oak	<i>Quercus agrifolia</i>	9	10	10	Poor	Leaning; Fungal infection
15	Honey Locust	<i>Gleditsia triacanthos</i>	11	20	15	Poor	Included bark tissue; Coodominant leaders

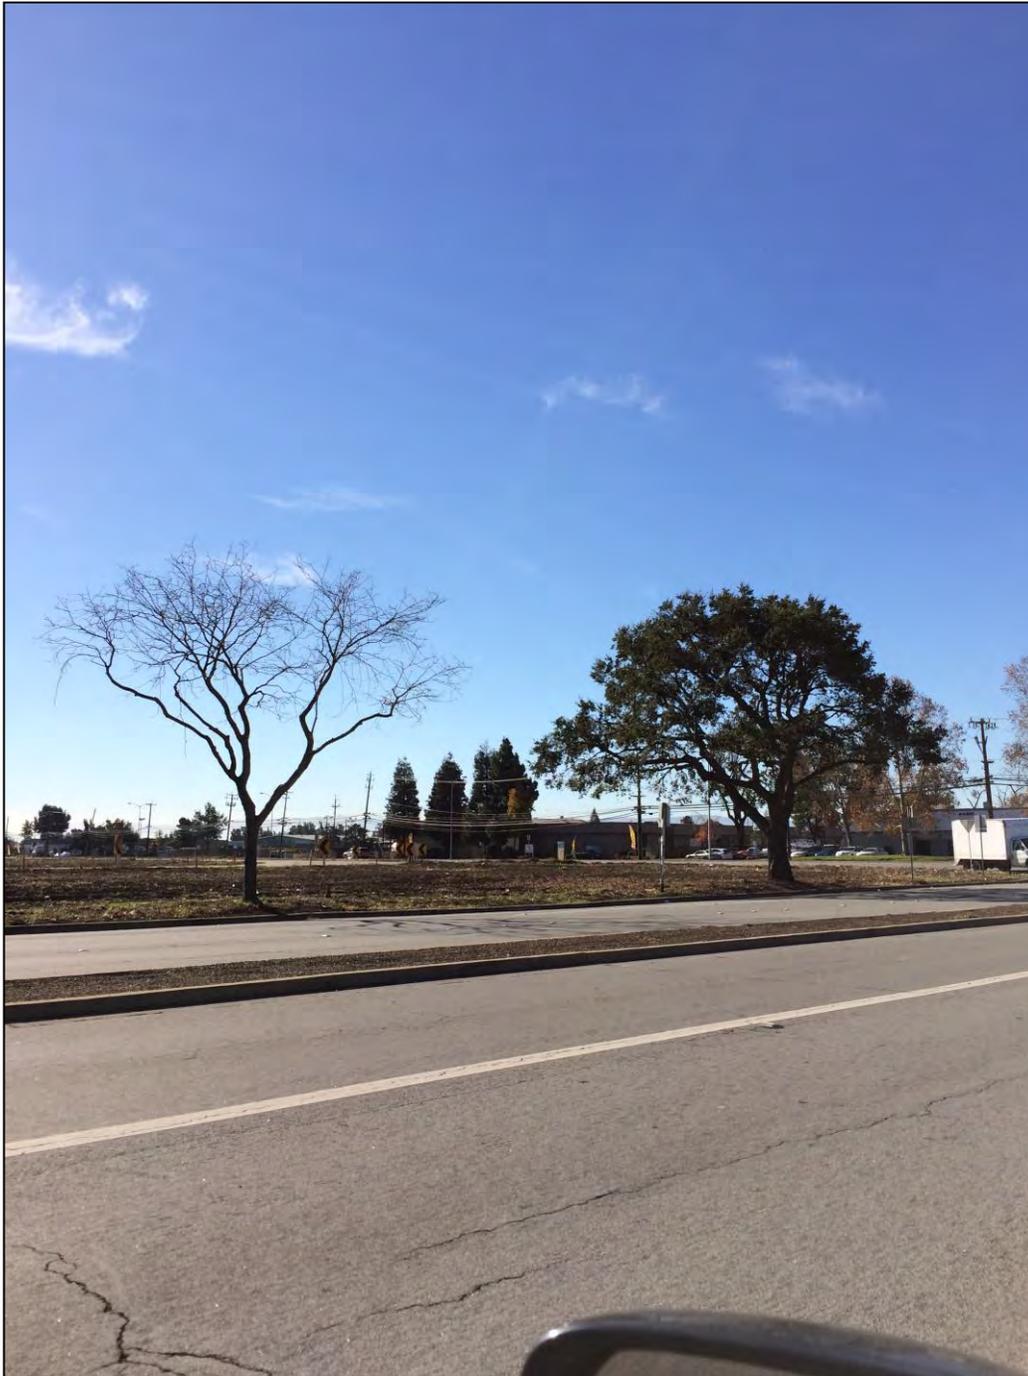
Figure 12: Trees #15 and #16

Tag	Common Name	Species	Diameter (inches)	Height (feet)	Canopy (feet)	Overall Condition	Comments
16	Coast Live Oak	<i>Quercus agrifolia</i>	27	30	40	Good	Leaning; Fungal infection; Thinning canopy; Poor pruning cuts
17	Chinese Pistache	<i>Pistachia chinensis</i>	6	10	10	Poor	Slight lean; Basal pruning cuts
18	Chinese Pistache	<i>Pistachia chinensis</i>	6	10	10	Poor	Slight lean; Basal pruning cuts
19	Coast Redwood	<i>Sequoia sempervirens</i>	9	20	10	Poor	Stunted growth; Water-stressed; Low canopy density
20	Chinese Pistache	<i>Pistachia chinensis</i>	6	10	10	Poor	Thinning canopy; Poor structure
21	Chinese Pistache	<i>Pistachia chinensis</i>	8	15	20	Poor	Major trunk wound; Poor pruning cuts; Leaning
22	Coast Redwood	<i>Sequoia sempervirens</i>	13	35	15	Poor	Stunted growth; Water-stressed; Low canopy density
23	Coast Redwood	<i>Sequoia sempervirens</i>	13	35	15	Poor	Stunted growth; Water-stressed; Low canopy density

Along South Grimmer Boulevard, many of the trees lining the street have either been over pruned or not maintained at all. For these reasons, most of the trees along South Grimmer Boulevard exhibit poor structure. Several are dead or nearly dead. However, there is one tree on the property that is of exceptional value, Tree #16 *Quercus agrifolia* (coast live oak). If possible, Tree #16 should be preserved in place.

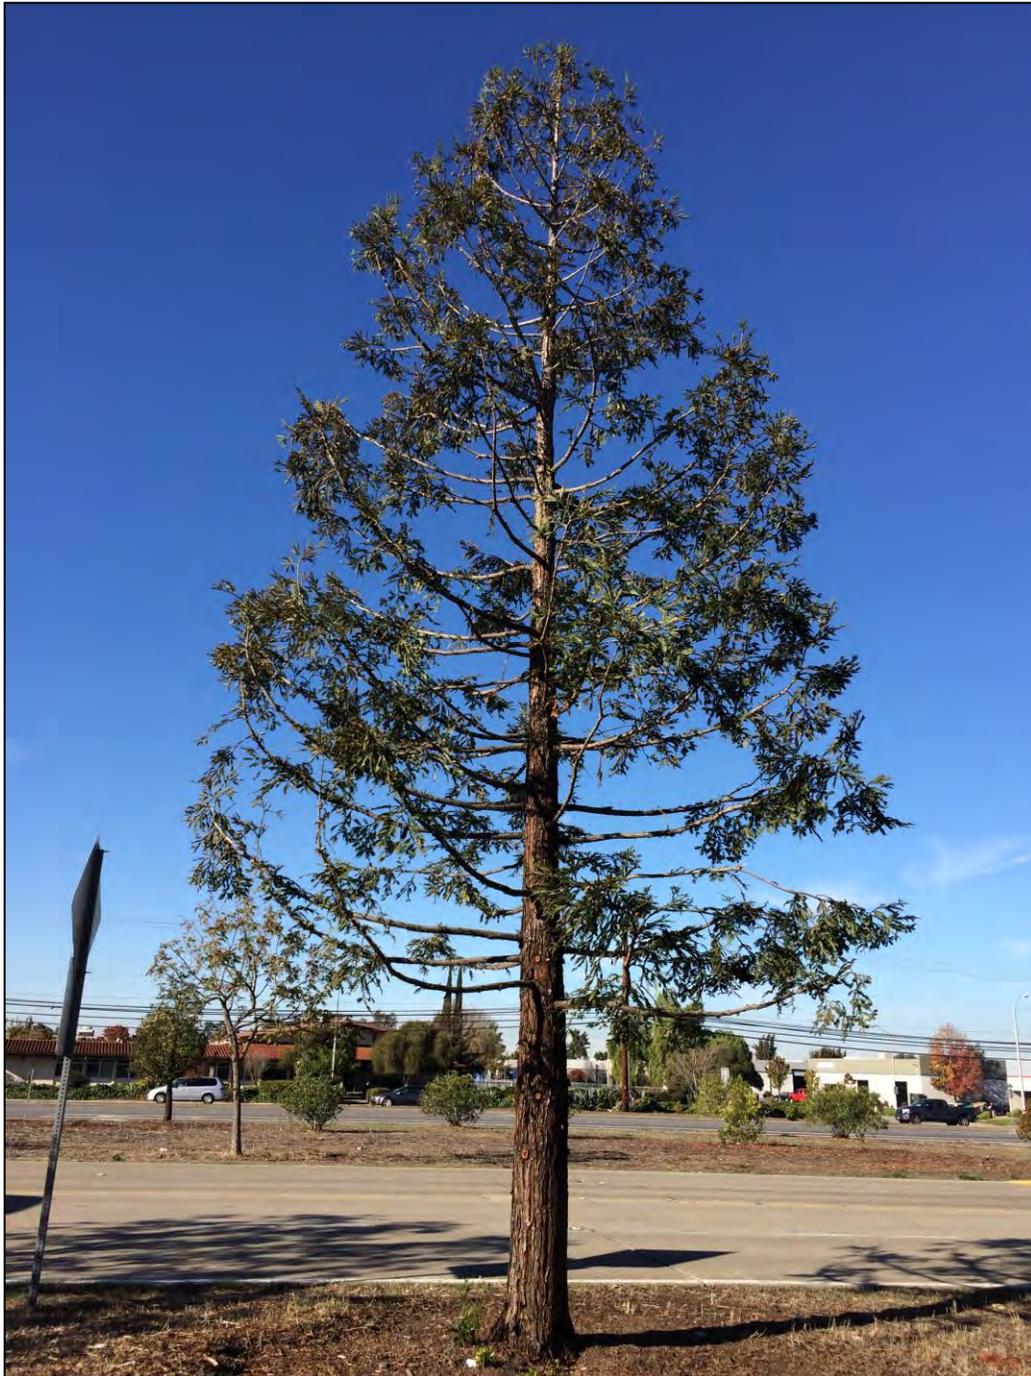
Figure 20: Tree #24

24	Coast Redwood	<i>Sequoia sempervirens</i>	12	35	15	Poor	Stunted growth; Water-stressed; Low canopy density
25	Chinese Pistache	<i>Pistachia chinensis</i>	6	15	20	Poor	Leaning; Thinning canopy
26	Chinese Pistache	<i>Pistachia chinensis</i>	7	15	20	Poor	Leaning; Thinning canopy; Vehicle strike
27	Coast Redwood	<i>Sequoia sempervirens</i>	18	40	20	Poor	Stunted growth; Water-stressed; Low canopy density
28	Peruvian Pepper Tree	<i>Schinus molle</i>	12	25	35	Moderate	Volunteer
29	Peruvian Pepper Tree	<i>Schinus molle</i>	17	20	30	Moderate	Topped ; Volunteer
30	Peruvian Pepper Tree	<i>Schinus molle</i>	14	20	30	Moderate	Topped ; Volunteer
31	Deodar Cedar	<i>Cedrus deodara</i>	8	20	10	Poor	Leaning; Roots uplifting
32	Chinese Pistache	<i>Pistachia chinensis</i>	7	15	20	Poor	Leaning; Thinning canopy
33	Chinese Pistache	<i>Pistachia chinensis</i>	8	15	20	Poor	Leaning; Thinning canopy
34	Coast Redwood	<i>Sequoia sempervirens</i>	14	35	25	Poor	Stunted growth; Water-stressed; Low canopy density

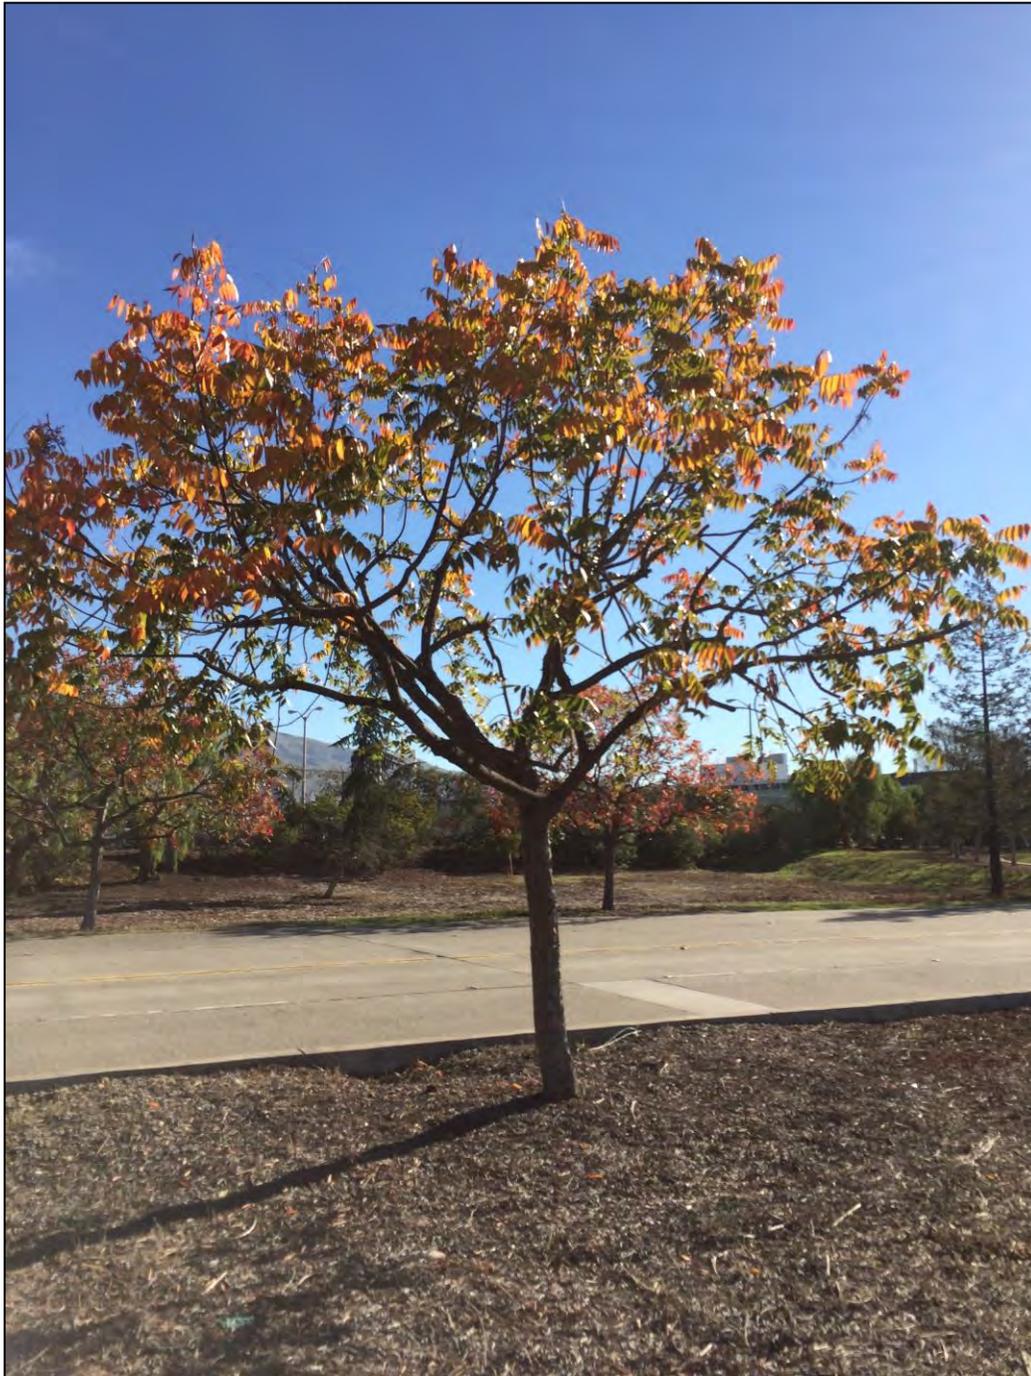
Figure 33: Tree #43

43	Chinese Pistache	<i>Pistachia chinensis</i>	7	15	20	Poor	Leaning; Thinning canopy
44	Chinese Pistache	<i>Pistachia chinensis</i>	6	15	20	Poor	Leaning; Thinning canopy
45	Chinese Pistache	<i>Pistachia chinensis</i>	6	10	15	Poor	Leaning; Thinning canopy
46	Chinese Pistache	<i>Pistachia chinensis</i>	6	15	20	Poor	Leaning; Thinning canopy
47	Chinese Pistache	<i>Pistachia chinensis</i>	6	10	10	Very Poor	Mostly Dead
48	Coast Redwood	<i>Sequoia sempervirens</i>	14	20	10	Poor	Topped; Stunted growth; Water-stressed; Low canopy density
49	Coast Redwood	<i>Sequoia sempervirens</i>	8	10	10	Poor	Stunted growth; Water-stressed; Low canopy density; Leaning
50	Coast Live Oak	<i>Quercus agrifolia</i>	9	10	10	Moderate	Overpruned
51	Coast Live Oak	<i>Quercus agrifolia</i>	7	10	5	Poor	Severe canopy dieback
52	Italian Cypress	<i>Cupressus sempervirens</i>	16*	30	5	Good	Inaccessible
53	Italian Cypress	<i>Cupressus sempervirens</i>	16*	30	5	Good	Inaccessible

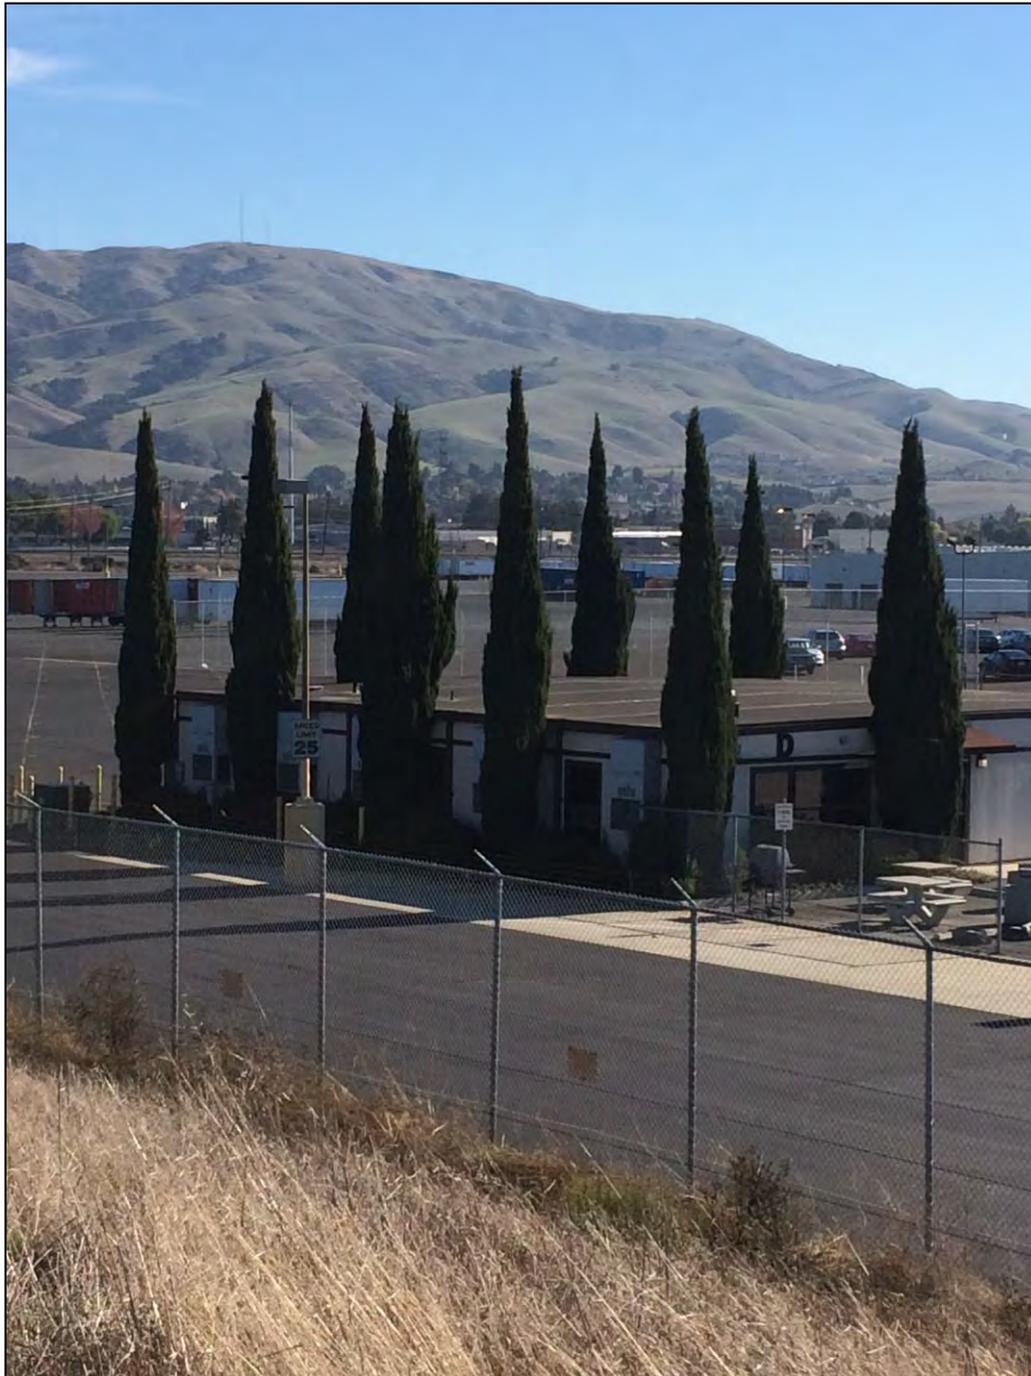
Figure 42: Tree #52 through #60

Tag	Common Name	Species	Diameter (inches)	Height (feet)	Canopy (feet)	Overall Condition	Comments
54	Italian Cypress	<i>Cupressus sempervirens</i>	16*	30	5	Good	Inaccessible
55	Italian Cypress	<i>Cupressus sempervirens</i>	16*	30	5	Good	Inaccessible
56	Italian Cypress	<i>Cupressus sempervirens</i>	16*	30	5	Good	Inaccessible
57	Italian Cypress	<i>Cupressus sempervirens</i>	16*	30	5	Good	Inaccessible
58	Italian Cypress	<i>Cupressus sempervirens</i>	16*	30	5	Good	Inaccessible
59	Italian Cypress	<i>Cupressus sempervirens</i>	16*	30	5	Good	Inaccessible
60	Italian Cypress	<i>Cupressus sempervirens</i>	16*	30	5	Good	Inaccessible
