## CONDITIONS ASSESSMENT & TREATMENT RECOMMENDATIONS

RODRIGUES FARMHOUSE PROPERTY  
41948 MISSION BOULEVARD, FREMONT  
APN 513-450-4-2  
CITY OF FREMONT PROJECT #: PLN2018-0013  
[17267]

PREPARED FOR:  
CITY OF FREMONT

JANUARY 24, 2018

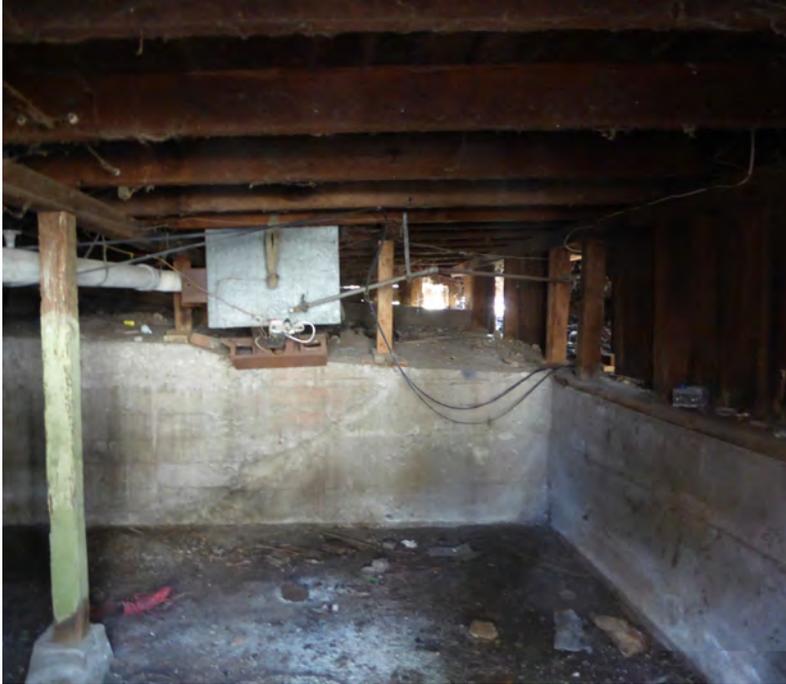
Walls and the floor of the farmhouse are not straight or plumb. The building rests on a partial concrete foundation (in fair condition with evidence of efflorescence), concrete footings (Good), and areas of stacked and shored boards resting on grade below support posts (Good/Fair). The woodwork under the house is in fair condition, with some joists cracked or split. Exposed historic wiring passing through joists presents a fire concern (though the house appeared to be disconnected from electrical power). Debris including trash, cabling, scrap wood, sticks, and dried grass is present throughout the crawlspace area. The paired cellar doors that allow access down into the concrete-supported area of the crawlspace have been heavily damaged. On the south side of the building, the crawlspace access opening is uncovered.

Image 7 - (left) Partial concrete foundation.

- Character-defining features should be retained.
- Install a new structural<sup>3</sup> foundation under the farmhouse in accordance with the 2016 California Historic Building Code.

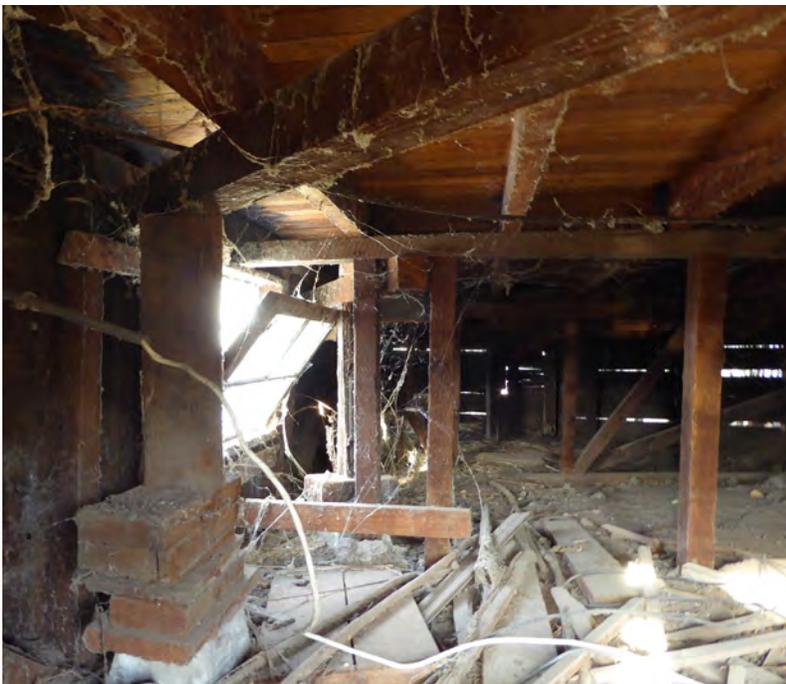
Image 8 - (left, below) Debris and posts direct on grade.

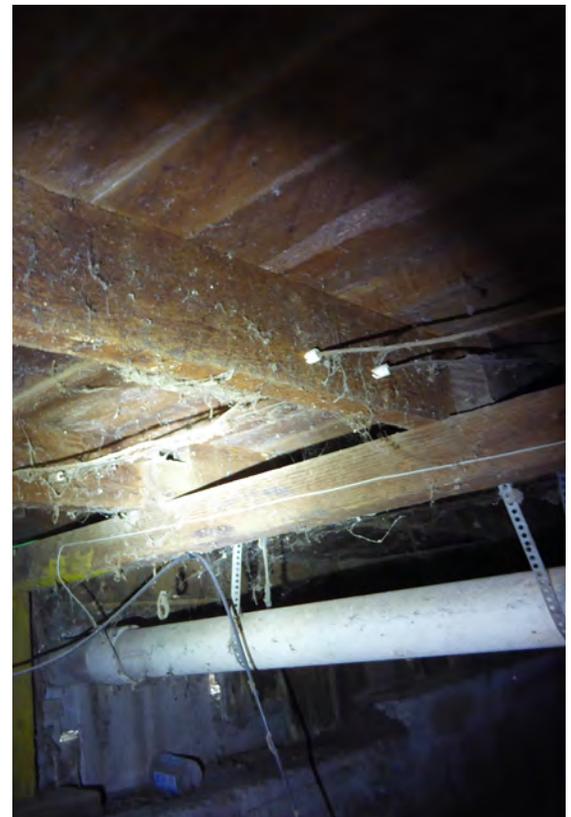
Image 9 - (right, below) Wiring and a split floor joist at floor joists.

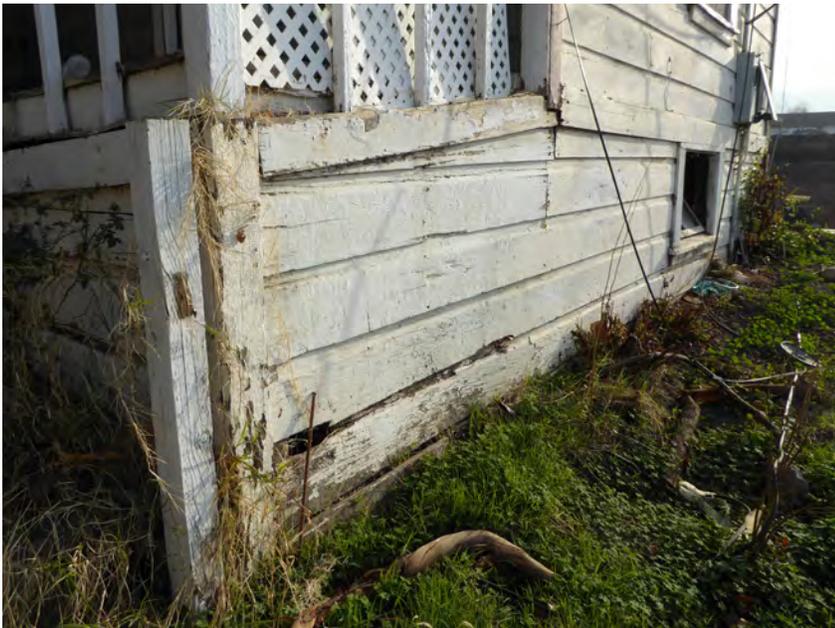
Image 10 - (left) Typically the siding is reusable above the floor level.

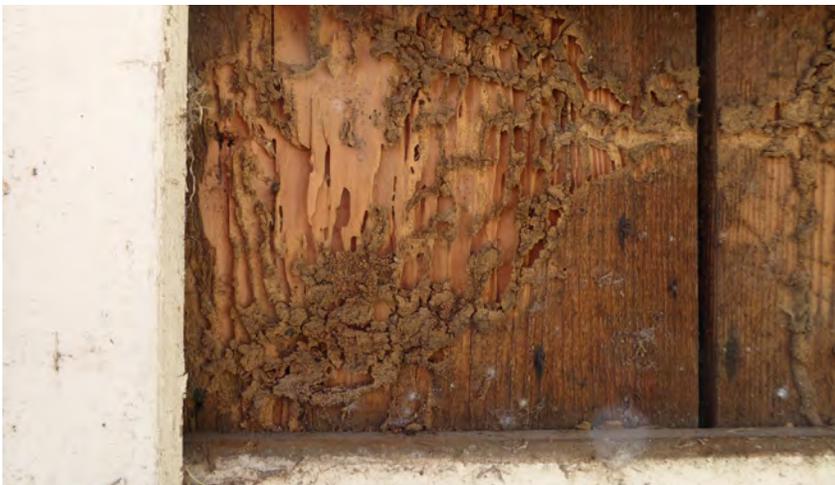
Image 11 - (left, below) Termite damage at sheathing under the siding; note that adjacent siding is in good condition.

- The sheathing under siding and the structural frame should be fully examined for termite damage and/or rot.
  - The walls may be corrected to be true, straight, and plumb, with sheathing and siding adjusted accordingly on the frame.

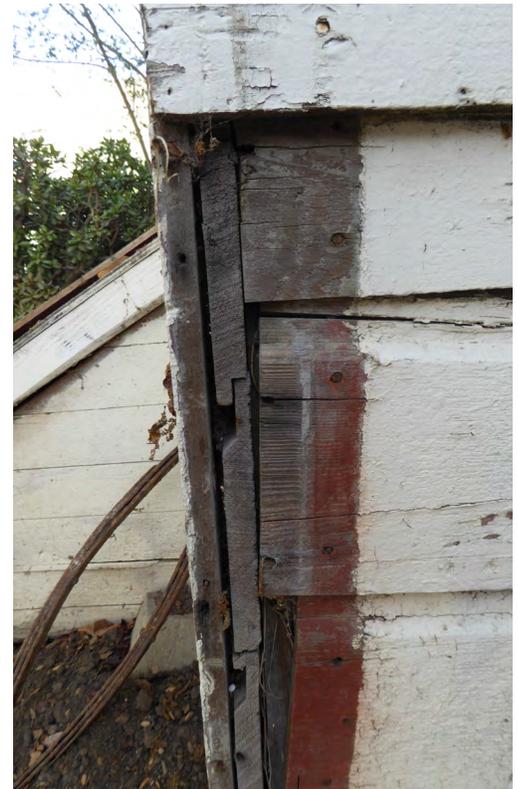
Image 12 - (right, below) Missing casing at the trim exposed the siding construction in this section of the building.

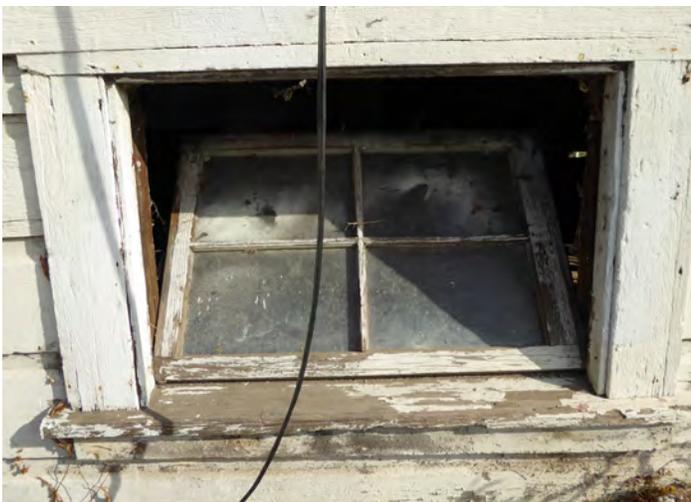
Another original window remains on the west elevation at the level of the crawlspace and is in poor condition. This window remains operable, but has heavy paint delamination and UV degradation. Joints at all of the window components are separating.

*Image 13 - (below) Crawlspace window*

- Window sashes and frames should be replaced in kind to match the remaining historic windows. Deficient design, like that of the dramatically sloping sills which allow for easy water and air infiltration, should be corrected. Insulated glazing may be used in lieu of the original single pane glass, but the profile and overall thickness of the window should ideally be a close to the original as possible. Muntin and casing profiles should match the original.

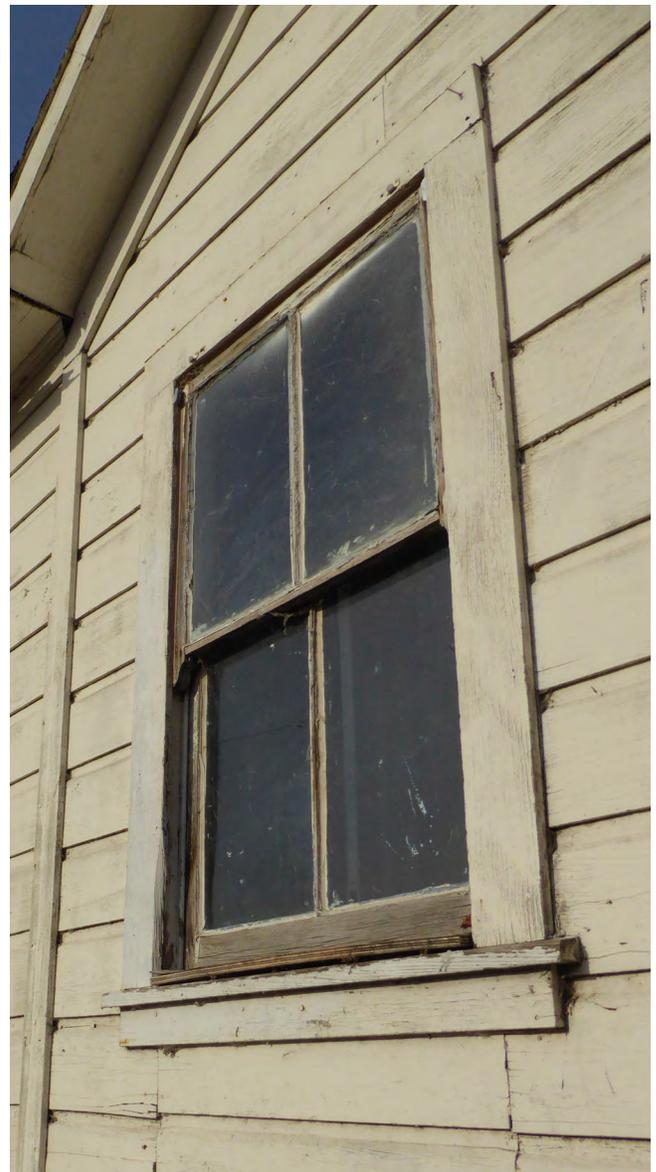
Windows throughout the farmhouse have been replaced within their original openings for the most part. One original window remains on the south façade, but even this window has been modified and is in poor condition. At this window, the sash weights are intact and the window carries its original hardware. A 2x4 has been added to the heavily sloped sill, the glazing has been replaced, and the bottom rail of the lower sash is loose and separated from the side rails. From the exterior, paint delamination is evident as is UV degradation of the wood in all parts of the window.

*Image 14 - (right) Original window on the main floor level*

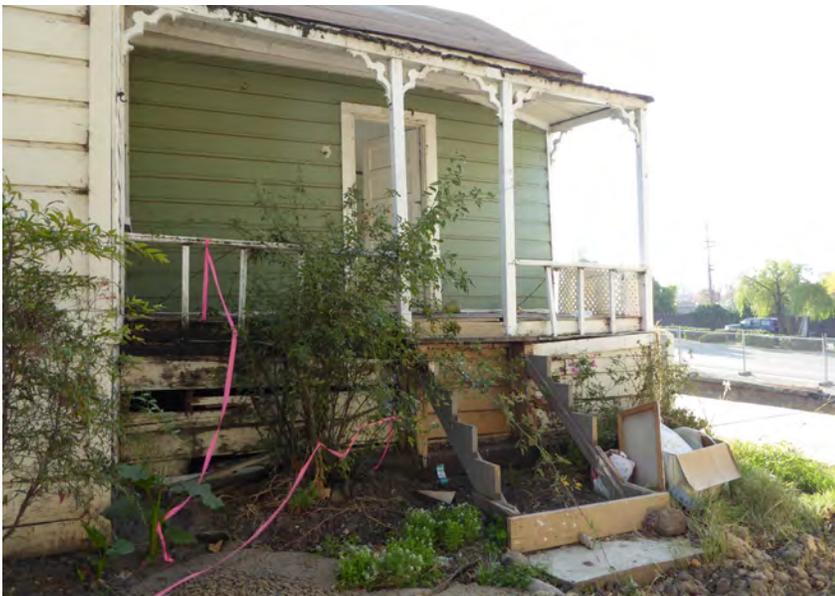
The open porch at the northwest corner of the building slopes toward its outside corner. Its roof likewise slopes toward the corner. Siding of the porch apron is heavily deteriorated with open holes and breakage common. Plank flooring is partially covered over by plywood and is rotting in some areas. Support posts are in fair condition as is the tongue-and-groove ceiling. Nails penetrate the ceiling from the roof and it bows in some areas. The roof over the porch itself is in very poor condition, with breakage and loss around all edges. Scrollwork brackets are in fair condition with paint delamination and minor UV damage. The stair treads have been removed.

Image 15 - (prior page, top left) The open porch.

- The open porch materials should be replaced in kind as Condition Drawings indicate is required. Biological growth can be cleaned from any remaining members using an appropriate cleaner. The roof above the porch should be reframed and roof material replaced to match the rest of the farmhouse. Ceiling boards should be salvaged and reused. Flooring planks may be replaced as required.

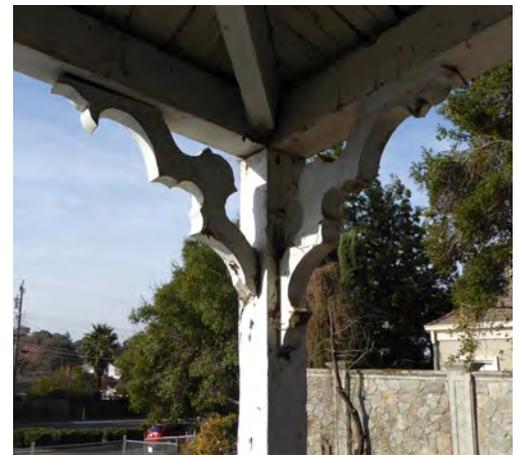
Image 16 - (prior page, top right) The brackets are in fair condition.

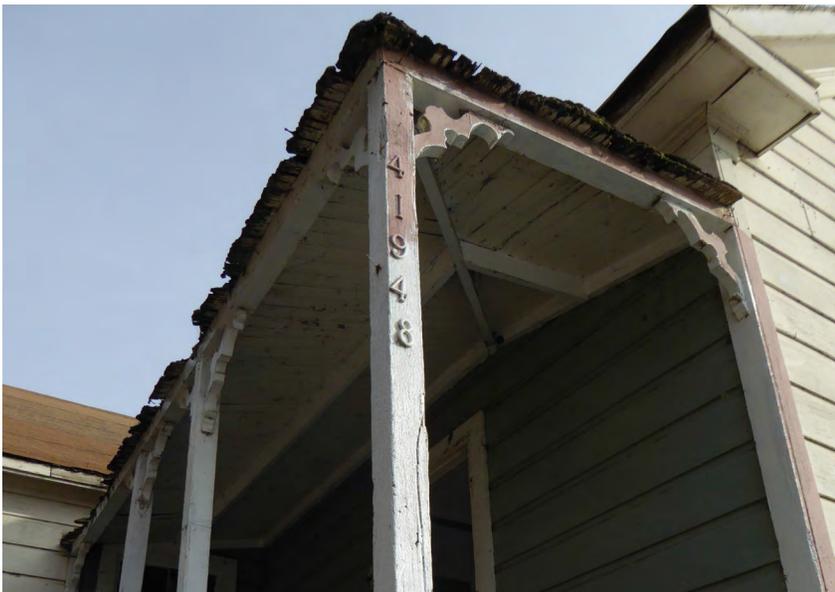
Image 17 - (prior page, bottom left) The heavily deteriorated porch roof.

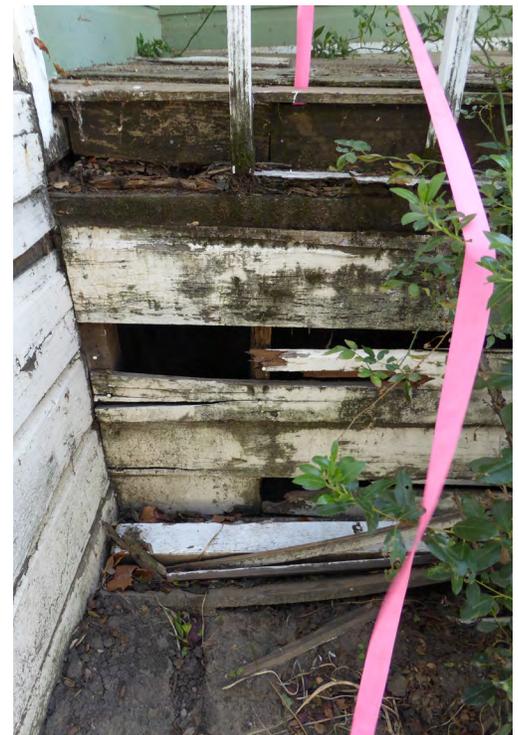
Image 18 - (prior page, bottom right) The siding under the porch is in poor condition.

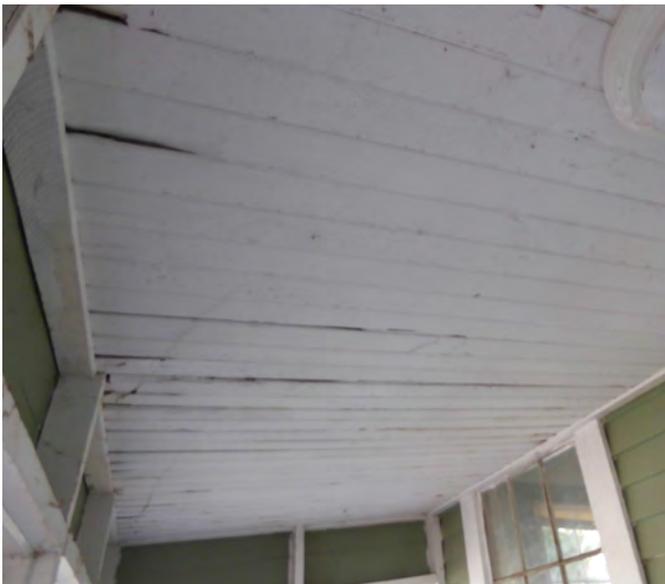
The screen porch is sloping toward the northeast corner. The plank flooring is in fair condition. Tongue-and-groove ceiling boards are in fair condition and are separating in some areas. The door casing into the interior of the farmhouse has been modified and a new aluminum door cut in to the exterior street wall.

Image 20 - (bottom left) The porch ceiling.

- The screen porch materials should be replaced in kind as Condition Drawings indicate. The porch should be made square with the foundation installation. Siding should be salvaged and reused. Screen material may be replaced where holes exist, with seams installed behind casing elements. Casing of the farmhouse door can be modified to match the historic profile. Flooring and ceiling boards may be replaced as required where damaged or missing.

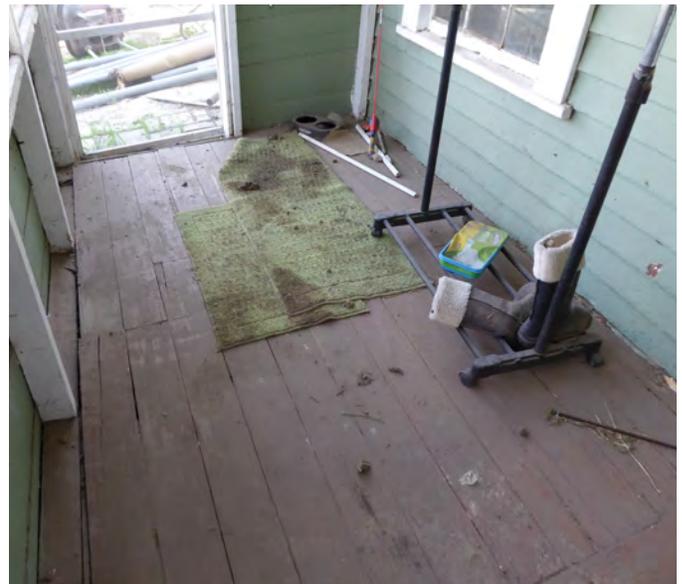
Image 21 - (bottom right) The porch floor.

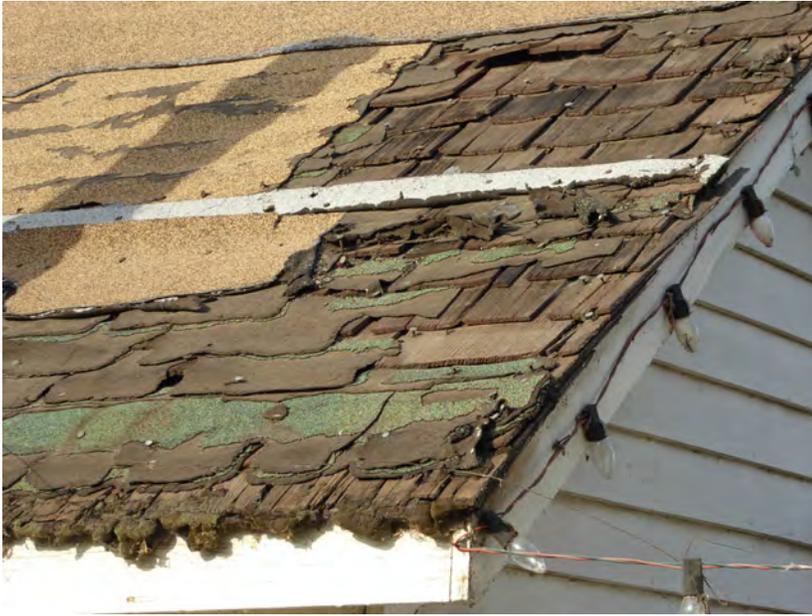
The roof of the farmhouse is in poor condition. Underneath the added layers of bitumen roll roofing, wood shingles are visible on all areas of the farmhouse. Previous water intrusion is evident in the interior, though the current performance of the roof is unknown. Gutters and fascia boards on many façades are in poor condition with certain inoperability. The soffit is damaged or missing adjacent to the damaged gutters, notably at the southeast corner of the farmhouse. Here, there is also evidence of sistering in the roof rafters and deterioration is visible of the roof decking under the extant shingles.

*Image 22 - Wood shingles are visible under the many layers of added roofing.*

- The roof should be stripped of all existing roofing and replaced with wood shingles to match those at the lowest, historic layer.
  - Any structurally deficient members of the roof should be sistered or replaced in kind with wood that matches in species, size and profile.

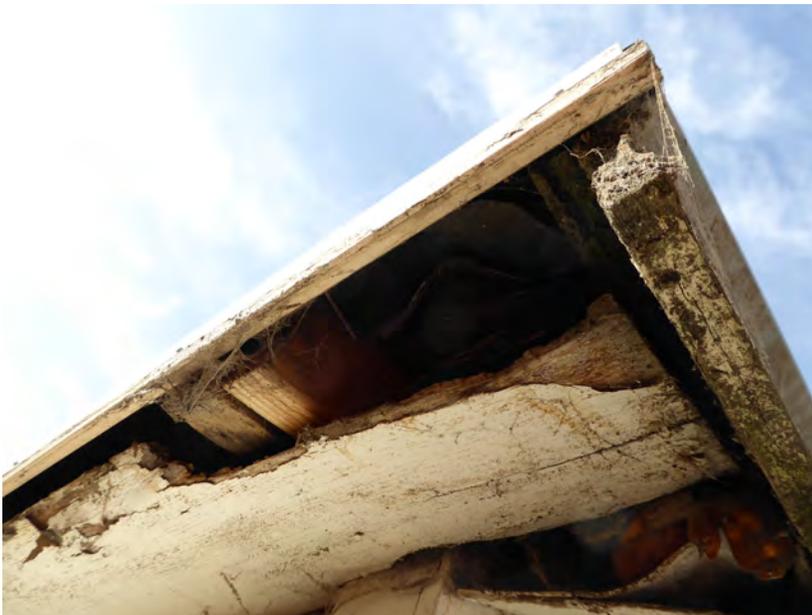
*Image 23 - Water damage has caused the soffit and fascia board to rot.*

- Deteriorated fascia boards and soffits should be replaced in kind to match remaining material in locations indicated in Condition Drawings.
- Gutters and downspouts should be cleared and reinstalled or replaced in kind where damaged. New solutions may be inserted where required by the new foundation work.

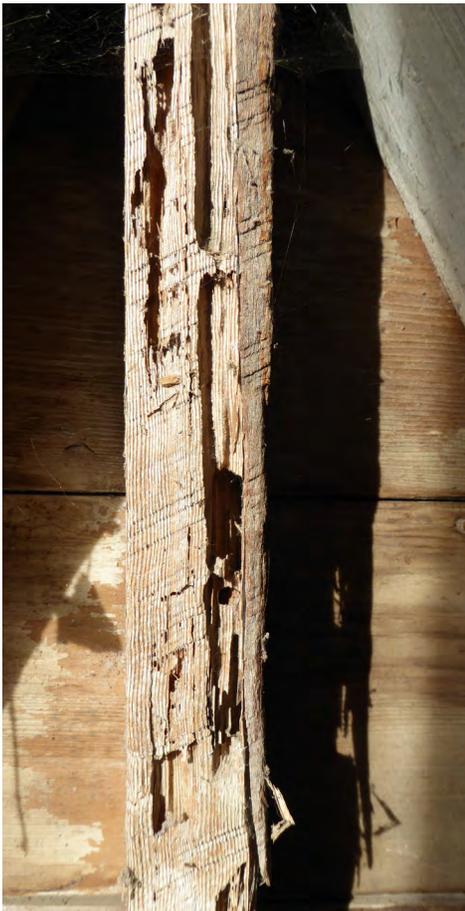
The framing of the tankhouse suffers from considerable termite damage, splitting, and evidence of water leakage from the roof. The concrete foundation and floor both carry large cracks and partial exfoliation. Debris is also present within this space.

*Image 24 - (this page, left) Termite damage in the studs.*

- The damaged structural frame of the tankhouse should be repaired or replaced as directed by a structural engineer. The wood threshold should be replaced.

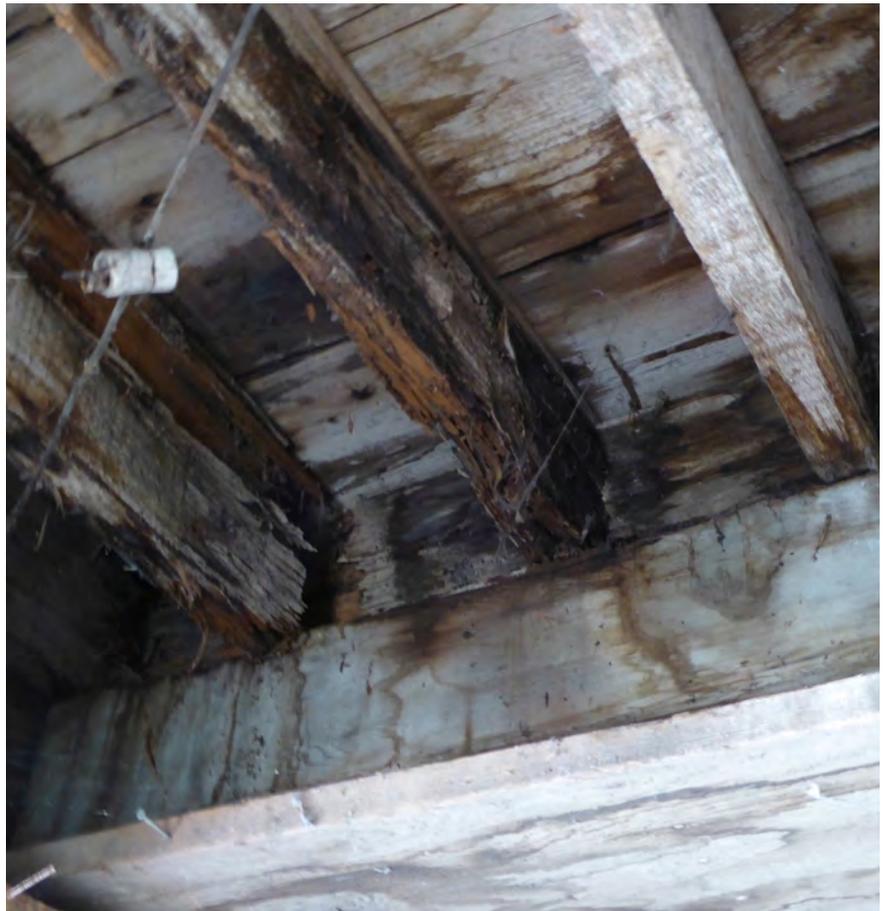
*Image 25 - (this page, right) Water and termite damage in the ceiling joists.*

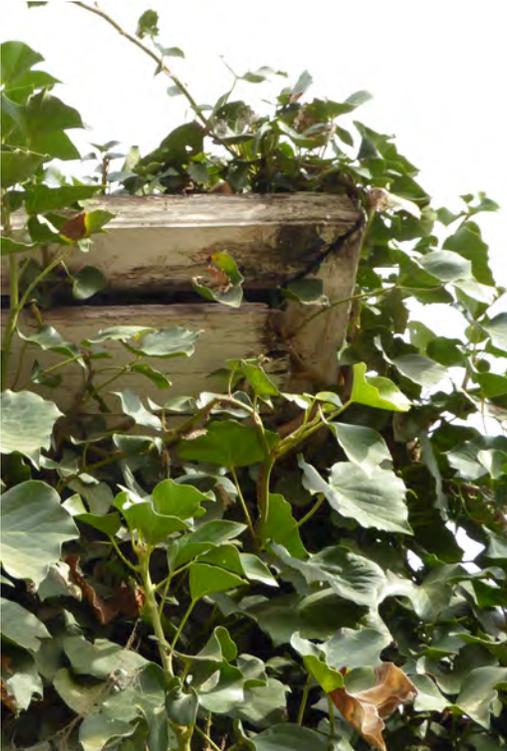
*Image 28 - (next page, bottom left) Rot at the roof eave.*

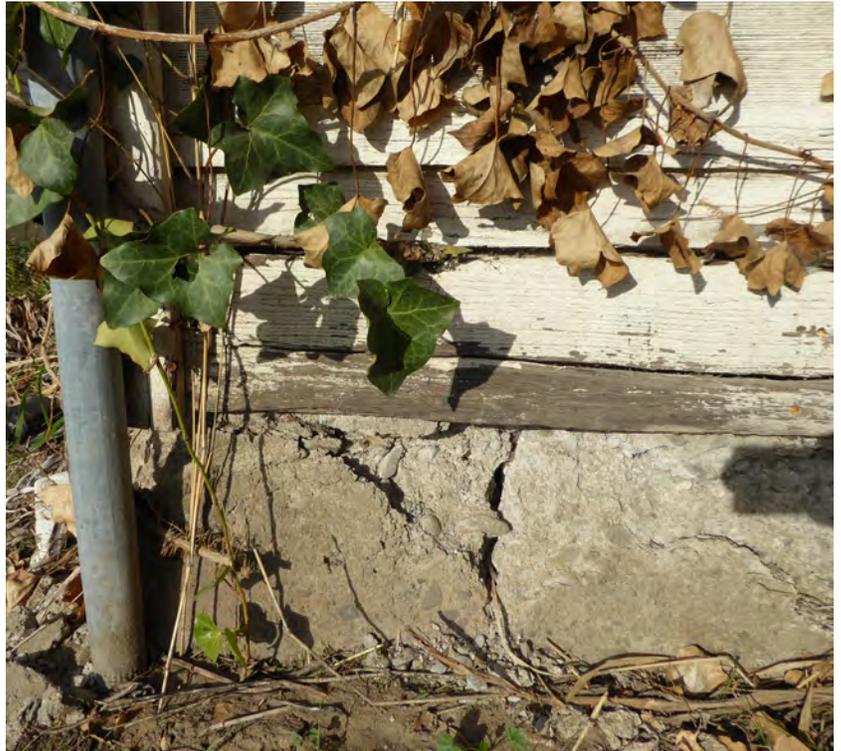
*Image 29 - (next page, bottom right) Concrete spalling and split siding at the base of the tankhouse.*

- The tankhouse's concrete foundation should be patched and/or reinforced as directed by a structural engineer. Areas of exfoliation should be patched to a finish that matches the adjacent material.

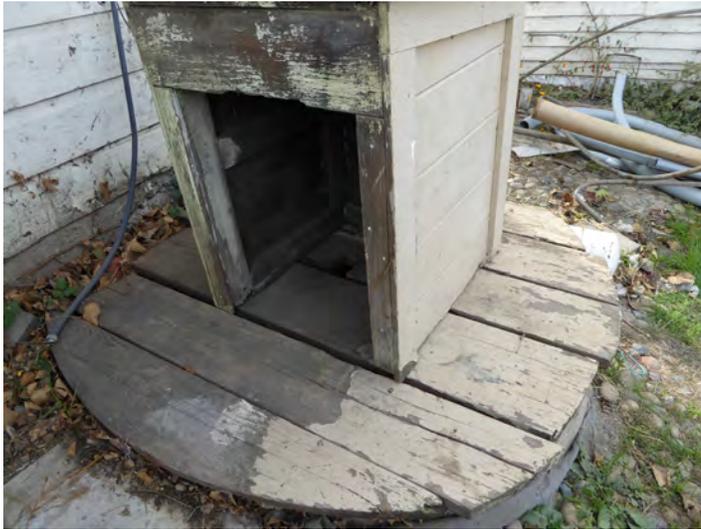
Paint delamination and UV damage to the substrate wood are the primary concerns though the wood is all reusable. The boards over the well gap and are not anchored to the brick well below presenting a safety hazard. The roof of the pumphouse is in poor condition with loss of some shingles. The anchoring nails are corroded and loose over some remaining shingles.

Image 30 - (top left) The boards which cover the well gap and have paint loss.

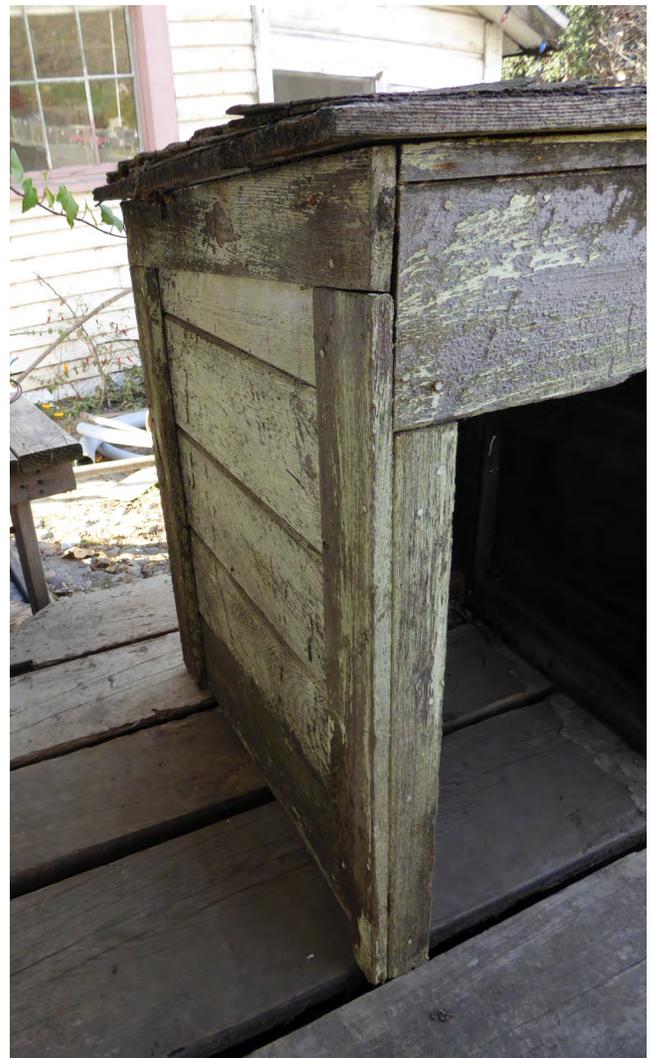
Image 33 - (bottom right) Paint delamination on the pumphouse.

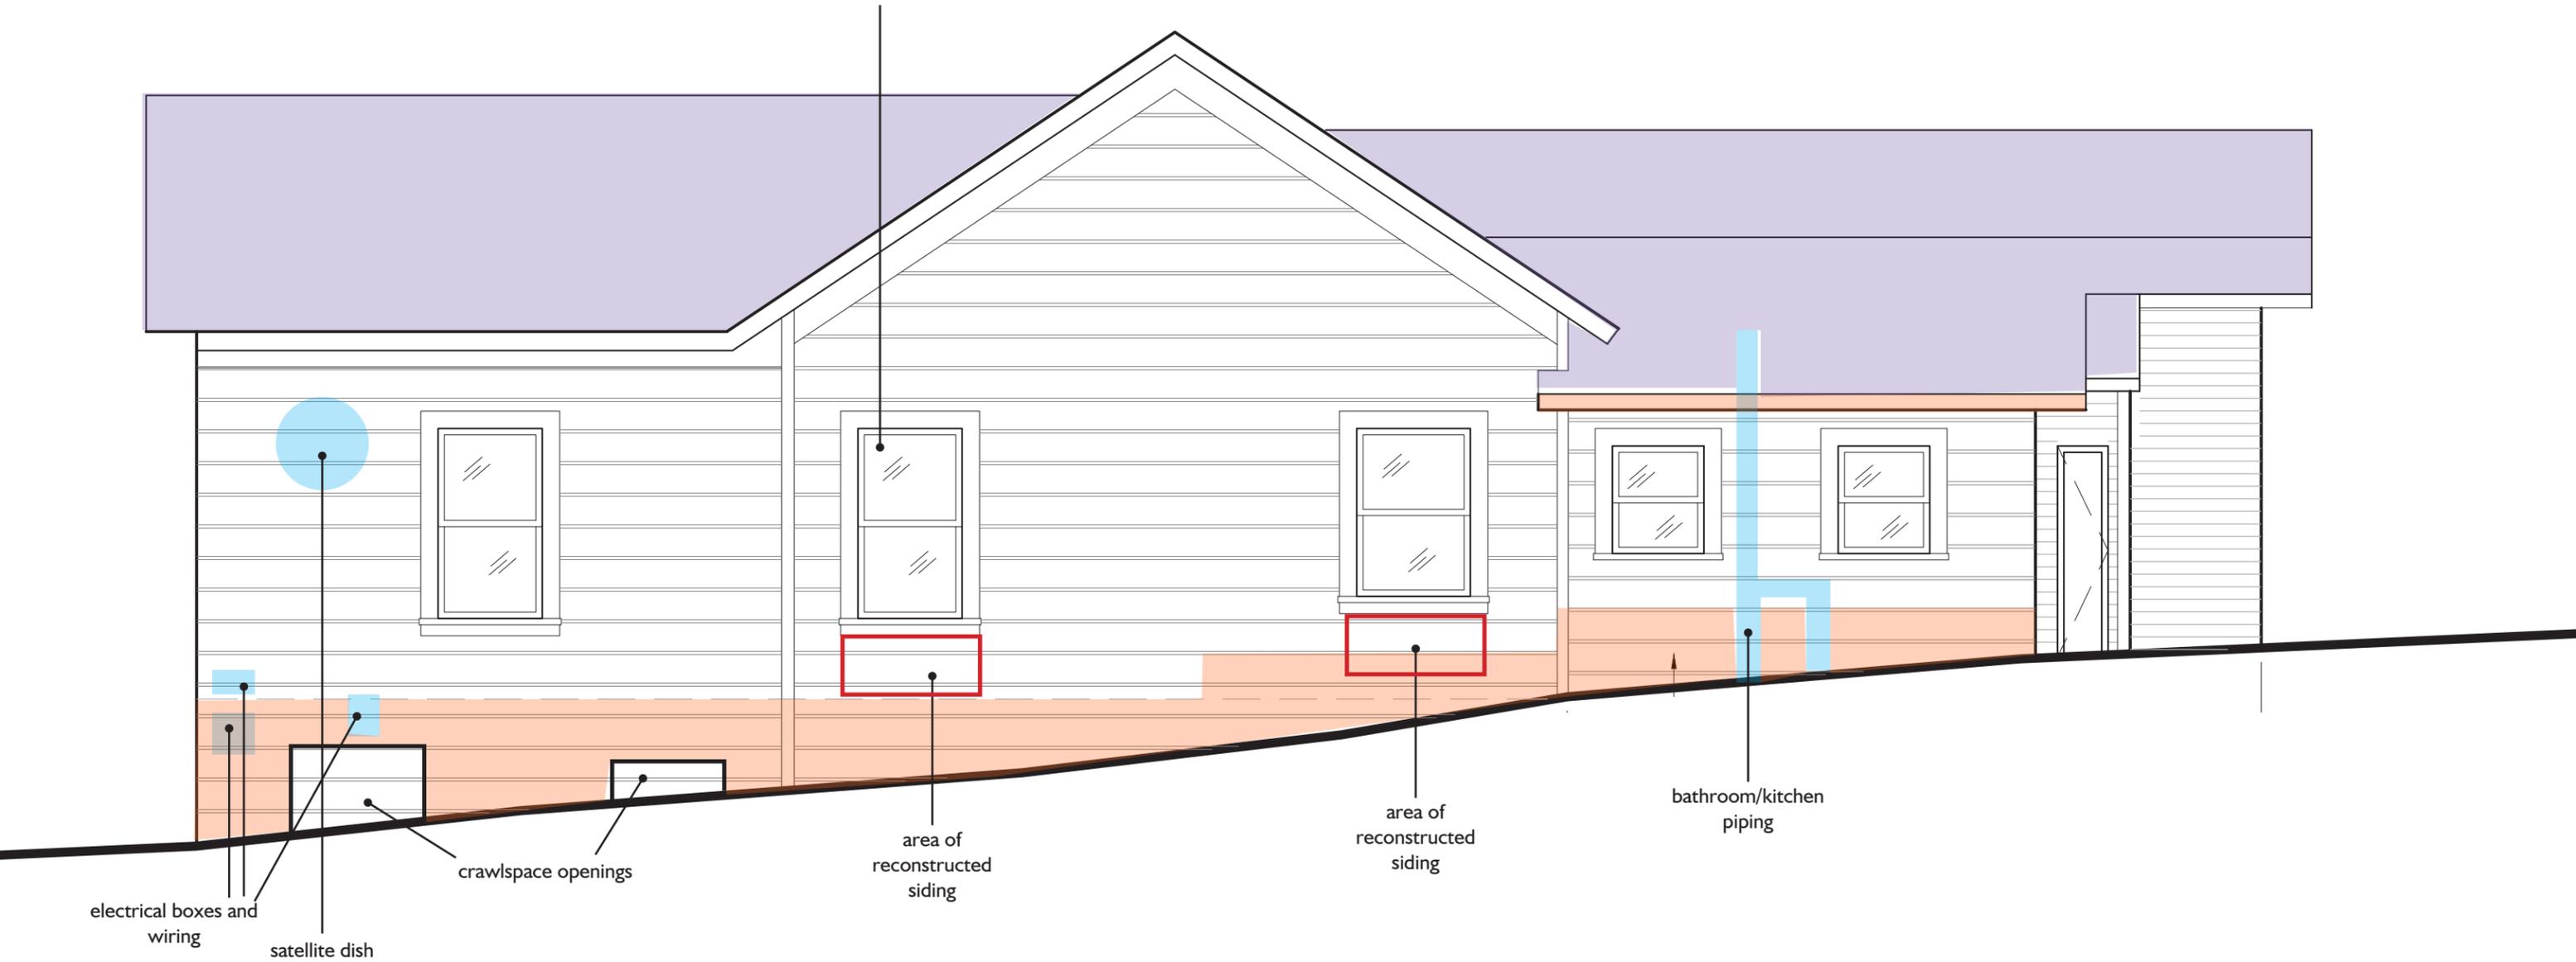
1 EXISTING SOUTH ELEVATION

ORIGINAL WINDOW:  
loose bottom rail, joint  
separation, replaced glazing,  
added 2x4 to sill

- replace all window sills and casing on this elevation

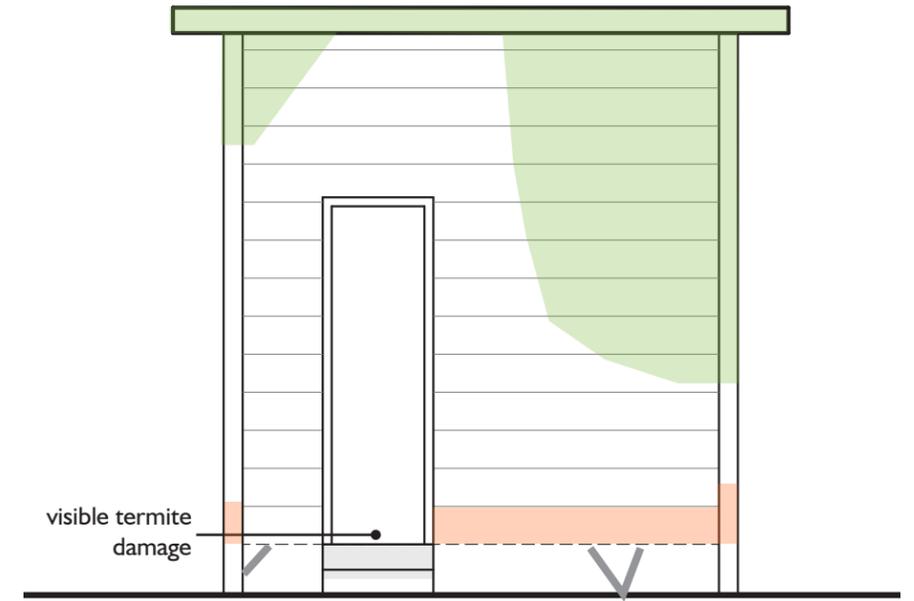
③ EXISTING FRONT ELEVATION

visible termite damage
