Tree Inventory Report

Osgood II
Fremont CA

November 2018

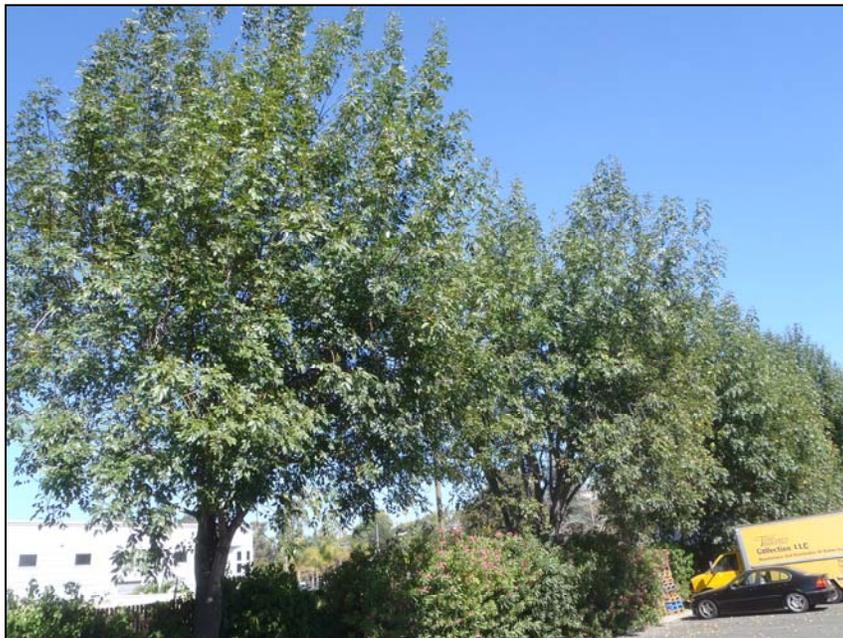
The site contained 18 trees, represented by 4 species. The most frequently occurring species was evergreen ash, with 12 trees. The evergreen ash had been planted along the northern property boundary, adjacent to the parking lot. Trunk diameters ranged from 8" to 24" and condition was good (9 trees) to fair (3 trees). None of the evergreen ash were in poor condition. Most had old topping points, but the trees had grown new crowns (Photo 1). In addition, several had displaced the adjacent curbs and asphalt from 3" to 5".

Photo 1 (L):
Looking northeast at evergreen ash #82 (R) and 83 (L). A row of 12 evergreen ash had been planted along the northern boundary and were in good to fair condition.

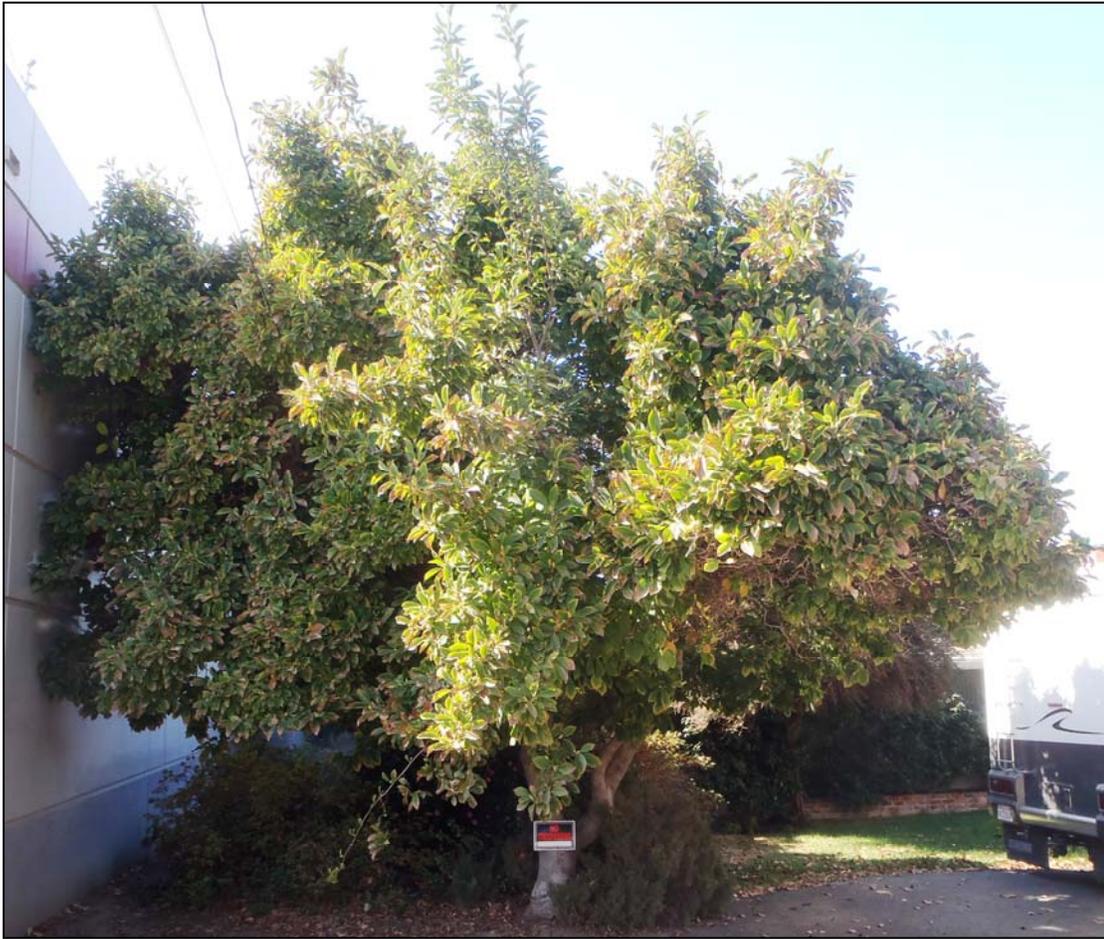
Photo 2: Looking west at saucer magnolia #65. The tree was mature and in good condition. It had a spreading crown and according to the homeowner, stopped traffic on Osgood when in full flower.

- Retaining select trees with high or moderate suitability for preservation, including perimeter evergreen ash, saucer magnolia #65 and Chinese pistache #86.
- Establishing **TREE PROTECTION ZONES** for each tree to be preserved. **TREE PROTECTION ZONES** are identified by the Consulting Arborist based on species tolerances, tree condition, trunk diameters and the nature and proximity of the proposed disturbance.
- Providing supplemental irrigation prior to and during the demolition and construction phases, especially for any of the coast redwoods identified for preservation.
