<b>Type of Services</b>	<b>Phase I Environmental Site Assessment</b>
<b>Location</b>	<b>43510 Osgood Road Fremont, California</b>
<b>Client</b>	<b>Seefried Industrial Properties, Inc.</b>
<b>Client Address</b>	<b>2201 East Camelback Road Phoenix, Arizona</b>
<b>Project Number</b>	<b>791-3-1</b>
<b>Date</b>	<b>September 10, 2015</b>

**Phase I Environmental Site Assessment**  
**43510 Osgood Road**  
**Fremont, California**

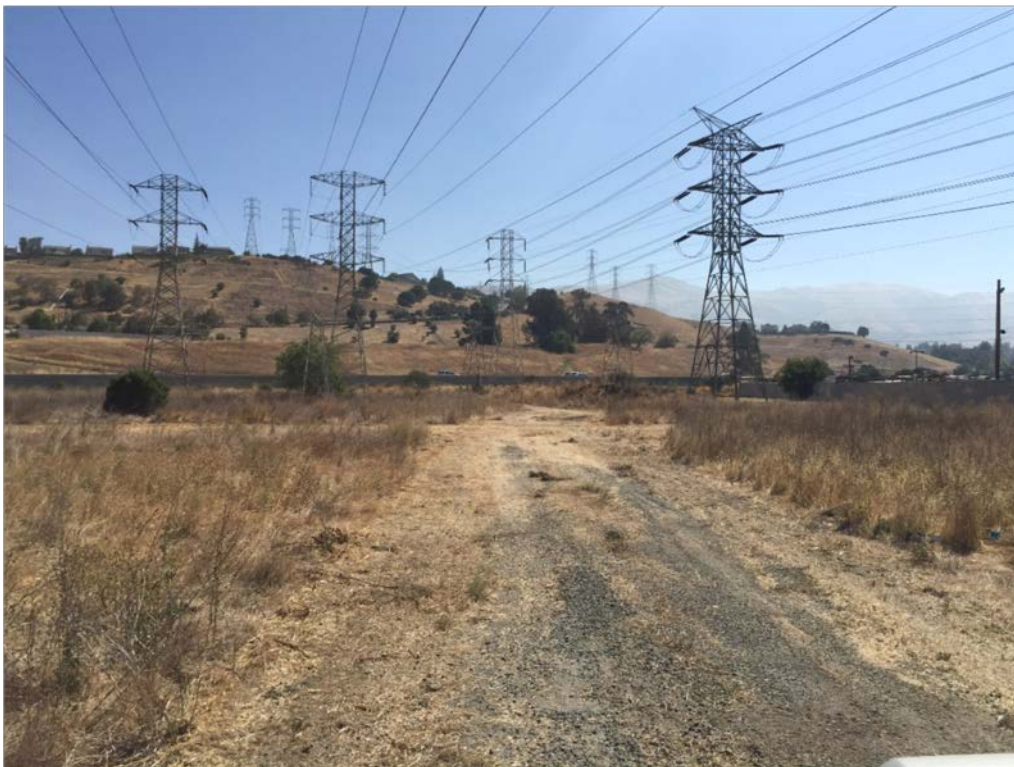
Seven high voltage transmission line towers and were observed at the eastern end of the Site. The transmission lines travelled off of these towners in an east-northeast / west-southwest orientation. The location of these towers are shown on Figure 2.

Photograph 1. Typical view of Site showing high voltage transmission towers and Cormack Road alignment.

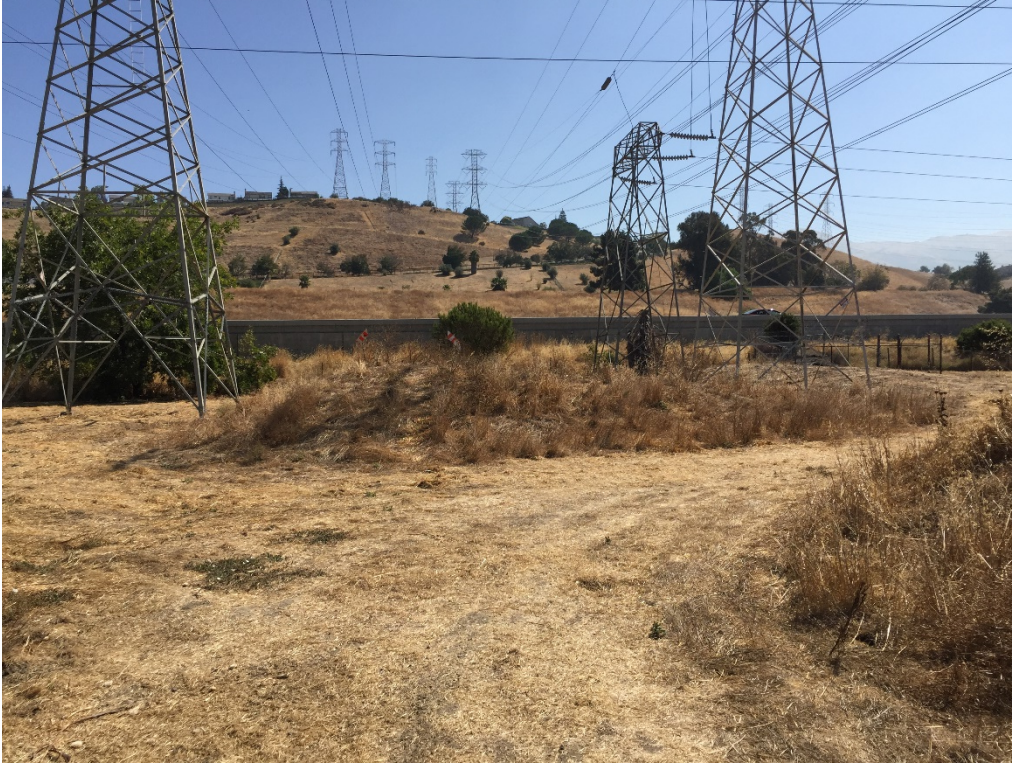
Photograph 2. Electrical transmission towers and soil stockpiles in areas not cleared.

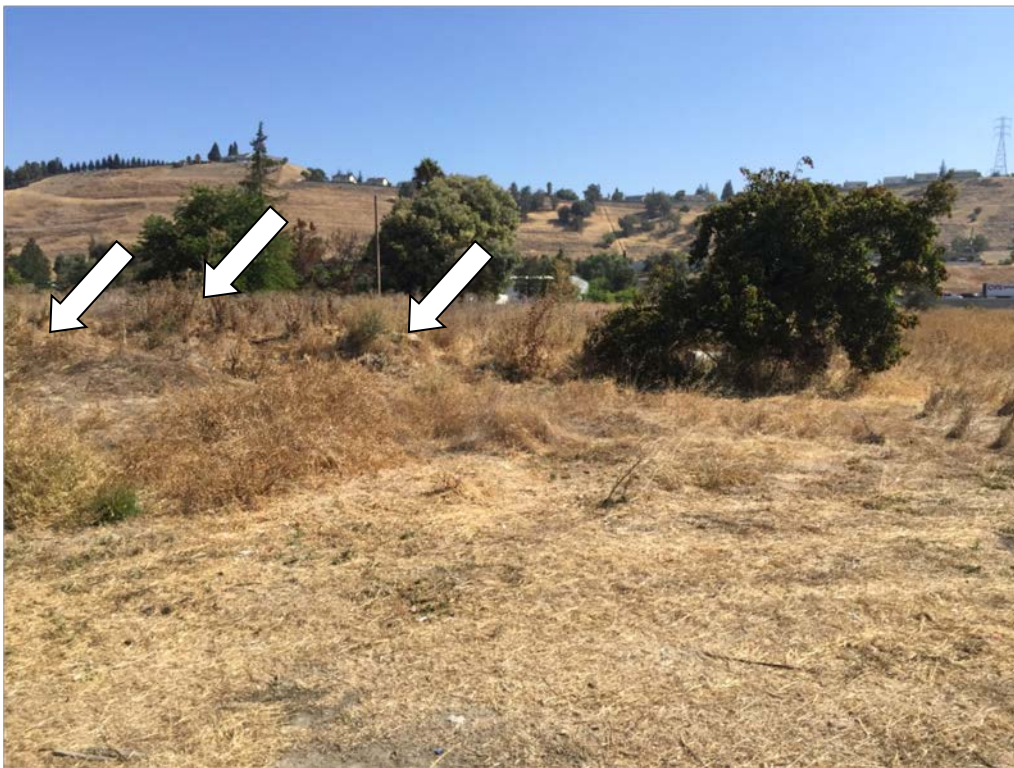
Several areas of stockpiled soil were observed throughout the Site. Concrete rubble was observed in a few of the stockpiles. The origin of these stockpiles was not readily apparent during our visit. In addition, a possibly asbestos-cement pipe was observed on-Site.

Photograph 3. Typical view of Site with arrows pointing to several small soil stockpiles.

During our Site visit, several soil stockpiles of unknown origin were observed throughout the Site. Aerial photographs and Google Street View images from 2011 show the western area of the Site was used as a staging area for the construction company contracted to widen Osgood Road. Stockpiled soil was present in these images, but most of this soil was removed after construction was complete. No information was available that indicated the origin of this soil or facility where this soil was disposed. We recommend collecting soil samples from the stockpiles present on Site as well as the staging area where the stockpiles were formerly present to determine soil quality.

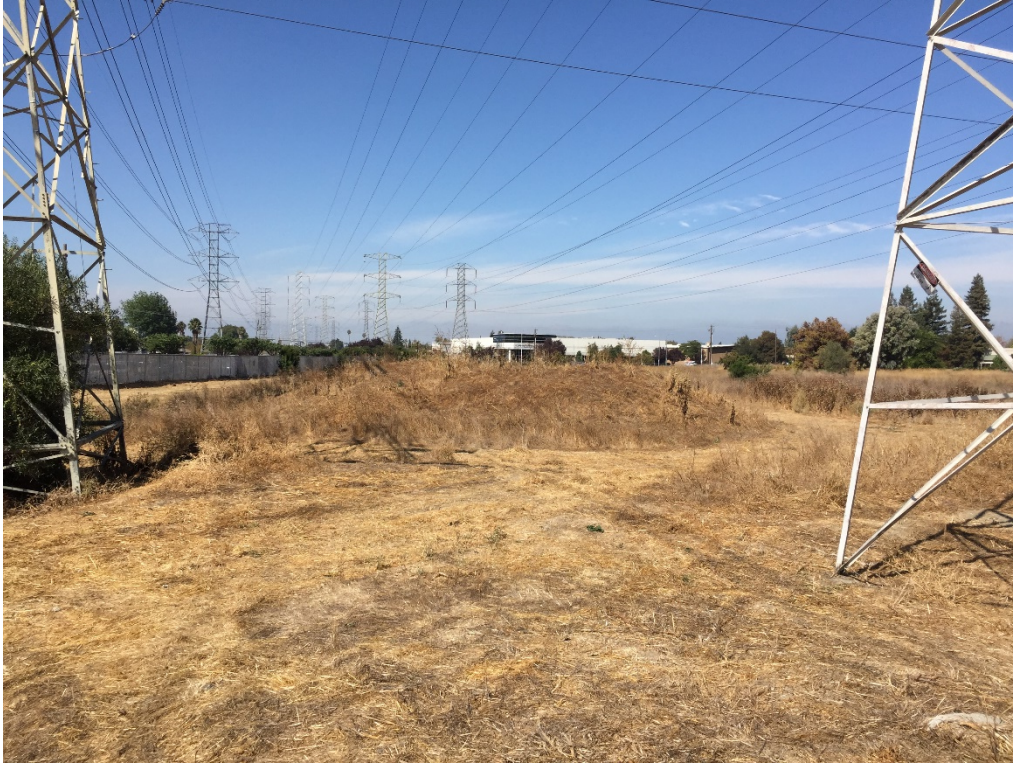
Photograph 4. Soil stockpile between towers.

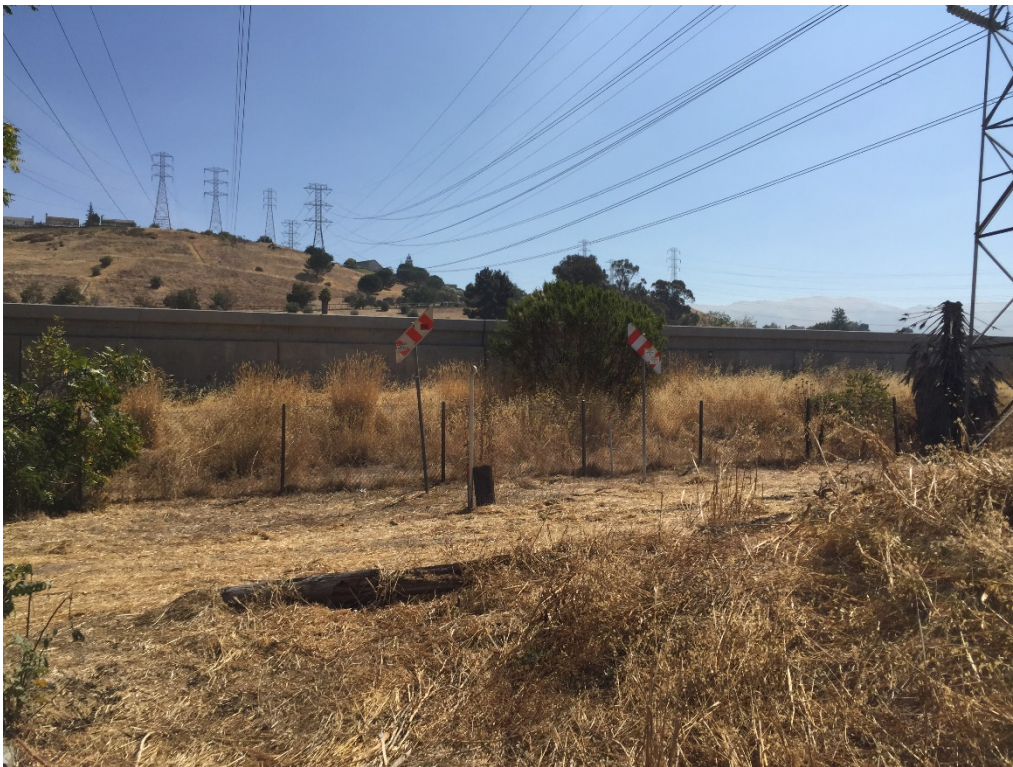
Signage indicating a buried natural gas pipeline was observed on-Site along the alignment of Comack Road and along the eastern property boundary. Similar signage was observed across Osgood Road on the adjacent property. The approximate alignment of this buried natural gas pipeline is shown on Figure 2.

Photograph 5. Natural gas pipeline signage on eastern boundary.

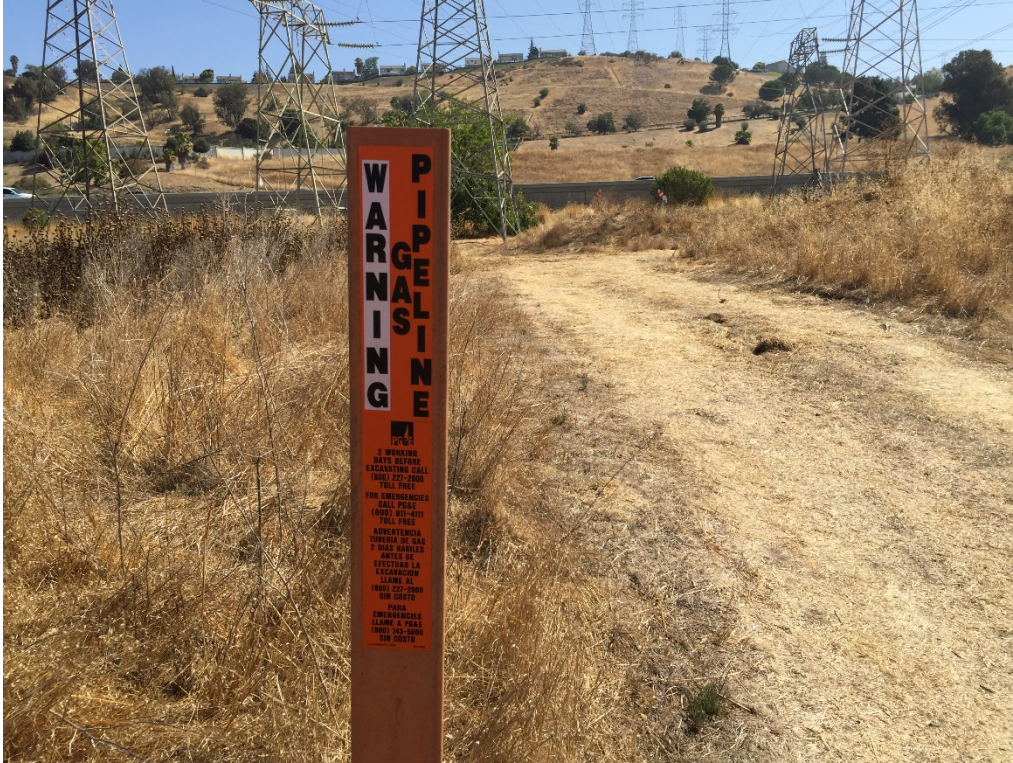
Photograph 6. Natural gas pipeline signage within property interior.

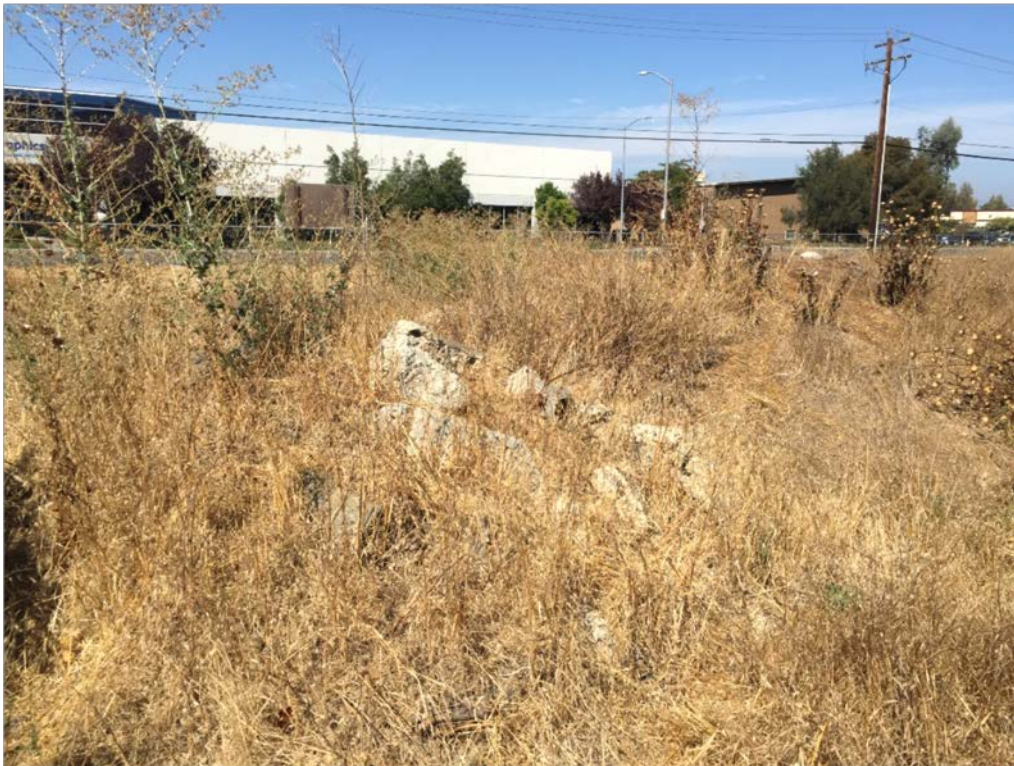
Photograph 7. Stockpile of concrete rubble.

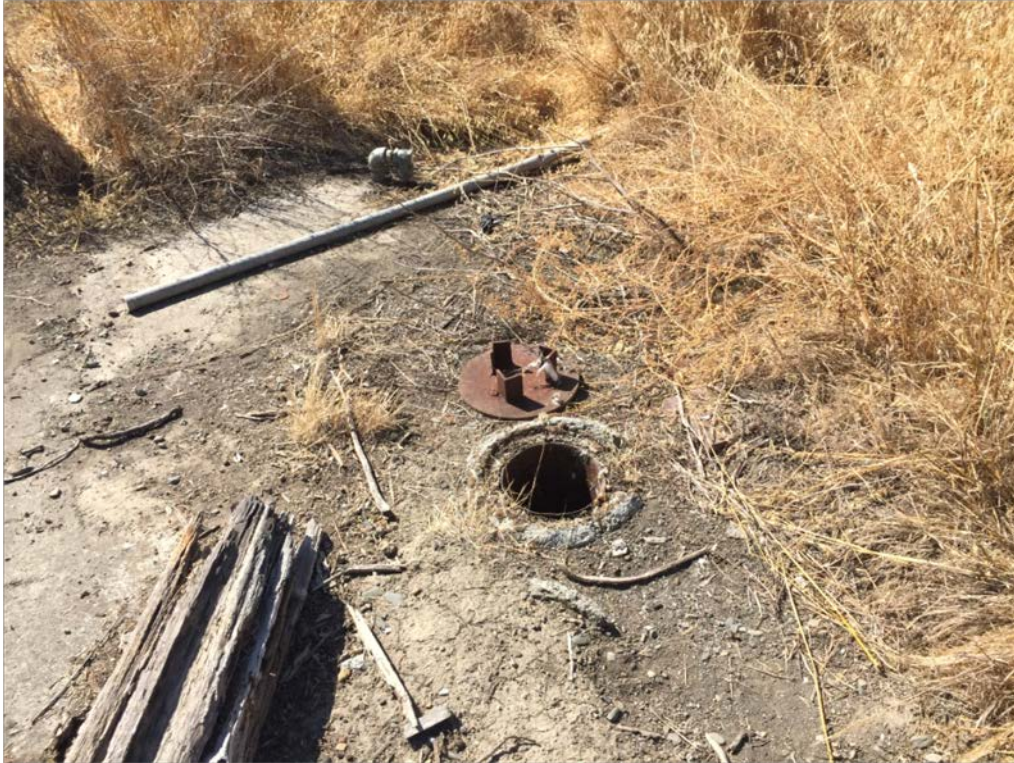
A water supply well was observed near the northwestern area of the Site. The well consisted of steel casing set within concrete. The concrete pad appeared to be a foundations for a small shed or building. No well surface features were observed (pump head or electrical controls). The well casing was covered with a removable steel plate. The steel plate was removed, and water was observed within the well casing at a depth of approximately 20 to 30 feet. Various metal and polyvinyl chloride (PVC) piping connections were observed near the well that were no longer connected. The location of this well is shown on Figure 2.

Photograph 8. Water well with cap removed and surrounding concrete pad.

One water well (well no. 5S/1W-11C07) was observed on the western side of the Site during our Site visit. A Well Completion Report could not be obtained from the California Department of Water Resources (DWR) as these reports are considered confidential documents and can only be obtained by the property owner. We recommend either requesting the owner provide these documents or requesting these documents from the DWR once ownership changes. Both wells will require destruction in accordance with Alameda County Water District (ACWD) requirements prior to Site development.

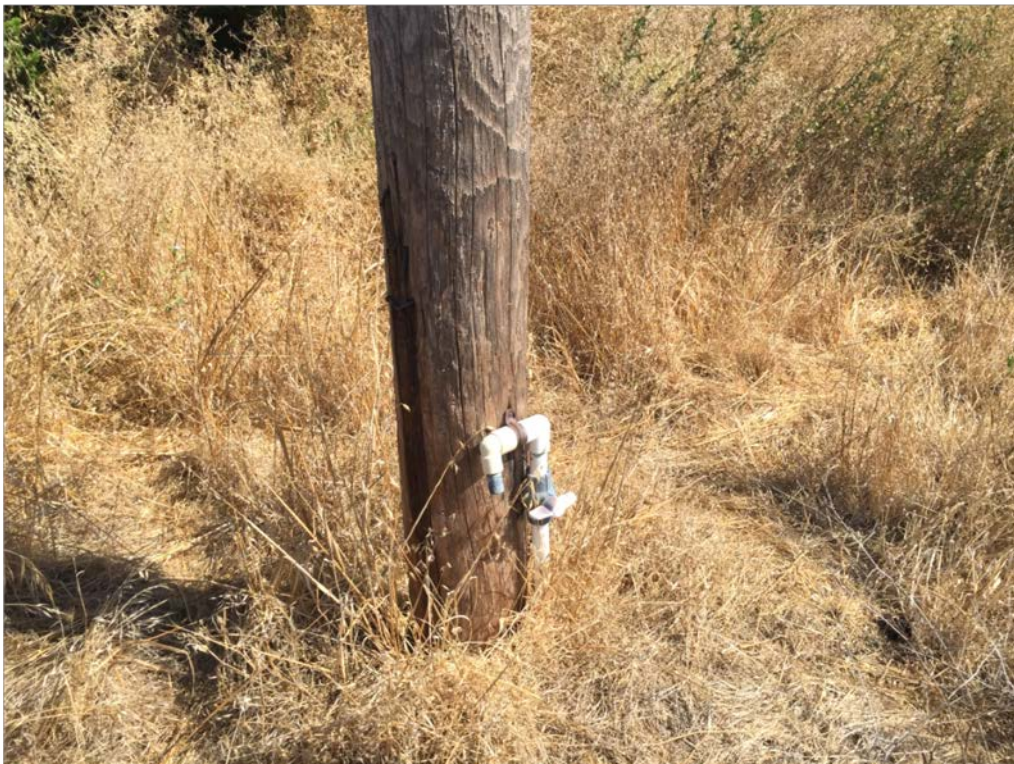
Photograph 9. Piping near water well. Piping is no longer connected to well.

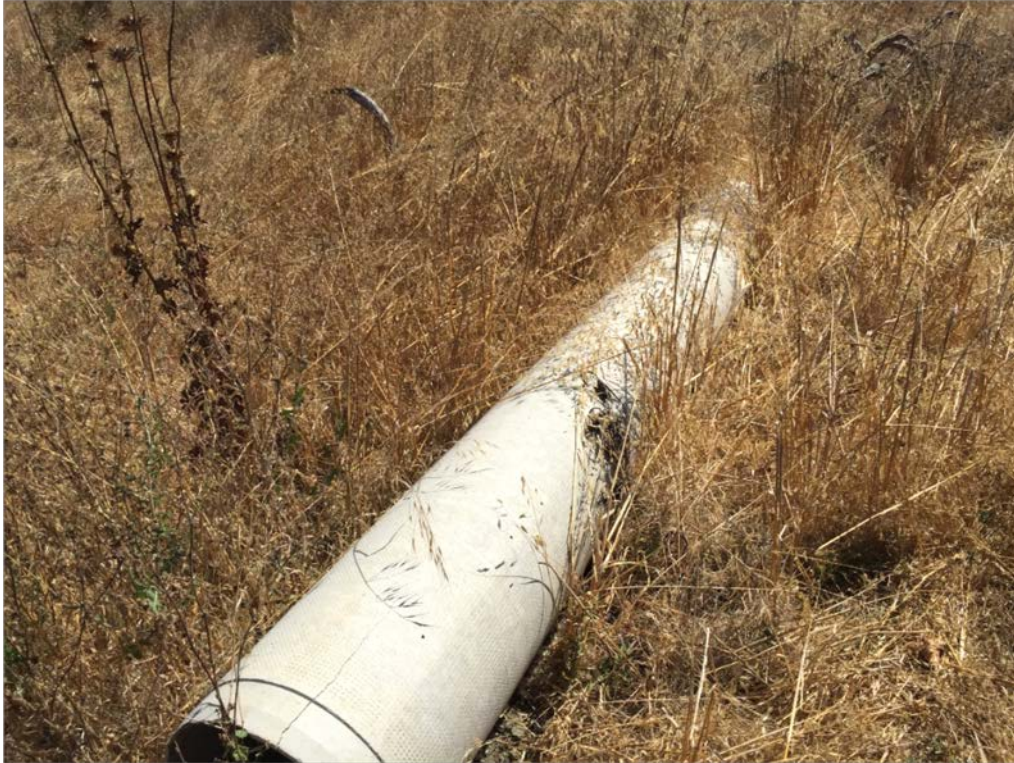
Photograph 10. Pipe (possibly asbestos cement) observed on Site.

A cement pipe (possibly asbestos-cement) was observed on-Site. We recommend the Site owner remove and properly dispose of this pipe prior to acquiring the Site.

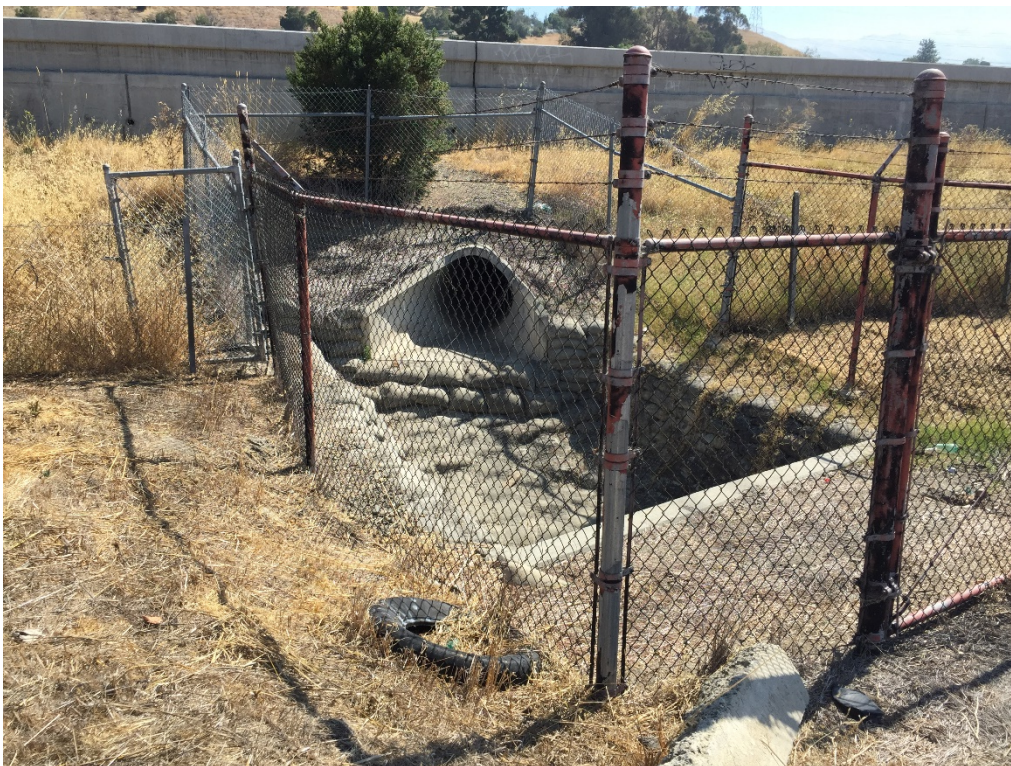
A drainage catch basin related to the adjacent highway 680 was observed along the western border of the Site. This basin was fenced, lined with concrete, and had large-diameter drainage pipes on either end of the basin. The location of this basin is shown on Figure 2.

Photograph 11. Drainage catch basin observed along the eastern border of the Site adjacent to Highway 680.
