Tree Survey Report

**243 Morrison Canyon Road
Fremont, CA**

**PREPARED FOR
Mission Peak Homes
47289 Mission Falls Court
Fremont, CA 94539**

November 2, 2016

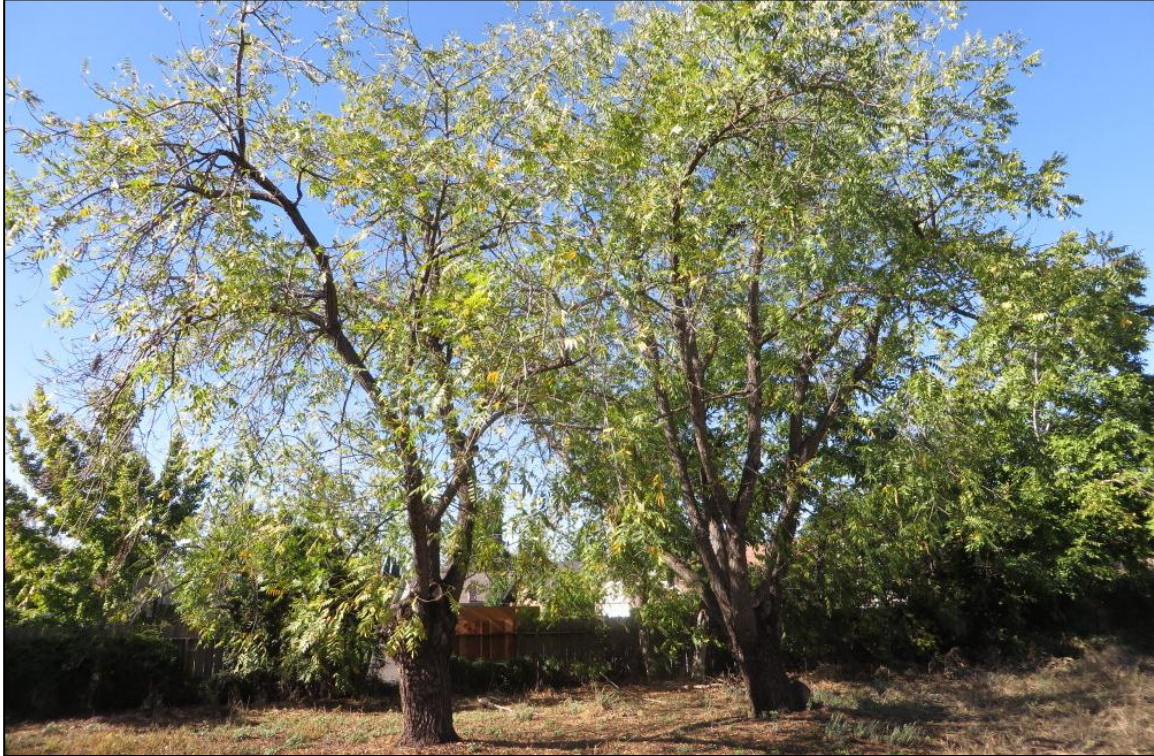
Approximately half the trees were California black walnuts (25 trees, 49%). No black walnuts were in good condition, 10 were in fair condition and 15 were in poor condition. Ten (10) of the black walnuts were multi-stemmed trees. Of the 15 single stemmed trees, trunk diameters ranged from 6 to 50" with an average of 19". The larger black walnuts were likely originally English walnuts with black walnut root stocks (Photo 1). As the English walnut declined, the root stock sprouted and grew a trunk around the decaying English walnut trunk. This is common in old orchards in California.

Photo 1 (above) – The large black walnuts were likely sprouted root stock from English walnut orchard trees.

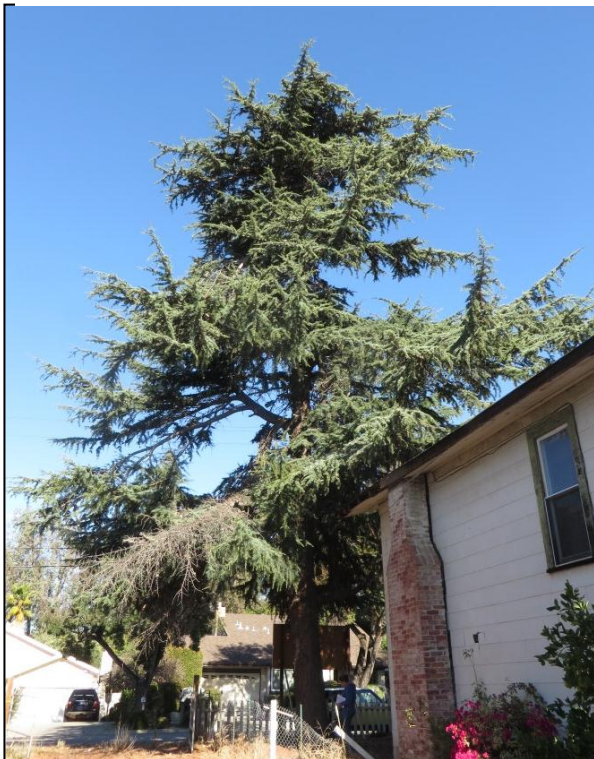
The largest healthiest tree growing on the property was deodar cedar #30 (Photo 2). It was 30" in diameter and growing near the house with good form and structure. Several branches had broken off in the past and were hanging dangerously in the crown.

Photo 2 (lower left) – The deodar cedar in the front yard was the largest, healthiest tree assessed.

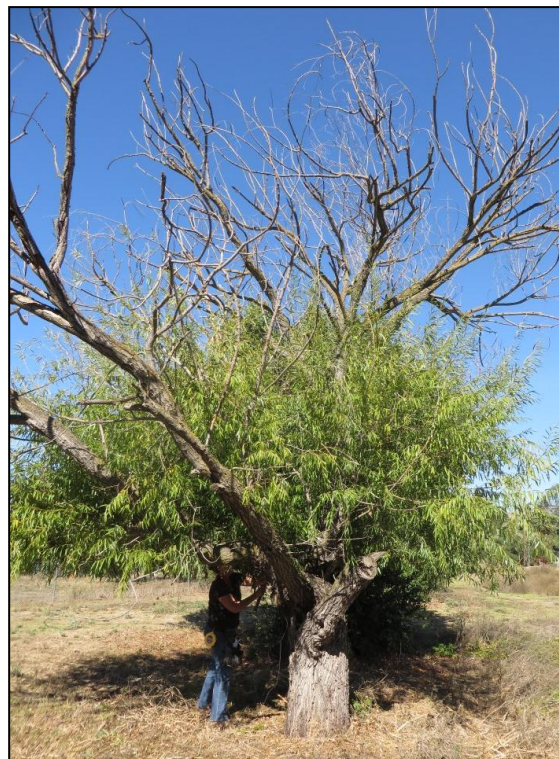
Photo 3 (lower right) – The Goodding willow was mostly dead and resprouting.

Two species were unusual for this type of site. The Goodding willow was growing in a dry area and was mostly dead and resprouting (Photo 3). The cook pine is a *Araucaria* species that looks very similar to the more common, Norfolk Island pine but typically grows with a strong lean (Photo 4).

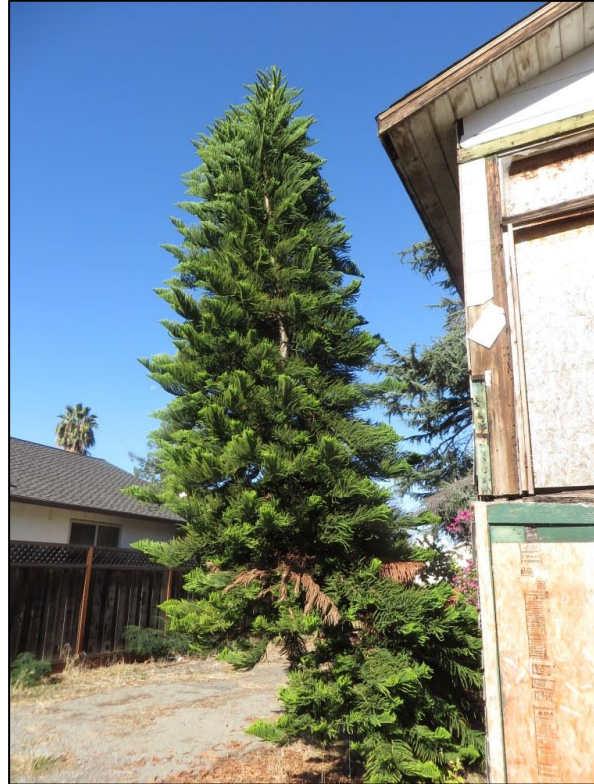
Photo 4 – This cook pine was growing away from the building near Morrison Canyon Road.
