Appendix C Technical Memorandum – Summary Historical Resources Report

Date: July 3, 2017; revised September 18, 2017

Subject: **Ursa Residential Development Project – Summary Historical Resources Report**

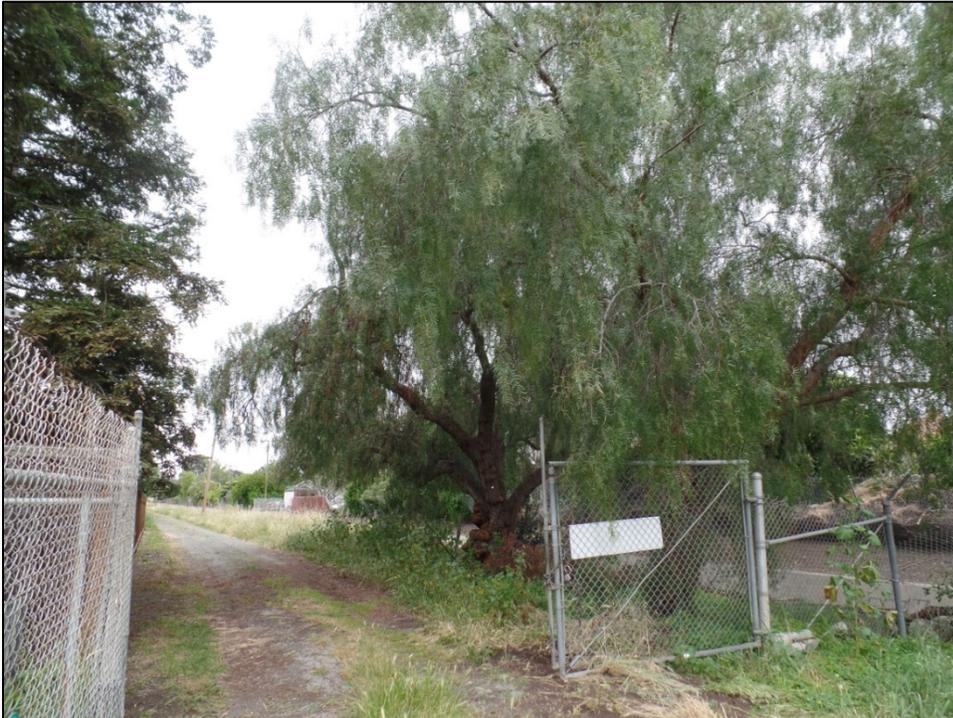
Photograph 1: Driveway looking west towards Warm Springs Boulevard parallel to channelized creek, camera facing west, April 11, 2017 (AECOM).

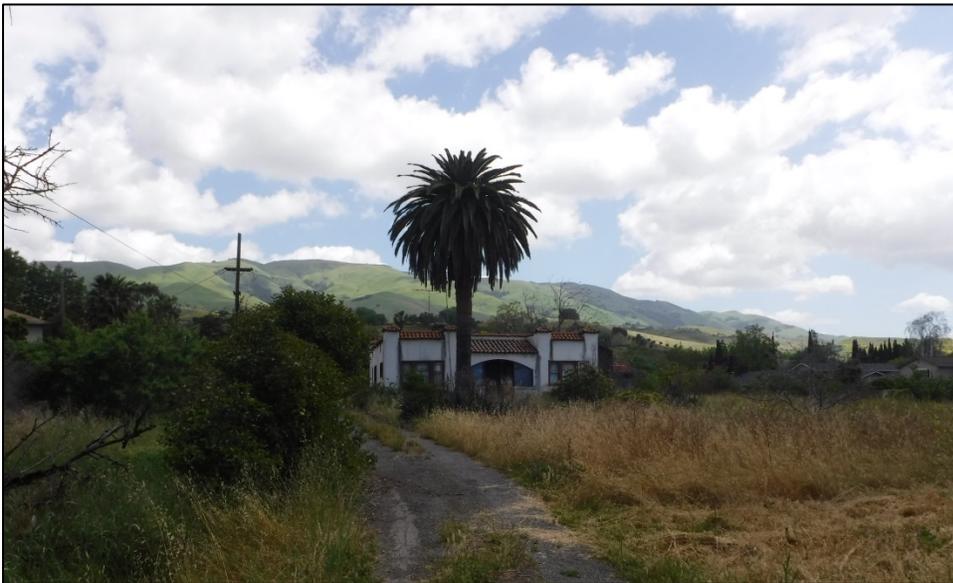
Photograph 2: West side of residence facing Warm Springs Boulevard, camera facing east, April 11, 2017 (AECOM). Note Canary Island palm tree and driveway leading to work yard at rear of residence.

Residence (Photographs 2, 3, 5, 6, 8 and 14)

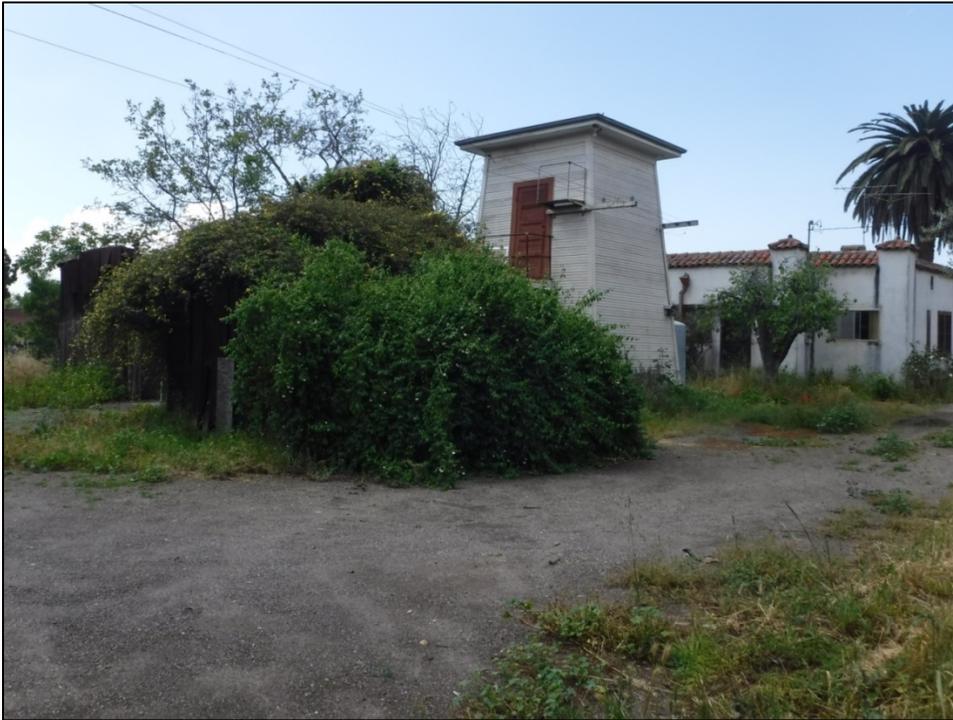
Photograph 3: Driveway terminus at work yard behind residence. Residence at far right, tankhouse at center, garage at center under vegetation, mixing shed at far left, camera facing southeast, April 11, 2017 (AECOM).

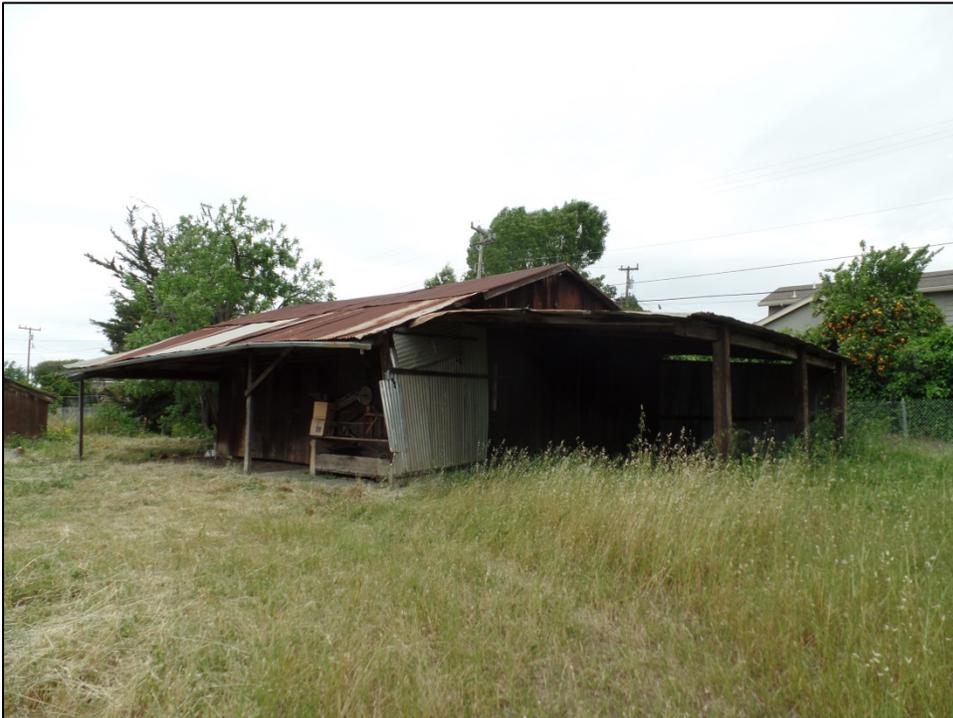
The processing shed is located at the northeast corner of the property, approximately 40 feet east of the barn (Photograph 4). The processing shed was built sometime between 1939 and 1948, and later added onto by 1976 at the east end. It is a one-story, wood frame building with a rectangular plan, concrete foundation, and vertical wood board cladding. The gable roof has a wide eave overhang with exposed rafter tails and corrugated metal sheeting. The wide shed roof overhand wraps around the west and south sides. There is remnant walnut processing equipment under the eaves of the building. A wide overhanging flat roof, supported by thick square wood posts, is located along the east side; the north side is vertical wood boards with three cut-in awning window openings.

Photograph 4: Processing shed in northeast corner of parcel, view of southeast side, camera facing northwest, April 11, 2017 (AECOM).

Processing Shed (Photograph 4)

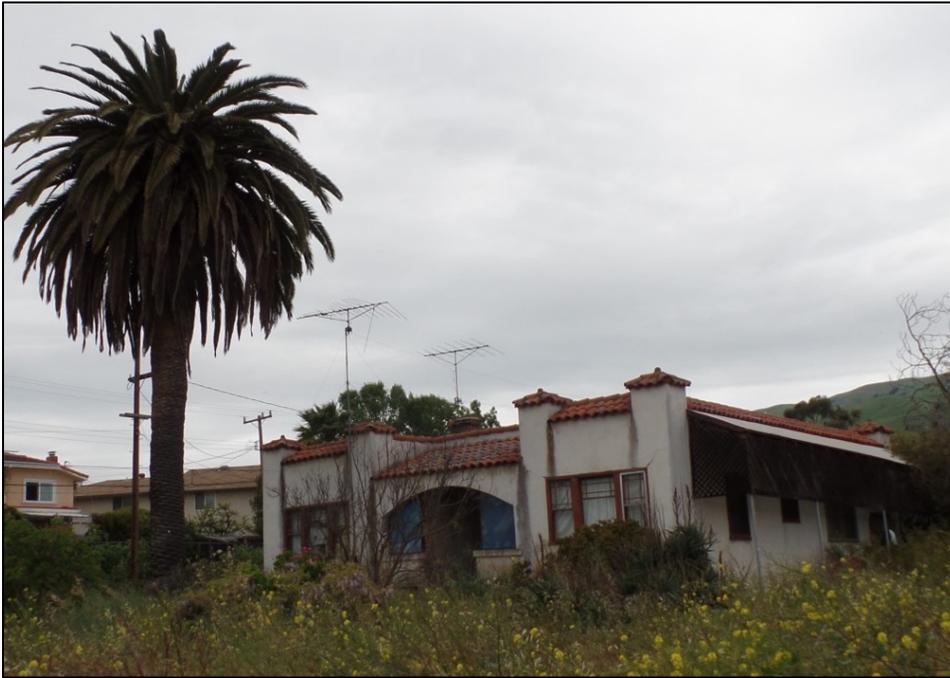
Photograph 5: Southwest corner of residence with Canary Island palm tree, camera facing northeast, April 11, 2017 (AECOM).

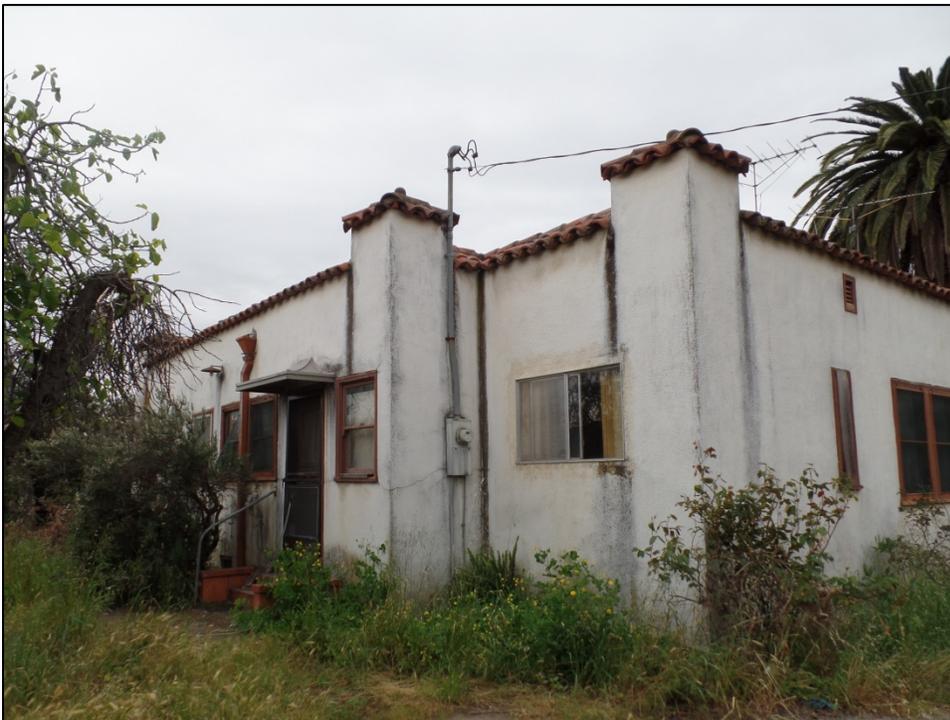
The one-story Spanish Revival style, residence built in 1928, sits on a concrete foundation and has a small 18' x 18' basement at the east end of the building accessed via the interior. The building is 1,684 square feet. The wood-framed building has a square plan, stucco cladding, and flat roof with a clay tile-clad hipped parapet with short towers capped by clay tile-clad hipped roofs that define each corner of the building. The symmetrical west façade has a central inset porch with a segmental arched opening and a clay tile-clad shed roof (Photograph 5). Fenestration is largely comprised of original wood frame windows with one replaced and resized aluminum sliding window at the rear of the residence (Photograph 6).

Photograph 6: Rear view of residence with replaced a resized window, entry to interior basement via back door, camera facing southwest, April 11, 2017 (AECOM).

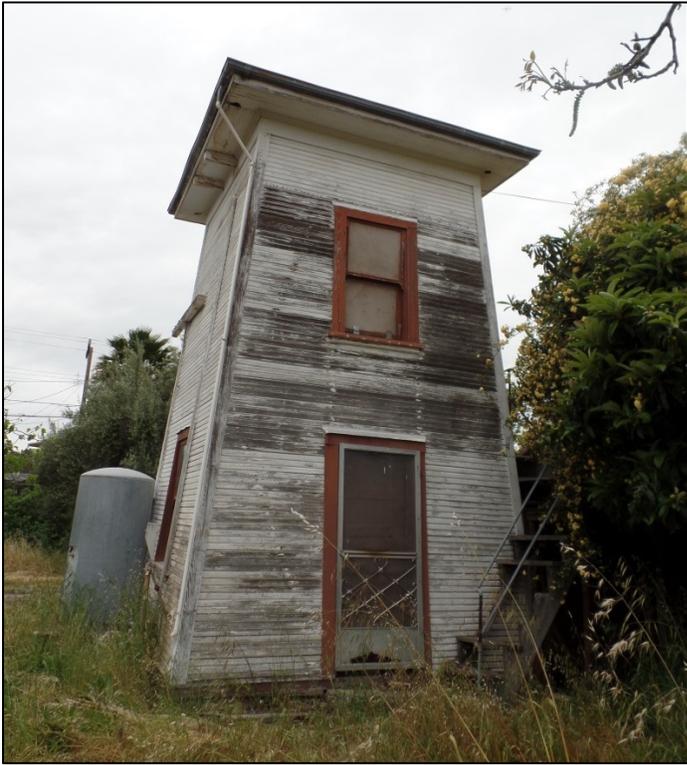
Photograph 7: South side of tankhouse with first-story entry door, camera facing north, April 11, 2017 (AECOM).

Tankhouse (Photographs 3, 7 and 8)

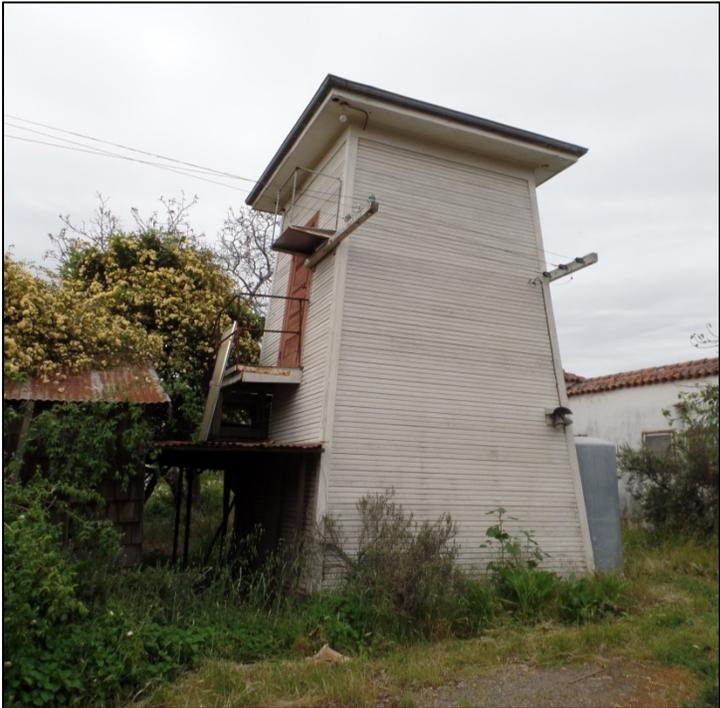
Photograph 8: Northeast corner of tank house with second story entry, garage at left and residence at right, camera facing southwest, April 11, 2017 (AECOM).

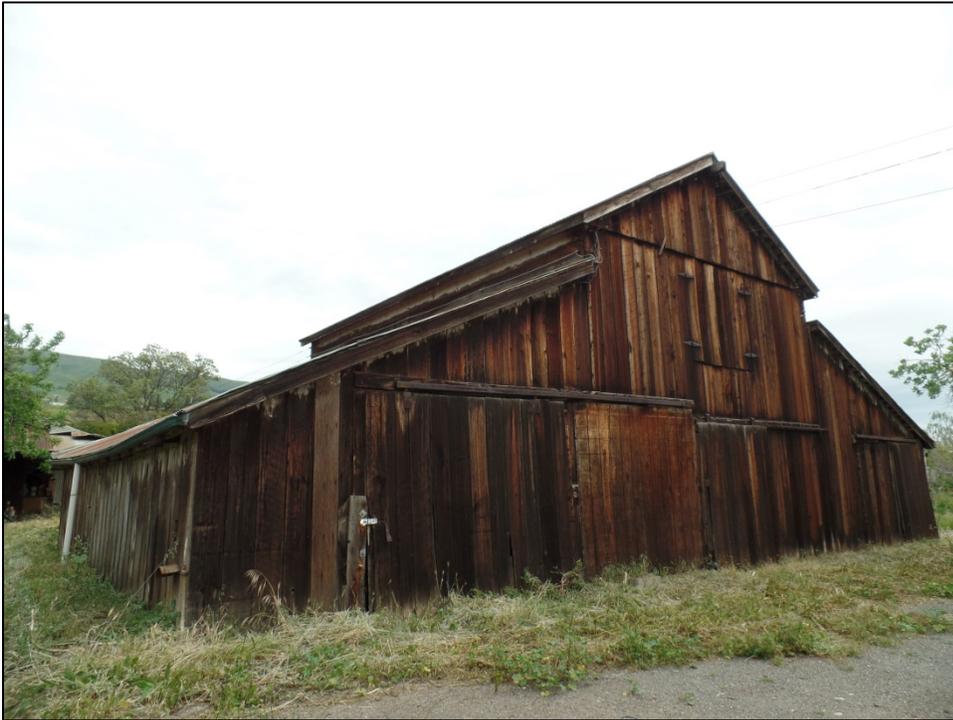
The circa 1905 barn is a large, wood frame structure located approximately 60 feet east of the tankhouse and oriented east-west toward the work yard (Photograph 9). The barn is clad with wide vertical wood boards, with remnant battens on the south façade. It has a central gable peak flanked by two shed roofs at a lower height, all with eave overhangs. Corrugated metal sheets cover the roof. A hay loft with hinged doors and a wood beam that once supported a pulley is located at each gable end. Three entrances with large wood sliding doors line the west façade. A concrete pad is located along the length of the east side of the barn that faces Ursa Drive (Photograph 10).

Photograph 9: Northwest corner of barn facing work yard and 60 feet east of tankhouse, camera facing southeast, April 11, 2017 (AECOM).

Barn (Photographs 9 and 10)

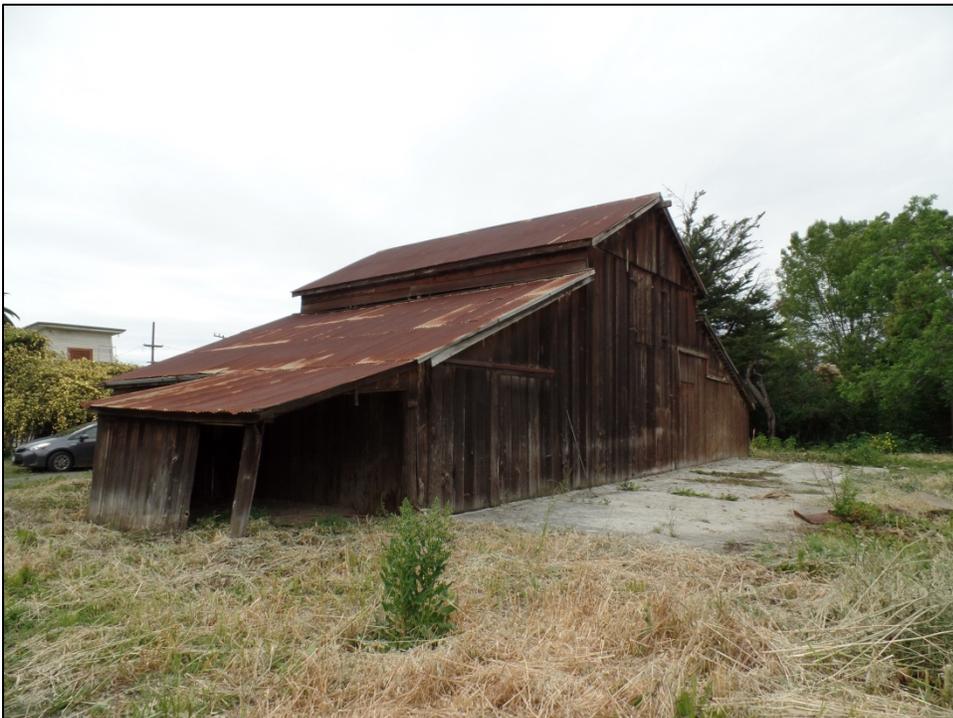
Photograph 10: Southeast corner of barn facing Ursa Drive with concrete pad, camera facing southwest, April 11, 2017 (AECOM).

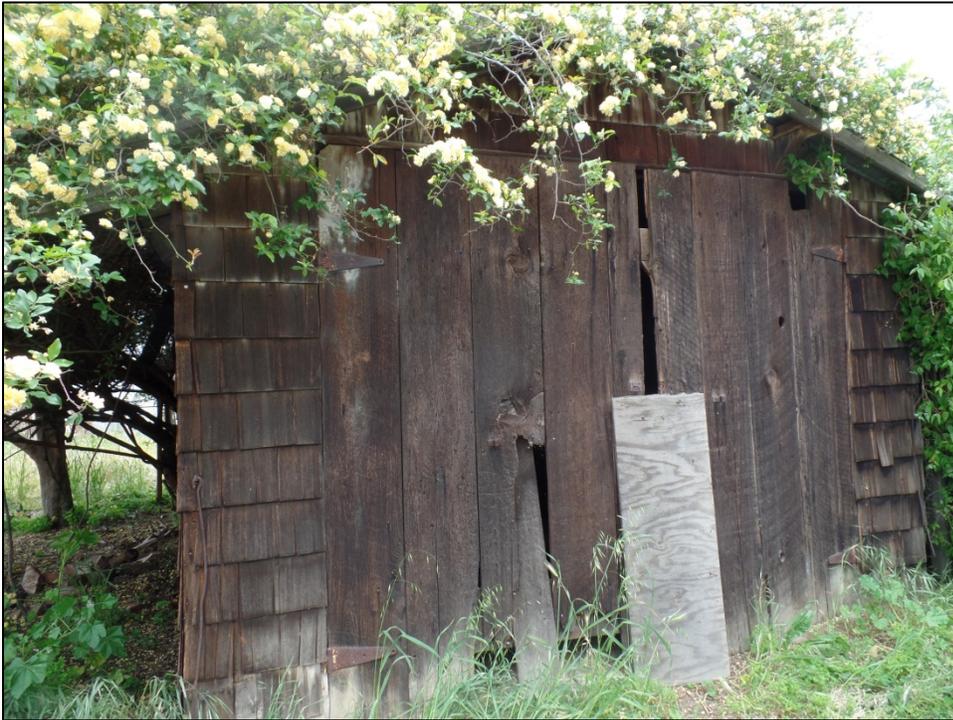
The one-car garage is located just east of the tankhouse facing the work yard and is covered with thick vegetation (Photograph 11). The garage was built circa 1928 when the residence was built. It has a rectangular plan, wood shingle cladding, and a gable roof with a wide eave overhang, exposed rafter tails, and corrugated metal sheeting. The east side has a set of hinged double doors constructed of vertical wood boards that may be replacements.

Photograph 11: East side of garage facing work yard, camera facing northwest, April 11, 2017 (AECOM).

Garage (Photographs 8 and 11)

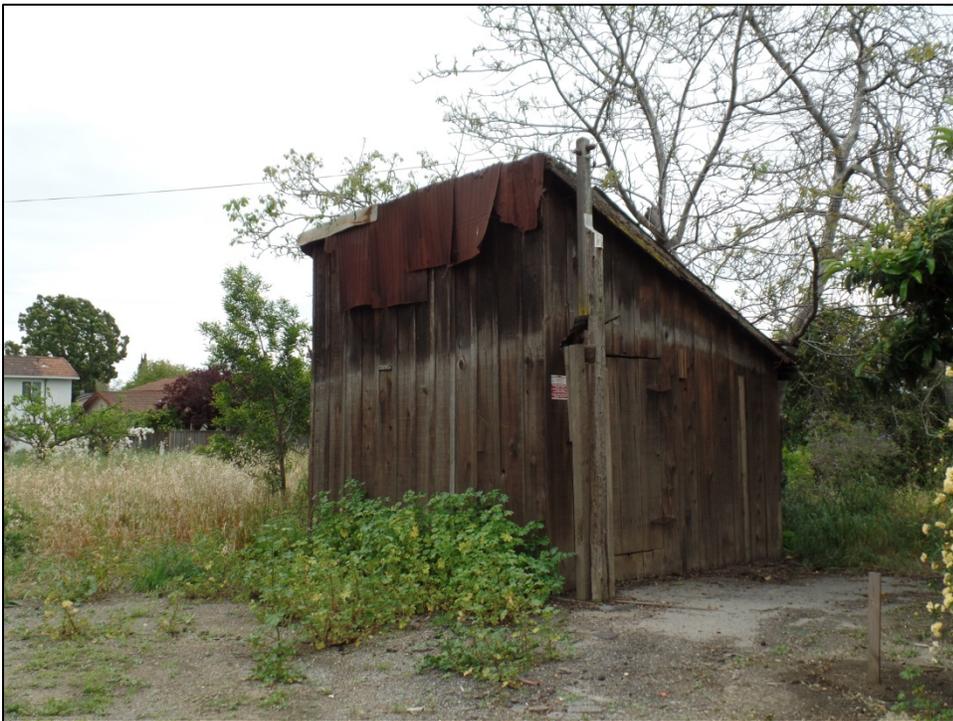
Photograph 12: Mixing shed, camera facing southwest, April 11, 2017 (AECOM).

Mixing Shed (Photograph 12)

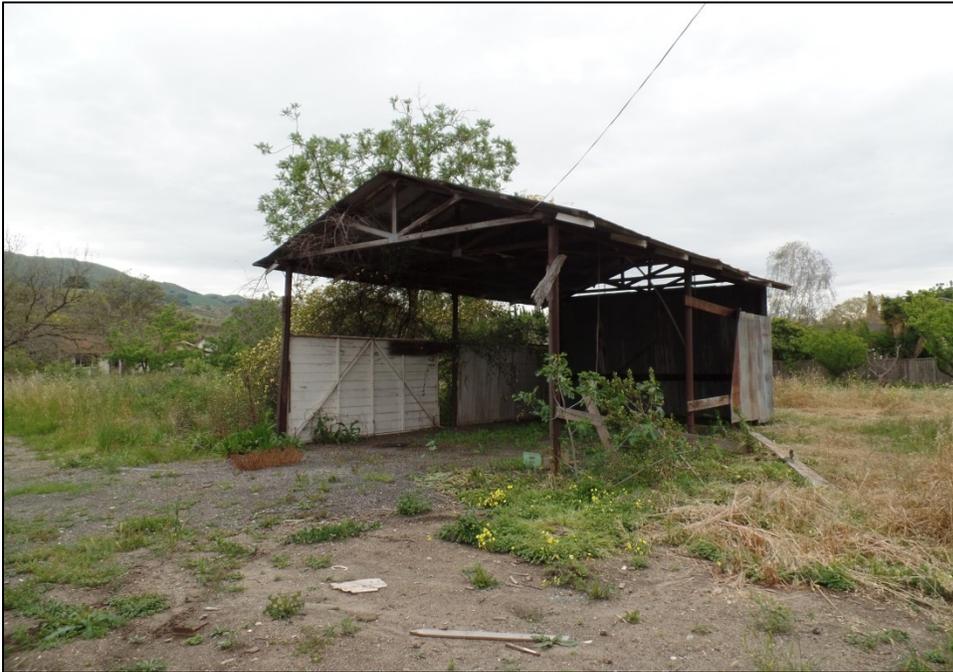
The 1930s mixing shed, approximately 20 feet south of the tankhouse and garage, faces the work yard (Photograph 13). It is a small, wood frame structure with vertical board and batten cladding and a shed roof covered in corrugated metal sheets. The structure is accessed by a hinged wood door on the north side (Photograph 12).

Photograph 13: Open air shed located south of barn facing work yard, camera facing southeast, April 11, 2017 (AECOM).

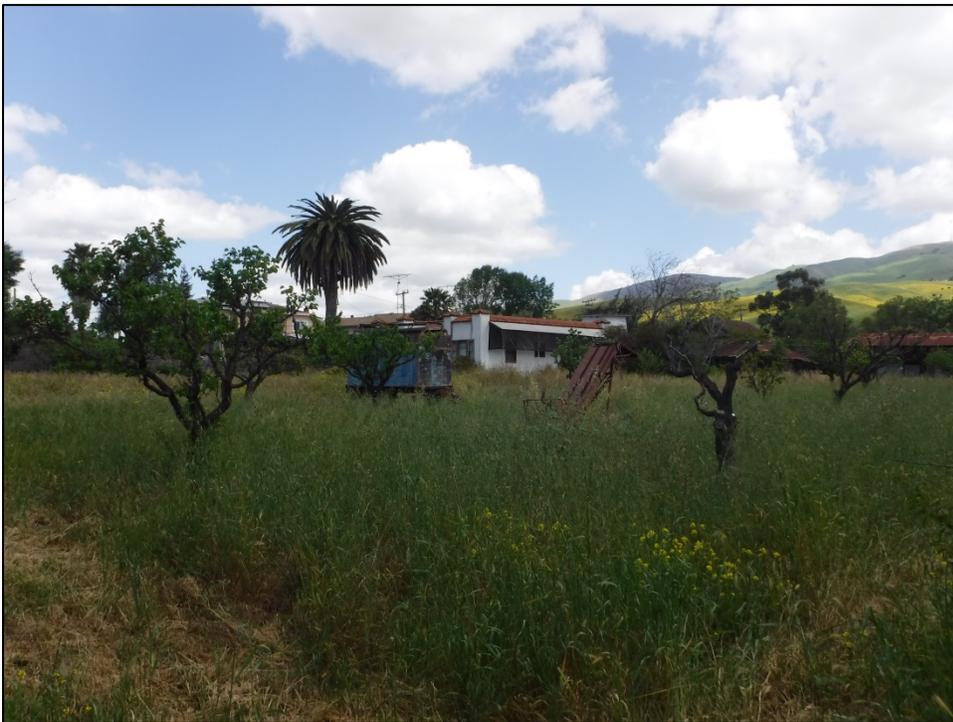
Photograph 14: View of remnant orchard from southwest corner of parcel looking towards residence, moveable equipment and machinery extant on the property, camera facing northeast, April 11, 2017 (AECOM).

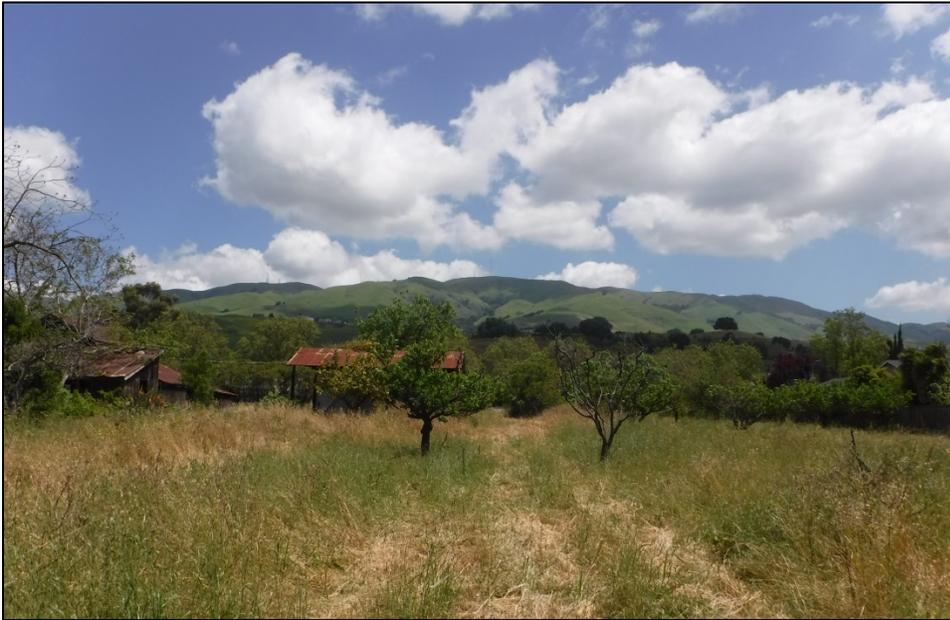
The south half of the 2.67-acre subject property contains a remnant orchard comprised of 34 apricot, 24 walnut, and six other miscellaneous fruit and nut trees planted in a grid pattern (Photographs 14 and 15). The orchard that historically spanned much of the 12.45-acre property has been reduced to approximately one acre. The walnut trees on the property were overall in fair condition, compared to the apricots which were in poor condition. The fair condition of the trees and the extant walnut processing equipment on the property suggests the walnut varieties were planted later in the developmental period of the property after the initial larger apricot orchard was established.

Photograph 15: View of remnant orchard from southwest corner of parcel looking towards east toward Ursa Drive, mixing shed, barn, and open air shed at left, camera facing east, April 11, 2017 (AECOM).

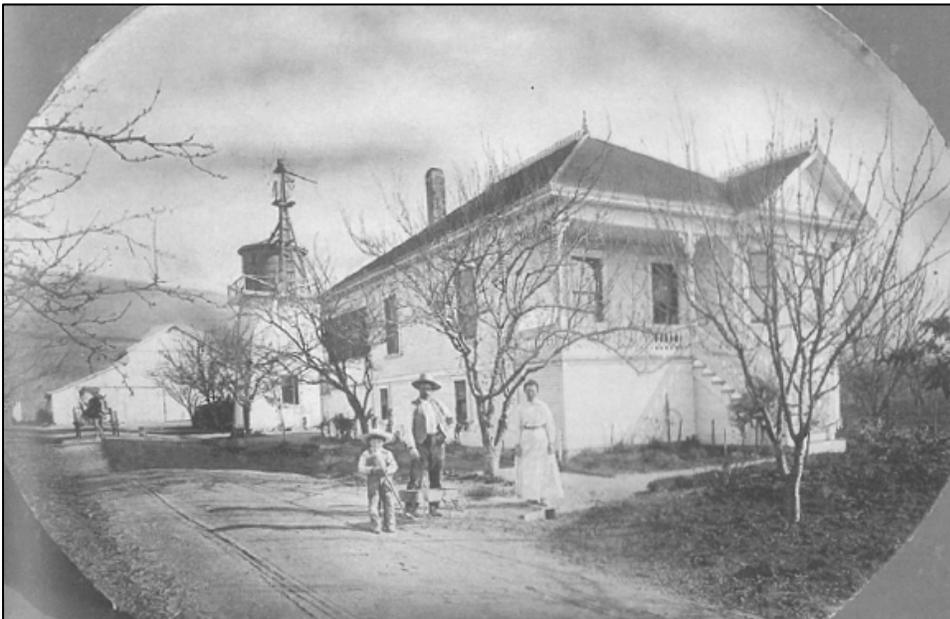
Plate 1: Undated early twentieth century photograph of the subject property at 48495 Ursa Drive, Fremont, California. Queen Anne house replaced with current 1928 Spanish revival residence. Extant tankhouse (with windmill and tank since removed) and barn at left (Holmes and Wipfli Schaffarczyk, 2013:35).

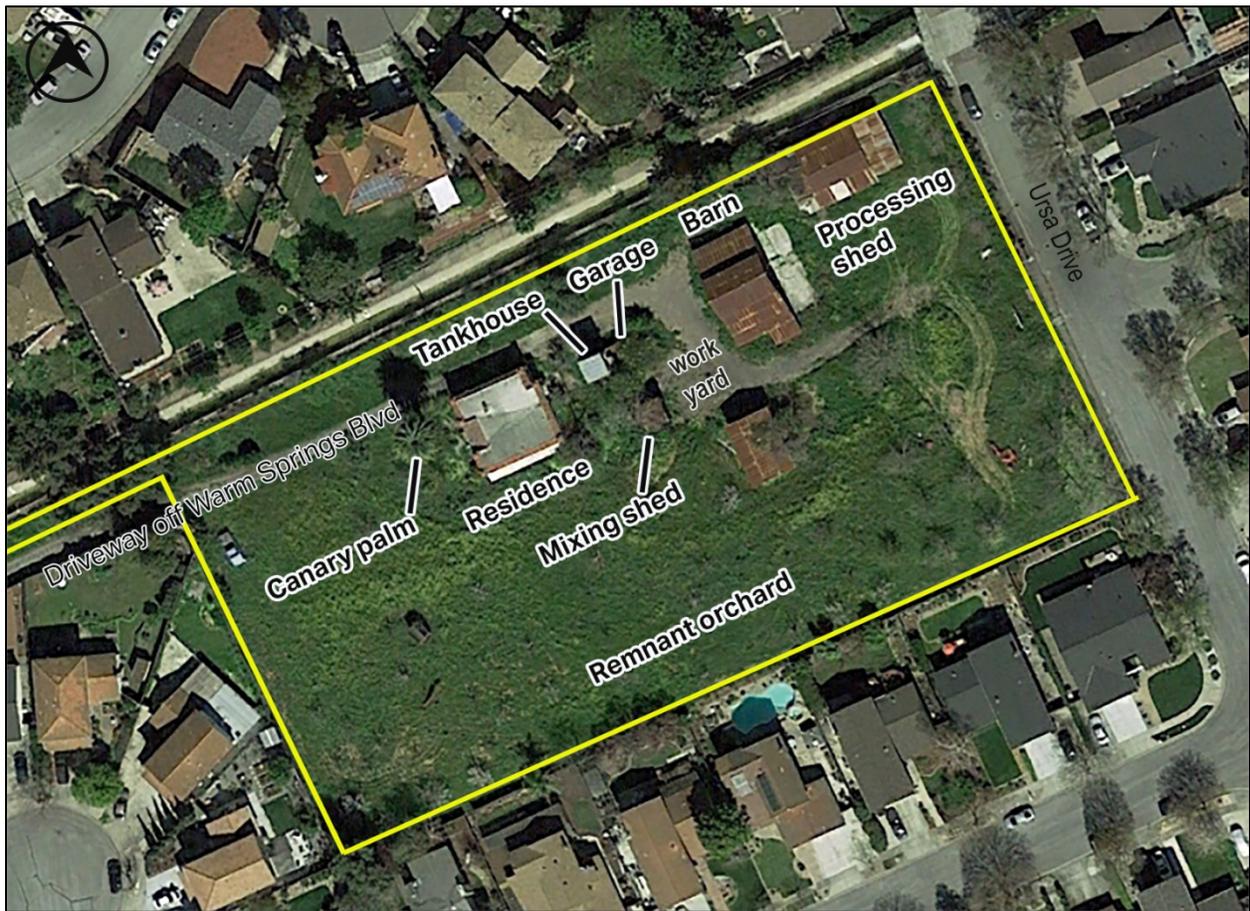
Figure 1: Site plan of 48495 Ursa Drive with contributing resources labeled, yellow line indicates legal parcel boundary and boundary of rural historic landscape (Base: 2017 Google Earth).
