PHASE I ENVIRONMENTAL SITE ASSESSMENT

1 JULY 2016

OMAHA WAY SUBDIVISION
(APNs 519-1188-001
519-1188-002, and 519-1189-001)
Fremont, California

For:
Omaha Fremont, LLC

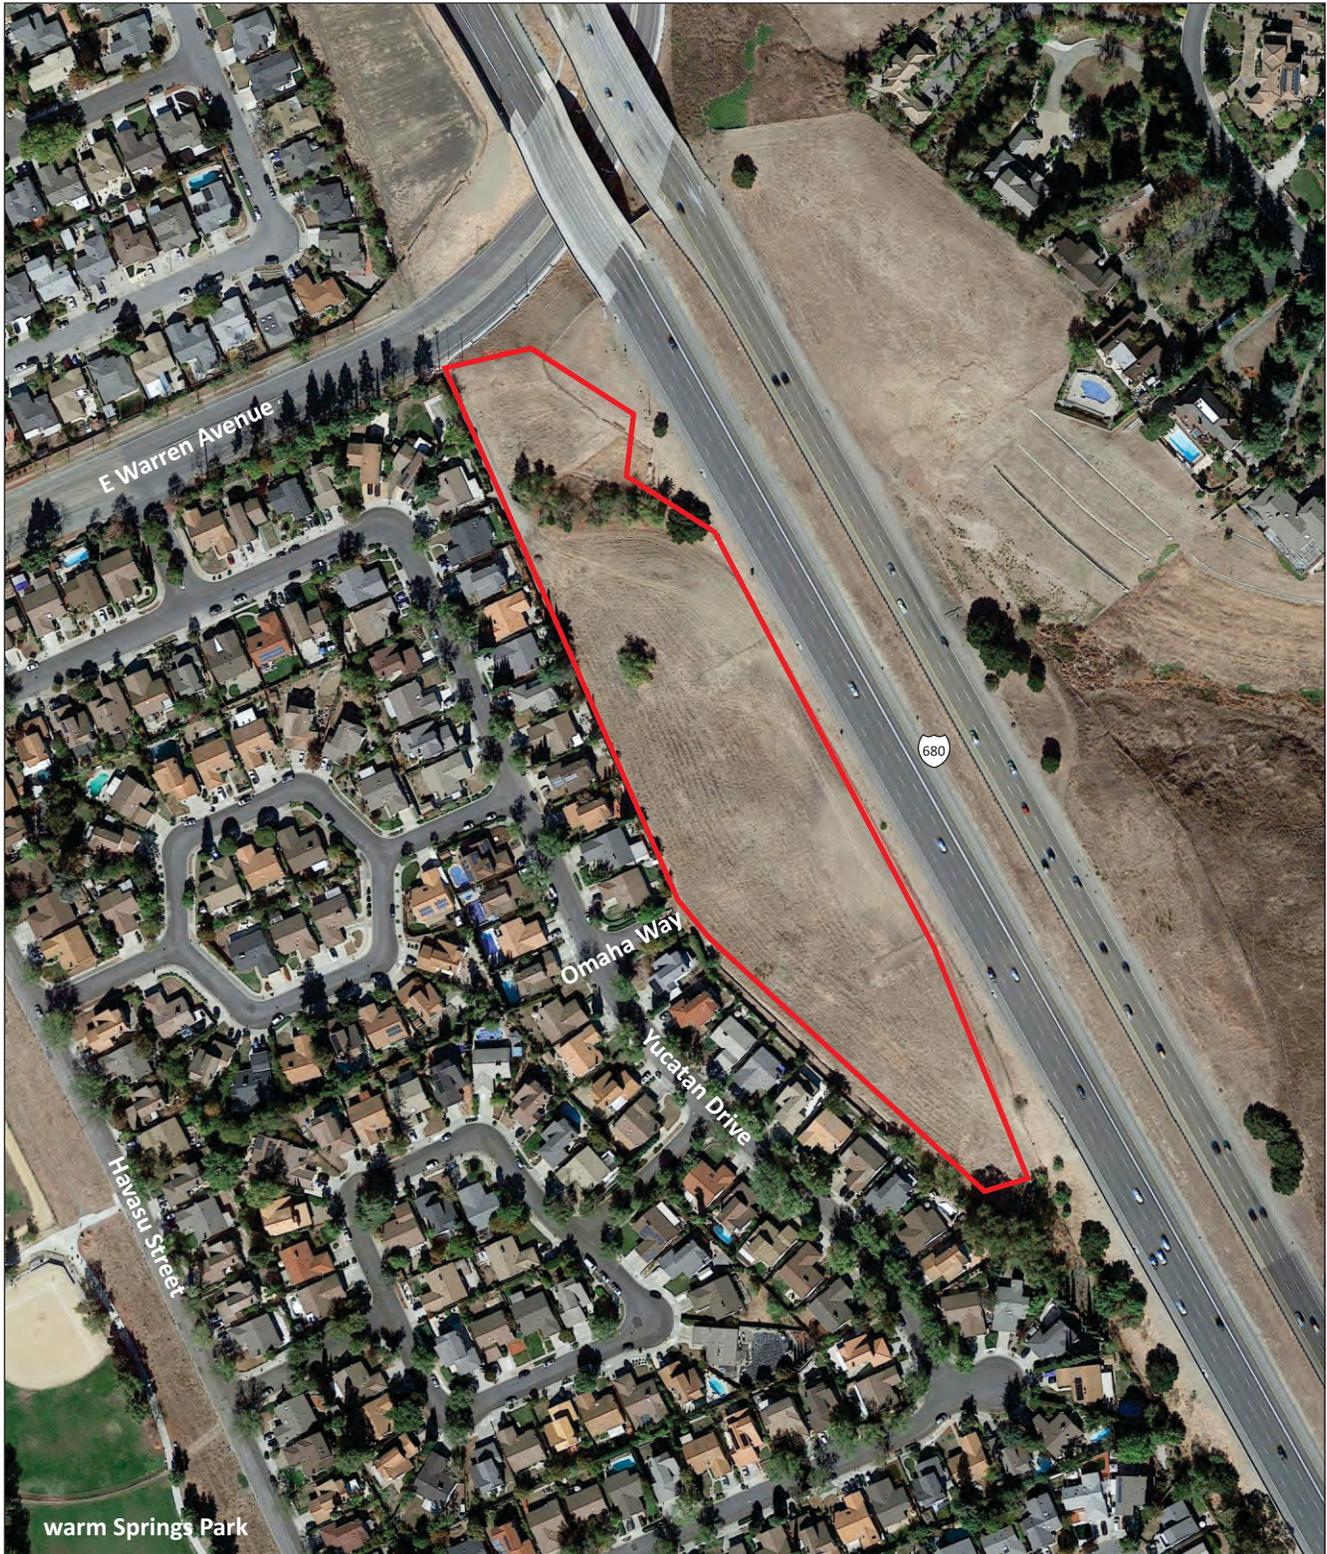
The Project site consists of three parcels (APNs 519-1188-001, 519-1188-002, and 519-1189-001), totaling approximately 6 acres in area, located near the intersection of Omaha Way and Yucatan Drive in Fremont, California (Figures 1 and 2). The Project site is bounded by the Interstate 680 (“I-680”) right-of-way to the east, East Warren Avenue to the north, and single-family residences to the west and south (Figure 2).

The paved shoulder of I-680, constructed between 1968 and 1974, is located approximately 25 to 40 feet east of the eastern Project site boundary (Figure 2). Beginning in 1973, the United States Environmental Protection Agency (“EPA”) ordered a gradual phase out of lead from gasoline that significantly reduced the prevalence of leaded gasoline by the mid-1980s. Prior to the 1970s, the EPA estimated that vehicles emitted approximately 75 percent of the lead consumed in leaded gasoline as particulate matter in the exhaust (DTSC, 2004). As a result, shallow soils within approximately 30 feet of the edge of pavement in highway corridors have the potential to be contaminated with aerially-deposited lead (“ADL”) from historical car emissions prior to the elimination of lead in gasoline (DTSC, 2009).

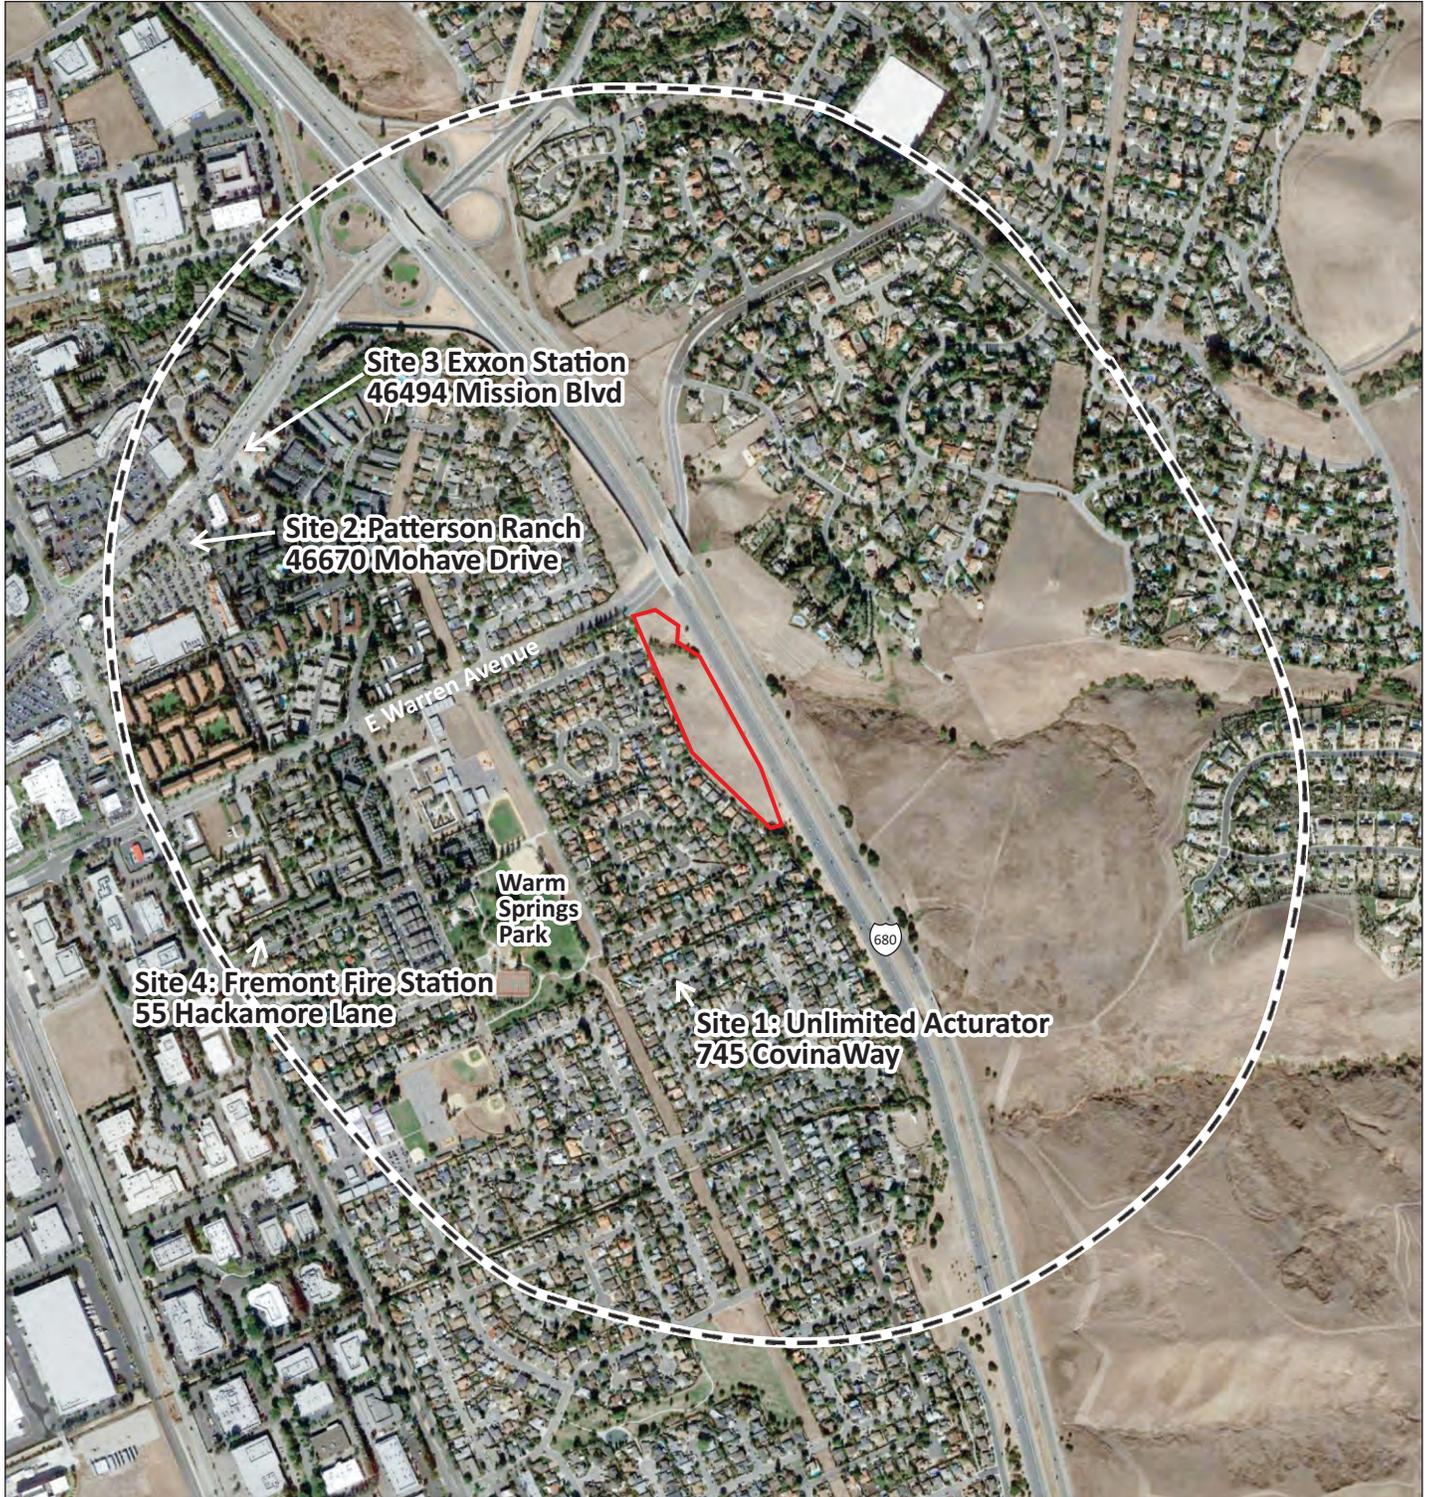
SITES ON REGULATORY DATABASES WITHIN ONE-HALF MILE OF THE PROJECT SITE

Note:
See Table 2 for site details.
Source: EDR, 2016.

Note: See Figure 3 for site locations.
 Complete environmental database report is contained in Appendix D.
 LUST = State and County leaking underground storage tank database.
 SLIC = Regional Water Board Spills, Leaks, Investigations, and Cleanups database.
 SQG = Federally-registered small quantity hazardous waste generator.
 UST = State underground storage tank site database.
