Subject: San Francisco Bay Regional Water Quality Control Board Comments on the *Mitigated Negative Declaration, Sabercat Trail Extension Project* SCH No. 2022010048

Sabercat Creek Mitigation Project

Annual Wetland Monitoring Report - Year 6 Wetlands and Waters Restoration

Caltrans District 04
04-ALA-680-PM 4.8/5.2
EA 04-253760

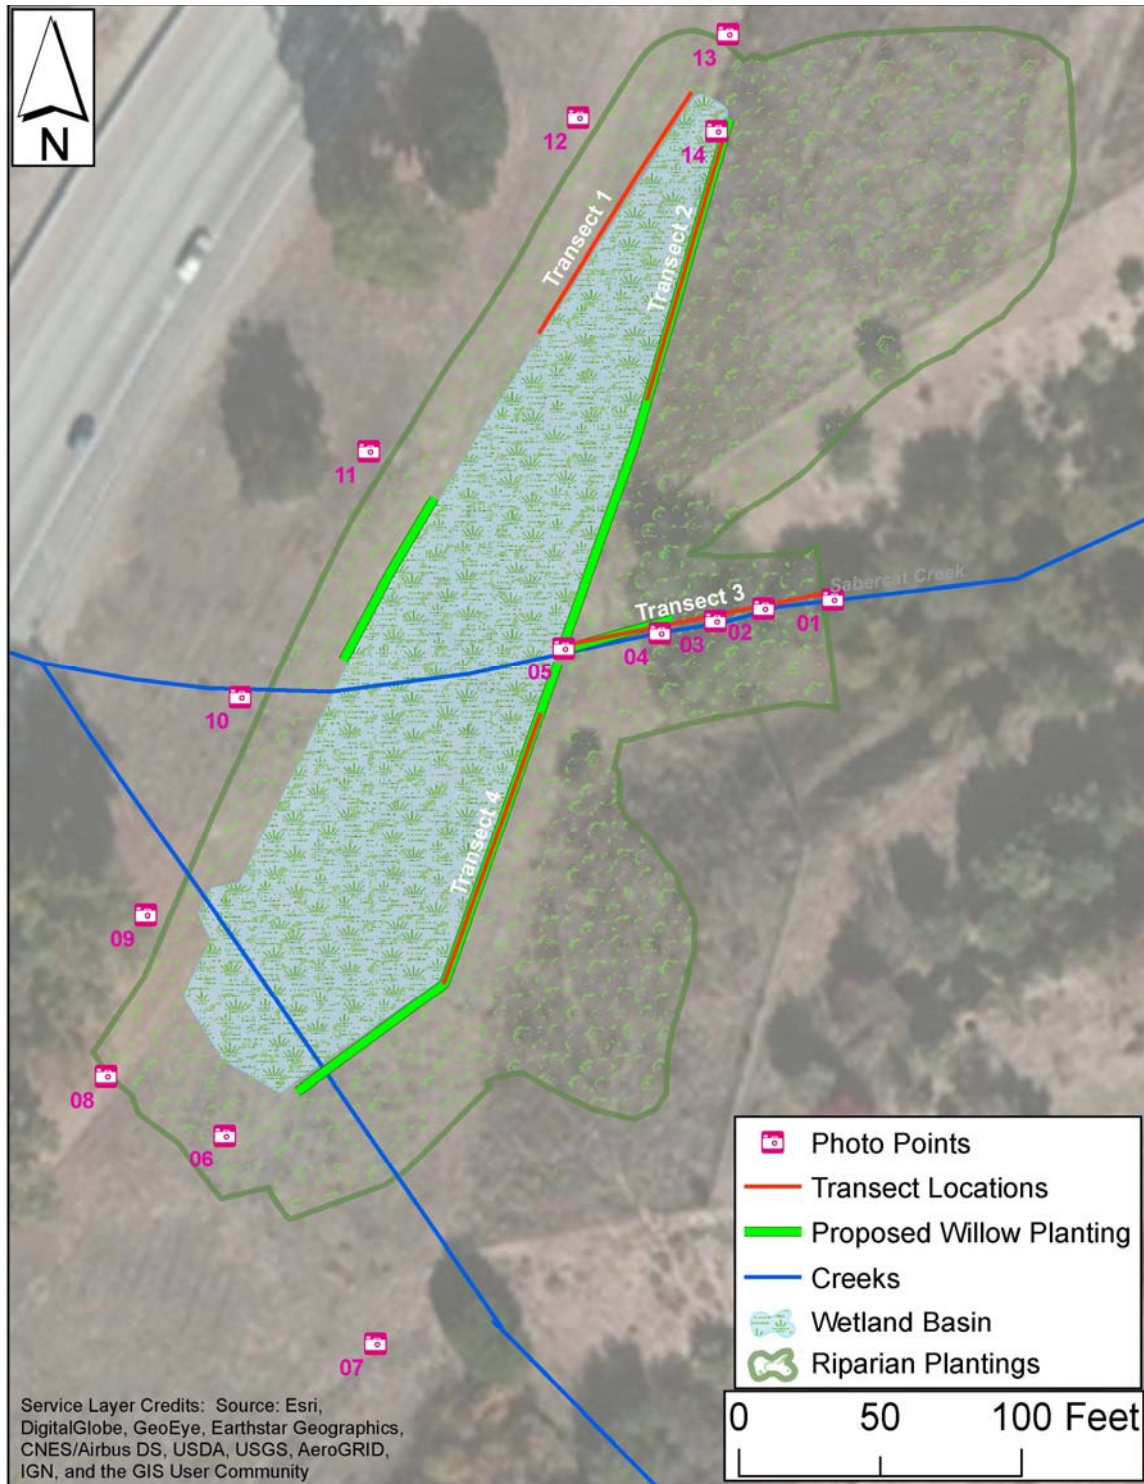
Figure 3. Transect and Photo Point Locations

- a. A series of photos of the subject feature are taken each year from each photo point.
 - i. Along the step-pool feature, two photos are taken from each point: one looking upstream and the second looking downstream.
 - ii. For overview photos, a panoramic series of photos are taken at each point.
- b. Compass bearing is recorded to indicate the direction the photographer was facing when each photo is taken.

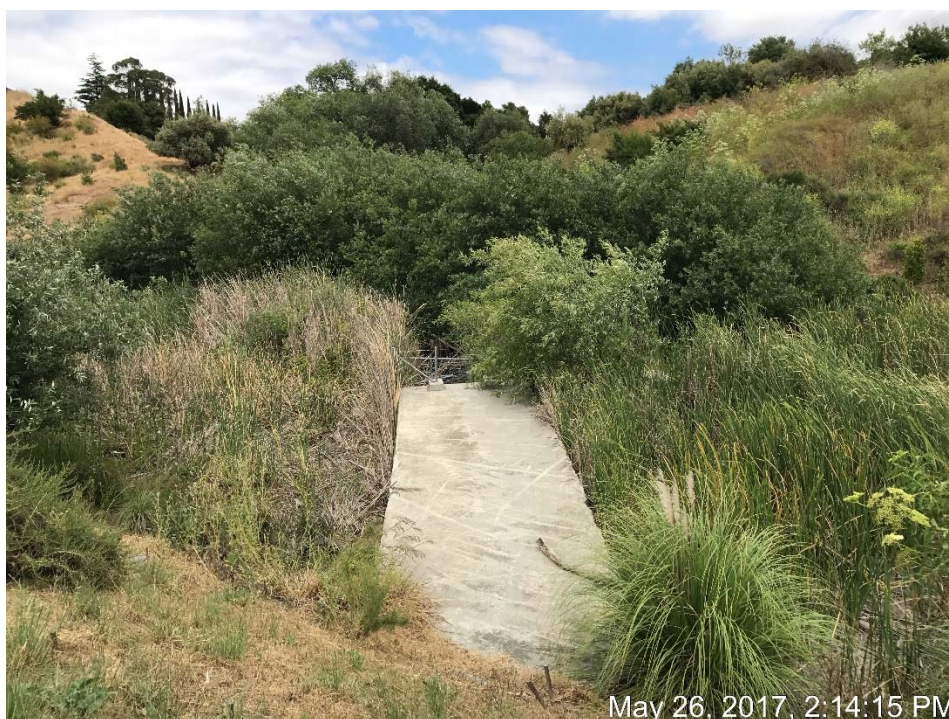
Photo 1. Emergent Vegetation in Created Wetland, Facing East

Plant establishment and recruitment in the created wetland were excellent (Photos 1 through 3). Narrowleaf cattail (*Typha latifolia*) was dominant throughout the wetland area, with alkali bulrush (*Bolboschoenus maritimus*) intermixed. Other species present along the edges of the wetlands included gray rush (*Juncus patens*), common rush (*Juncus effusus*), tall flatsedge (*Cyperus eragrostis*), mugwort (*Artemisia douglasiana*), and arroyo willow (*Salix lasiolepis*). Cattails were the dominant species in the Sabercat Creek channel step-pool reach, with mugwort (*Artemisia douglasiana*) intermixed. Recent high flows within Sabercat Creek have flushed aquatic vegetation from the channel, and no watercress was observed. No bare areas or erosion were observed. All vegetation appeared to be vigorous and disease-free, exhibiting new leafy growth, flowers, and viable buds. See Table 5 for vegetation observed.

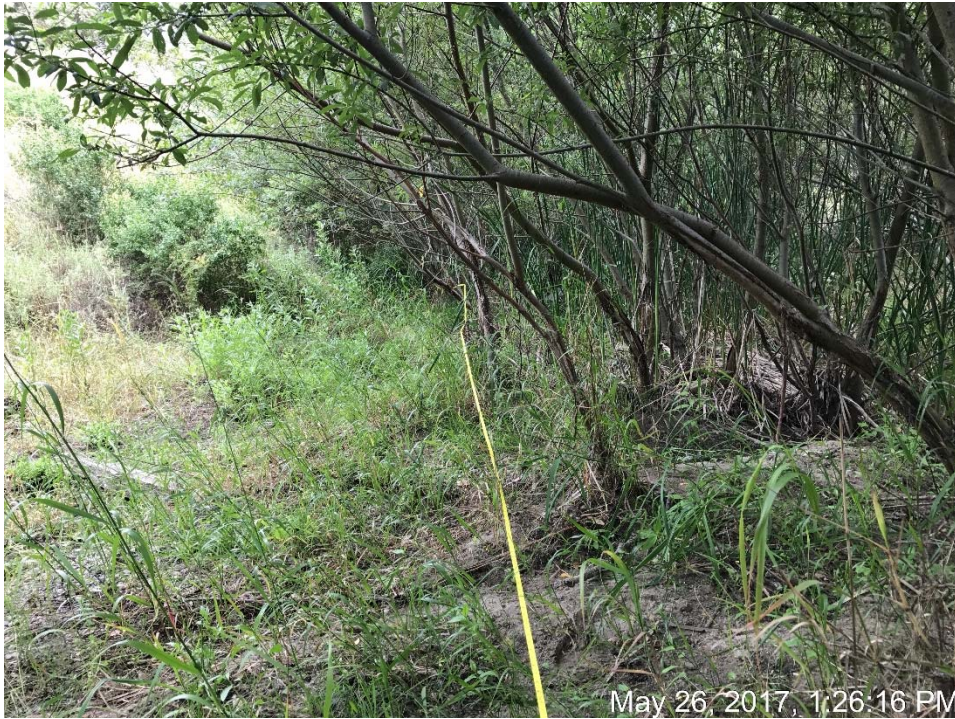
Photo 2. Plantings Along Step-pool Reach in May 2017.

A series of four boulder step-pools were constructed to reduce the velocity and energy of high flow discharges from Sabercat Creek into the wetland basin. The boulder step-pools consist of 1-ton, ½-ton, and ¼-ton rock keyed into the channel. A rock blanket was also installed to provide source material for the distribution of rocks downstream. Over time, the boulder step-pool design will mimic the natural distribution of rock and cobble within the creek, allowing stream patterns to change with varying flow regimes. The boulder step-pool reach was planted with willows to improve geomorphic stability. Willow stakes were placed between the rock blankets at the toe of the channel slope. The willows were planted in two staggered rows and were spaced from 3 to 5 ft apart.

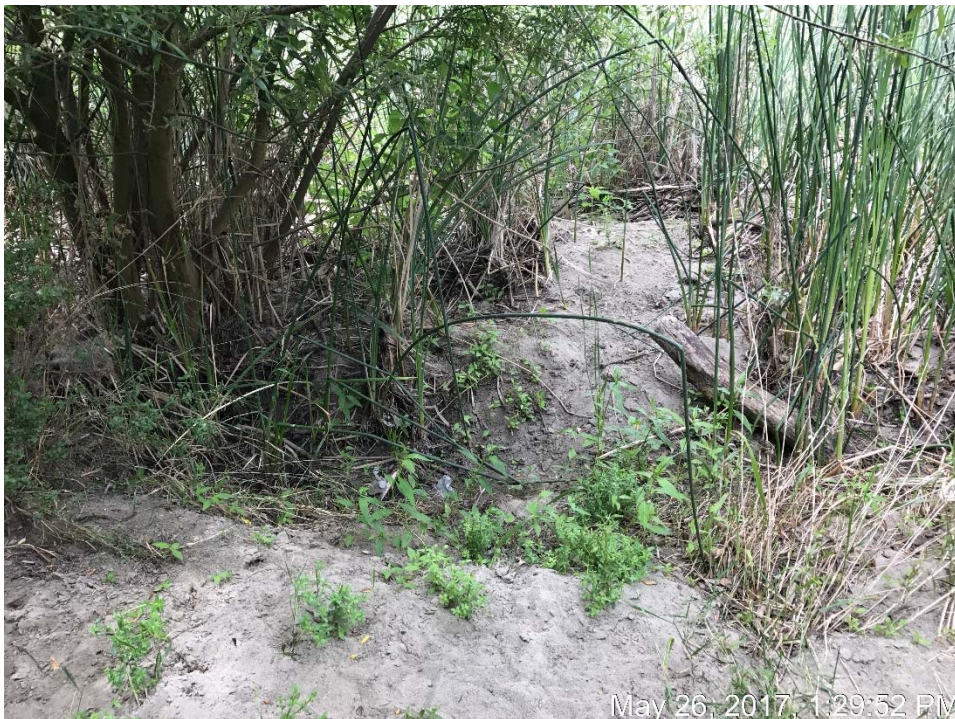
Photo 3. Newly Formed Side Channel in the Eastern Wetland Basin, Facing North.

During the May 26, 2017 spring monitoring event, the created wetland appeared to be dry, with a large amount of sediment that washed downstream and filled the eastern portion of the wetland. Due to recent storm events, Sabercat Creek has created a side channel to the east of the existing channel, transporting silt and sand deposits within the eastern part of the wetland. Emergent vegetation was observed within the entire wetland area, even with an increase in sediment deposition. At the time of the survey, Sabercat Creek had flowing water approximately 3 to 6 inches deep, with deeper pools holding approximately 12 inches of water. Qualitative data sheets are included in Appendix C.
