California Nursery Master Plan

Fremont, California

Draft Historic Resources Technical Report

April 24, 2015

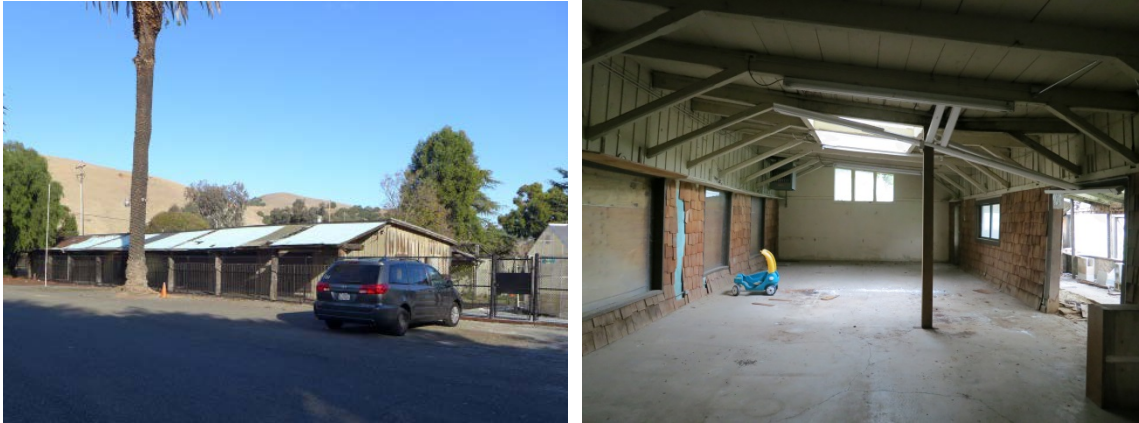
The one-story wood-frame building has two shed roofed sections linked by a covered breezeway (figures 1 and 2). Walls are clad in board and batten. The building is long and narrow, running in the north-south direction. The building has a deep, covered area on its west (front side). This covered area is formed by corrugated plastic roofing, sloping in the direction opposite the building roof, and supported at its west end by barked logs and beams. Concrete pavers form the floor of this area as well as the central breezeway. The building roof also extends out over the east side of the building. The wood ceiling opens here to create areas of corrugated-plastic-clad skylight; and a wall with large openings forms the eastern boundary of the space, supporting the roof.

Figures 1 and 2: The Garden Store, exterior and interior.

The Garden Store is in poor condition. The barked columns are termite infested, and some have completely lost their connection to the ground for this reason. Wooden elements supporting the roof are also generally in poor condition, with rotting ends often pulling away from each other. The building is enclosed in chain-link fencing as a precaution to keep the public away. While imminent collapse is not anticipated, it is not out of the questions, so the fenced enclosure seems prudent until corrective actions can be taken.

The Draft Master Plan outlines two schemes for the site. Both schemes would retain all historic buildings and structures except for one, the Garden Store. The condition of the store is such that the cost of

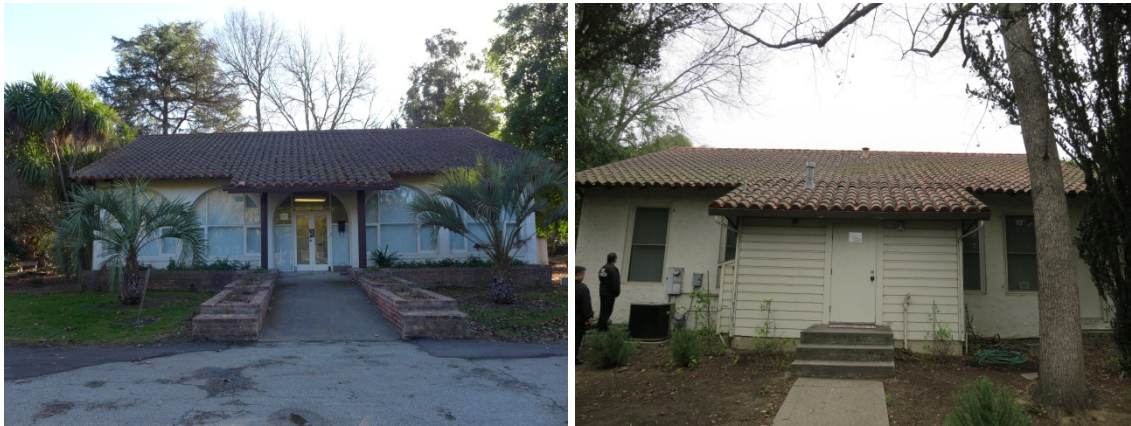
Figures 3 and 4. Nursery Office, front and rear elevations.

The building is a one story nearly-square footprint building with a side-gable roof. It is of reinforced concrete construction with concrete foundations (figures 3 and 4). The square footprint is broken at the rear by a small, non-original, central projection which currently contains toilet rooms. The building features five glazed arches on its primary, north-facing façade, stucco cladding and a clay tile roof.

Condition: The building appears to be in good condition.

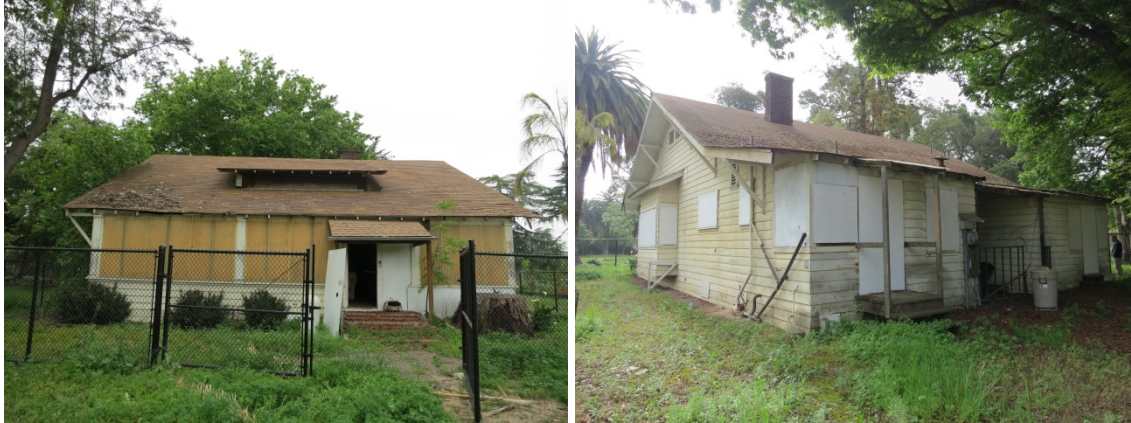
Figures 5 and 6: the President's House

The President's house is rectangular with a front gable, low pitched roof (figures 5 and 6). The asphalt shingle-clad roof, with typical craftsman-style knee braces beneath its wide eaves, also has a central, low-pitched shed-roofed dormer. The wood-framed house is clad with horizontal wood cladding. The eastern, front elevation features a wide front porch, currently enclosed with corrugated plastic. North of this porch, brick stairs lead to the entry door. Windows are currently boarded over. The rear features two shed-roofed additions. Plumbing, potentially indicating bathroom locations, was observed in three locations. The interior has been vandalized, but retains early 20th century kitchen casework (figure 7), and a brick fireplace. Notably, the interior is entirely clad in "Beaver Board" (figure 8). Beaver Board was a fiberboard material, made with compressed wood fibers or pulp. It began production in 1906, so was a very new material at the time the house was built.

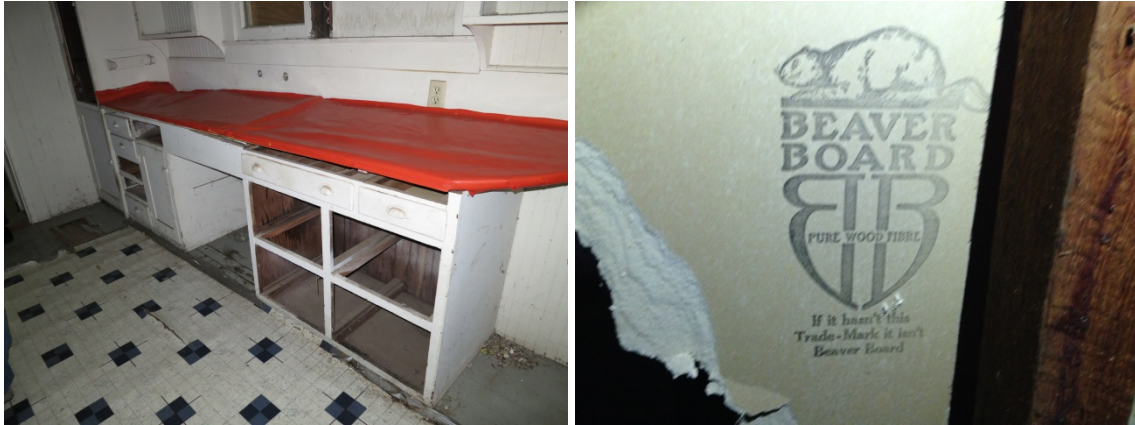
Figures 7 and 8. Kitchen casework, and Beaver Board.

The building is in fair condition. The exterior wood cladding typically is in contact with the ground, which can encourage termite infestation and wood rot. Termite damage was, in fact, identified in several locations at the building. We also noted some missing knee braces, and a missing roof rafter over the porch. Most windows are covered over on both the exterior and the interior, so were not available for evaluation. A few were visible on the interior; the wood elements appeared sound, but most of the glass has been broken.

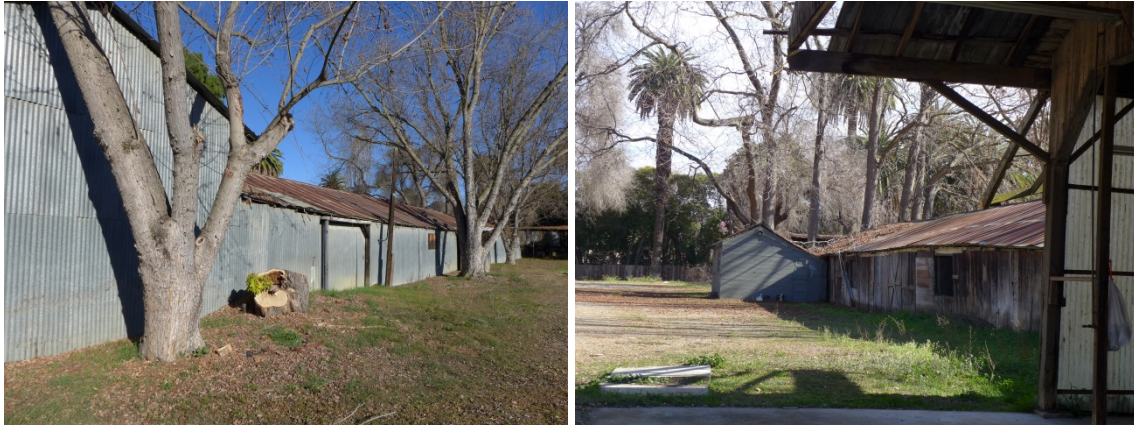
"This gabled wood-frame structure is composed of two sections: a higher section at the buildings west end, and a long low section to the east (figures 9 and 10). The higher section, with partial upper floor, is open at the front where the roof extends forward in cantilevered fashion. Wall cladding consists of vertical wood siding and corrugated metal. The low section is sheathed on the front with wood siding (vertical and horizontal) and at the side and rear with corrugated metal; doors and windows have been cut into the walls. Both sections have corrugated metal roofs. There are shed additions at both ends of the building." (Minor, page 3) The building has an earthen floor, and a truss-supported roof (figures 17 and 18)

Figures 9 and 10: The Packing Shed, south and north sides.

The building displays termite damage and wood rot. The roof sags in several areas, and the walls deviate from vertical in some locations, perhaps because the building lacks a proper foundation. The corrugated metal roofing is rusted. At the west end, portions of the roof are missing.

An open wood shed stands a few feet to the east of the main packing shed. This ancillary building is in extremely poor condition, and may be a hazard.

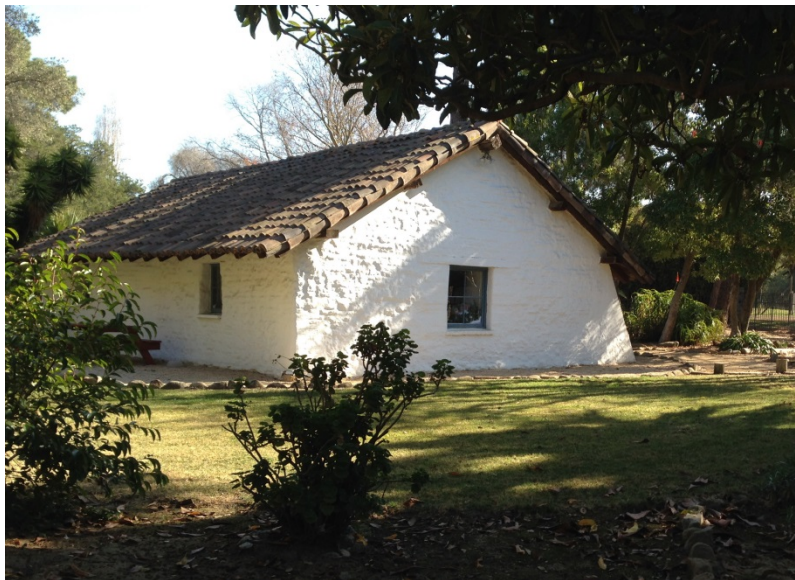
Figure 11: The Vallejo Adobe

Description: The adobe is a one-story rectangular-plan building with a gabled, clay tile roof (figure 11). The building is approximately 25 feet wide by 44 feet long, with walls that are nearly three feet thick. These uneven adobe walls are plastered and painted white. Multi light wood sash windows are located on the north, south and west walls. Plank doors with iron hinges are located on the south and west walls.

Condition: The adobe is in excellent condition. Some minor spalls and cracks were noticed on the exterior.

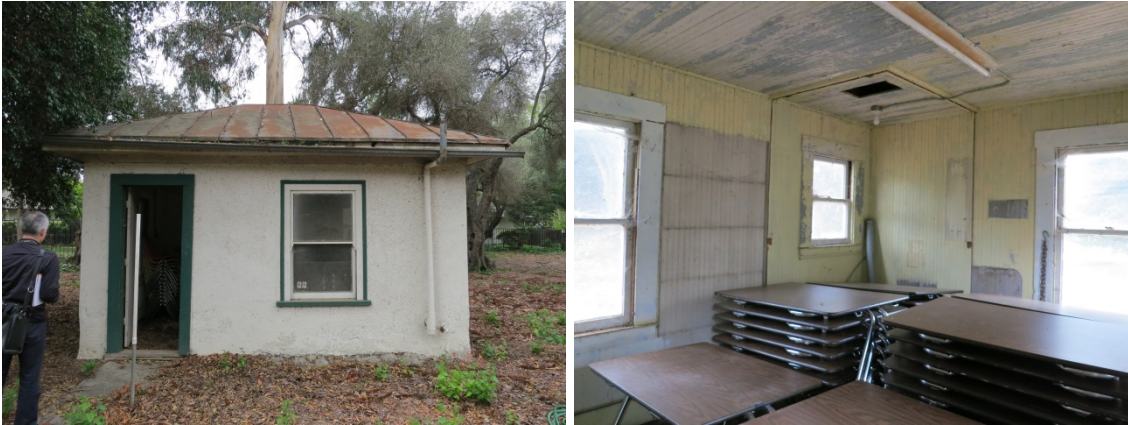
Description: This small rectangular building, set behind the Office, has stucco cladding and a standing seam metal roof. It has an earthen floor, and no apparent foundation. It has wood double hung windows and a wood door. The interior is clad with bead board (figures 12 and 13).

Figures 12 and 13: Changing Room, exterior and interior views.

The lack of foundation has caused the mud sill to deteriorate. The wood to earth contact has also resulted in termite damage.

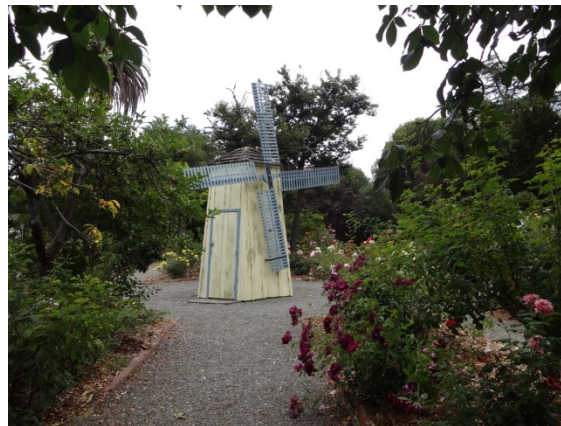
Description: This small wood-framed structure is hexagonal in plan, with battered wood board and batten walls and a wood shingle roof. Windmill blades attach to one side, and a wood door accesses the interior, which is used for storage (figure 14).

Figure 14: Windmill

Condition: Minor rot was observed at the rear of the structure

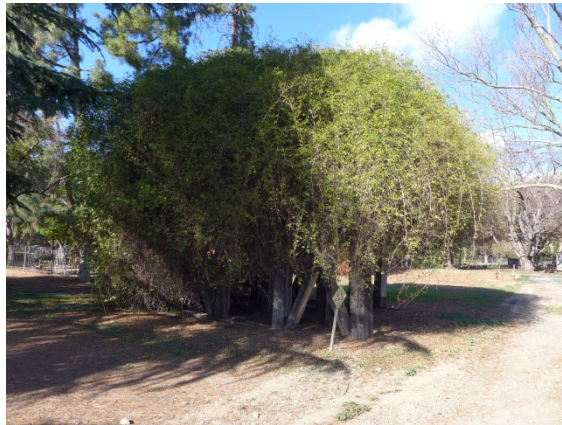
Description: 13 wood posts, 12" X 12", are arranged in a rectangular grid (figure 15). Diagonal braces and horizontal beams tie the posts together and support a wooden platform which once held a water tank. The entire structure is overgrown by a climbing rose bush.

Figure 15: Water tank support structure (beneath vines)

Condition: One of the posts has become loose at the top and is leaning precariously

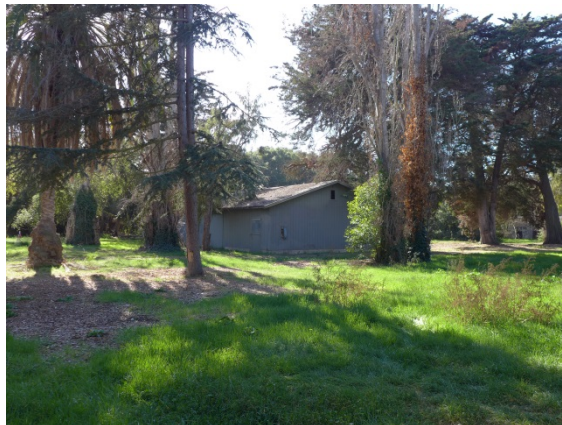
This is a rectangular-footprint, one story gable roofed structure (figure 16). The walls are clad with T-111 plywood, and the roof with vinyl shingles. There is only one window – a small aluminum slider window on the north elevation. Instead, overhead garage doors open at the center of each of the long elevations. In addition, both long elevations feature sliding, barn-type doors. Natural light enters the building through skylights. While not historic, this building is not offensive, is in reasonable condition, and is potentially useful for a number of activities.

Figure 16: The ROP Building

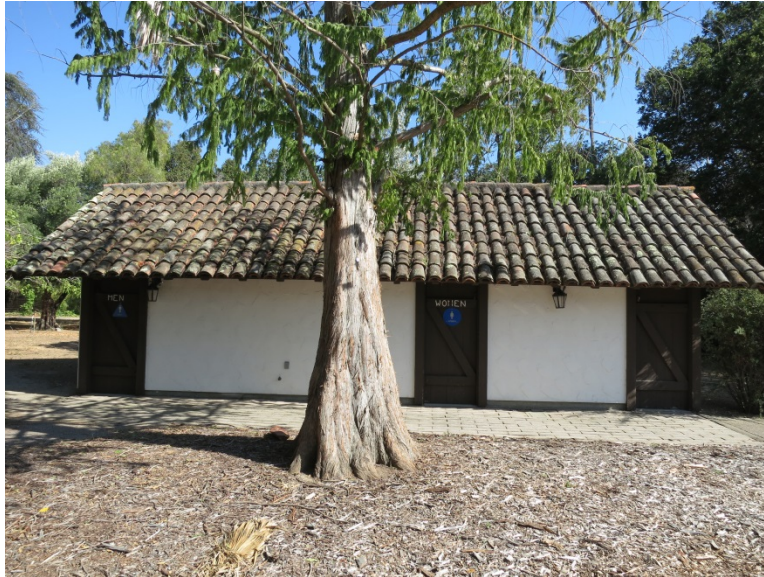
The existing public restroom building is located near the adobe, and constructed in a style to blend with that structure. Its rectangular walls are stuccoed and painted white, and it has a clay tile gabled roof (figure 17). Wood plank doors, and multi-lite wood windows further the comparison. The building contains a men's and women's restroom, as well as a storage/maintenance room at the western end.

Figure 17: the Public Restroom and Storage Building.
