Appendix E:
Cultural Landscape Resources Report

CULTURAL LANDSCAPE RESOURCES REPORT

California Nursery Historical Park
City of Fremont • Alameda County • California

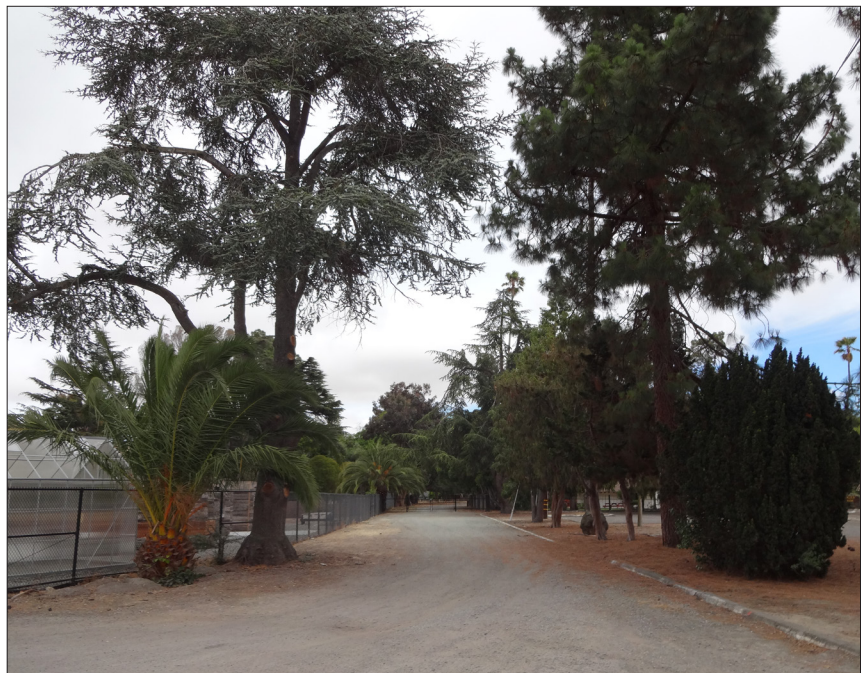
Photo b: East portion of the unnamed east-to-west road is still prominent, 2014

the internal circulation system, as is other east-to-west oriented circulation. (See photo b) Less prominent is a north-to-south road that runs between the President’s House and extends to the south boundary. This road is prominent in the 1959 aerial photo.

- CR 1. The project sponsor shall maintain the primary components of the circulation system including location, alignment and approximate width of Nursery Avenue, the road to the Office, and the path through the Boxed Tree Forest. Other primary circulation routes should reinforce a north-to-south and east-to-west grid.

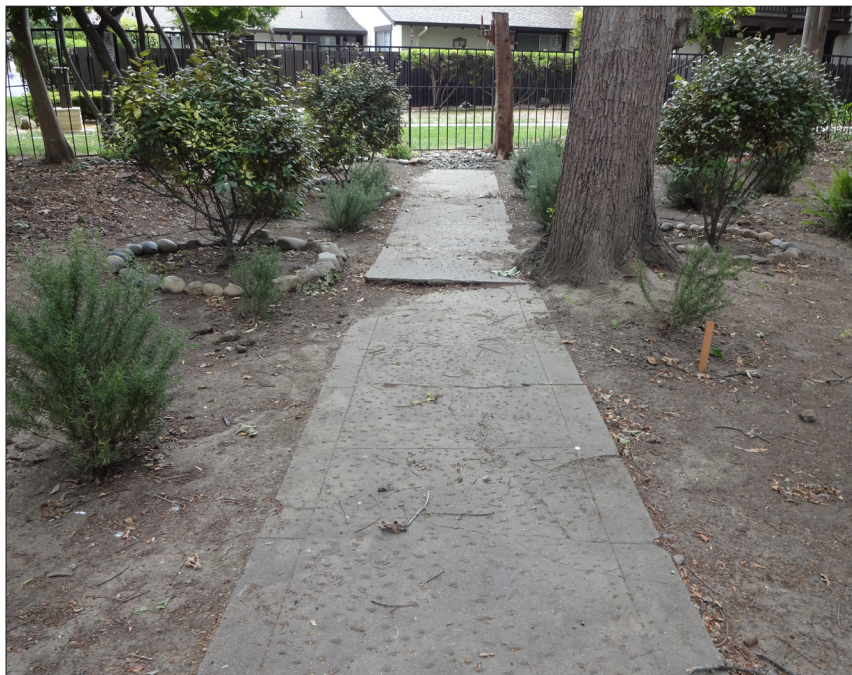
The 1936 plan of the nursery shows a 4-foot wide pedestrian walk on the south side of the office. This walk into the Office is still present. (See photo c) No other pedestrian walks are shown on the plan.

Photo c: Concrete walk on the south side of the office with a stipple finish and 6-inch band at the edge, 2014.

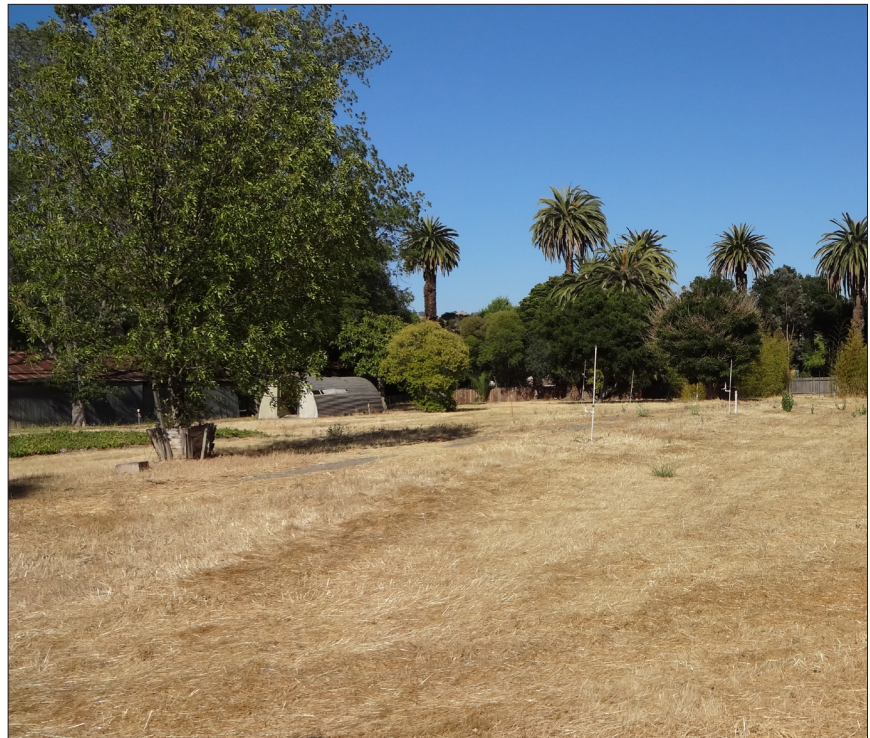
Historically, the nursery had open, unplanted fields or fields that changed with the seasons. These can be seen in the 1937-39 aerial shown in photo e and on the 1936 plan. Similarly, today the park site has areas of open fields, as seen in photo d.⁵

Above, photo d: Open field south of the packing shed, 2014

- CR 10. The project sponsor shall include one or more open areas free of trees. This area should be planted with a non-irrigated vegetative cover or topdressed with organic mulch or wood chips.

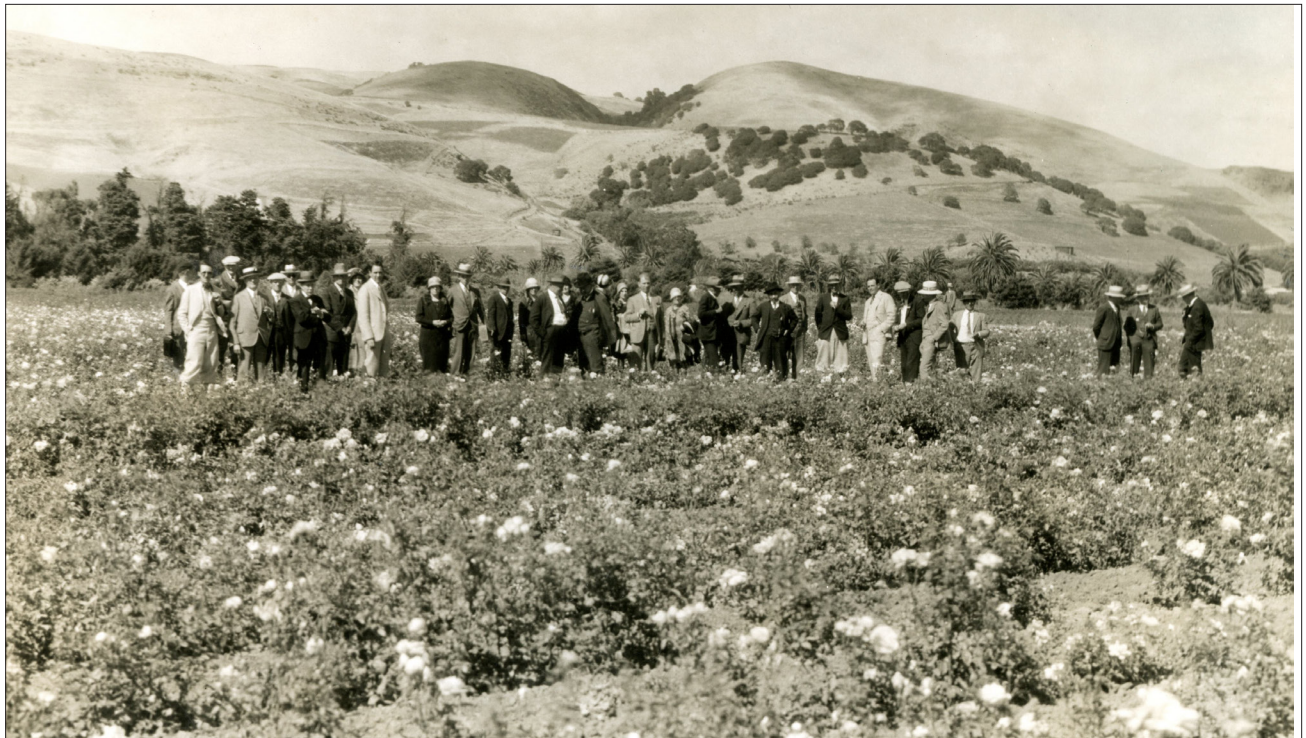
Originally, the nursery property occupied a broad, flat area at the base of the Diablo foothills to the north and a quarry to the south. Looking north along Nursery Avenue and the parallel roads one could see the foothills in the distance. (See photo f)

Above, photo f: Gathering of the American Association of Nurserymen with view of the Diablo Foothills in the background, 1939
Below, photo g: Current view of the Diablo Foothills, 2015

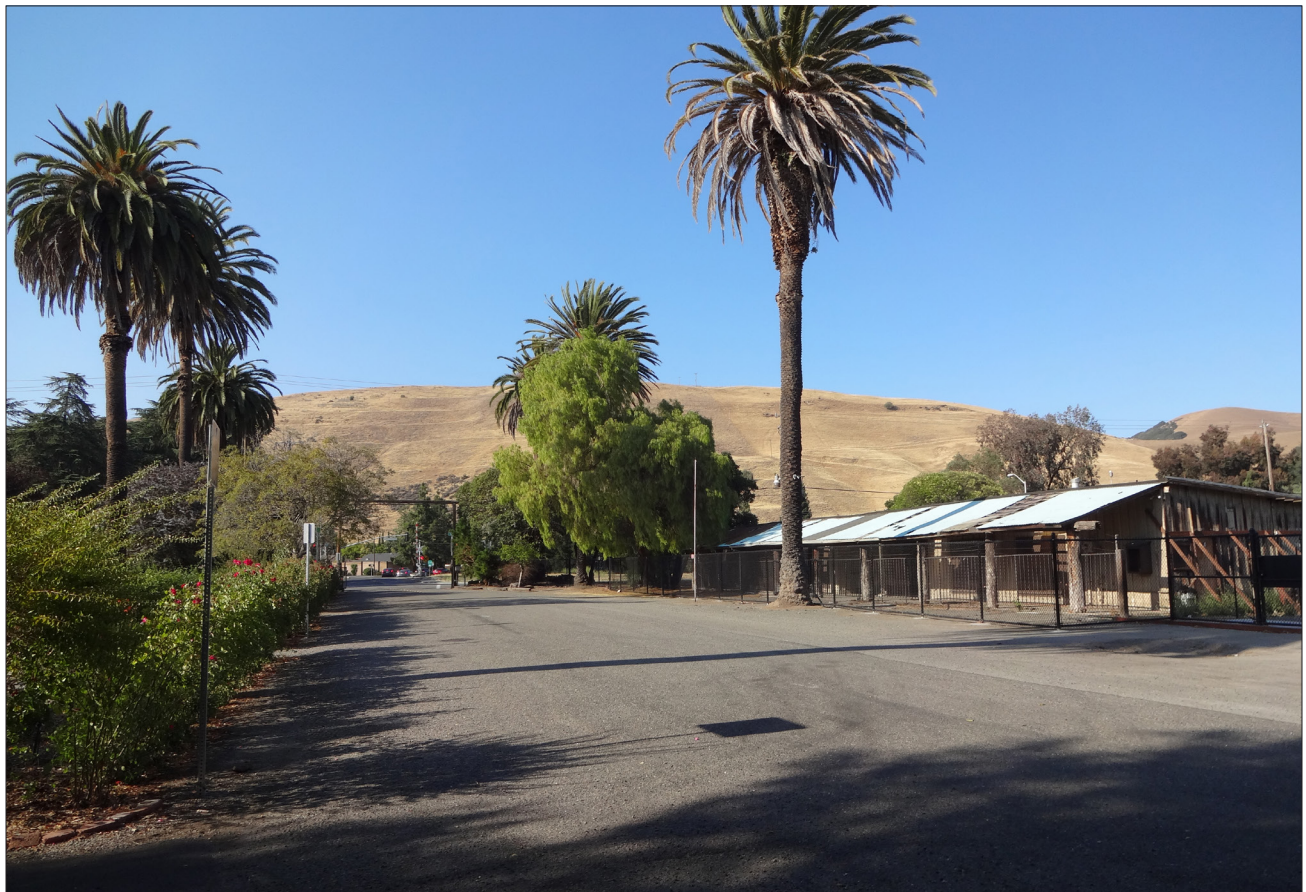
Today, that view is partially blocked by mature trees and recent nearby development but portions of this view remain. (See photo g)

- CR 2. The project sponsor shall retain the existing buildings and structures in their current locations except for the garden store.
- CR 3. The project sponsor shall maintain views to the foothills to the north of the site.

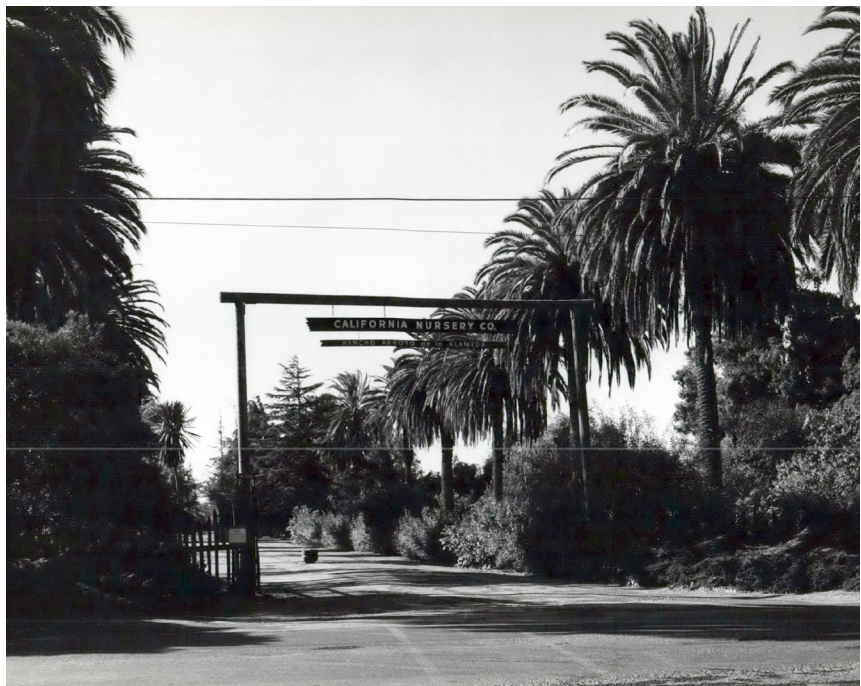
photo h: Entrance to the Nursery lined with date palms, 1971. Another group of palms is located beyond Nursery Avenue and the parking lot. These include excellent specimens of a variety of fern palms.

- CR 6. The project sponsor shall plant a variety of new trees to replace trees that have died or that are in poor condition. Some of the new trees shall be planted continuously in straight rows between the north-to-south dividing roads, in a manner similar to what is shown on the 1936 plan of the nursery prepared by H.C. Scherer. A minimum of six additional date palms shall be planted along Nursery Avenue to replace palms that once lined the entrance to the nursery.

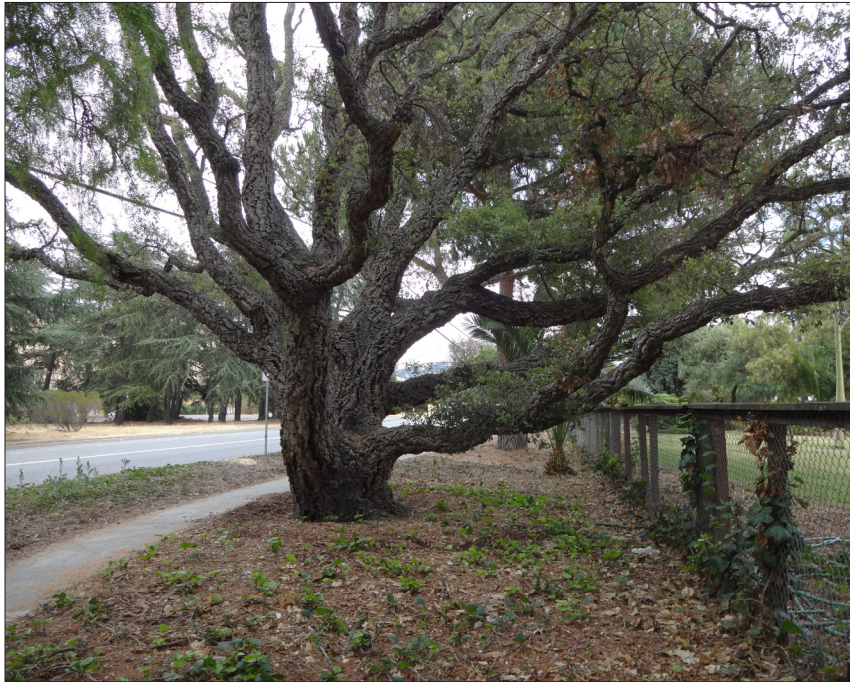
a 54" cork oak⁹ on Niles Boulevard opposite the Office (*See photo i*), two prickly melaleuca 55" and 59" in the northwest corner, a 55" bunya bunya in the southwest corner west of the Office, a 113" compact blue gum near the southwest corner of the Office, a 43" Ponderosa pine opposite the Packing Shed, four trees near the adobe including four date palms measuring 19", 20", 27" and 31", and five Monterey cypress trees north of the water company property measuring 27", 48", 49", 50", and 50". This last group appears to be a remnant from one of the horizontal bands of evergreens seen on the 1936 plan.

above, photo i: 54-inch cork oak on Niles Boulevard, one of the 15 individually designated City landmarks, 2014

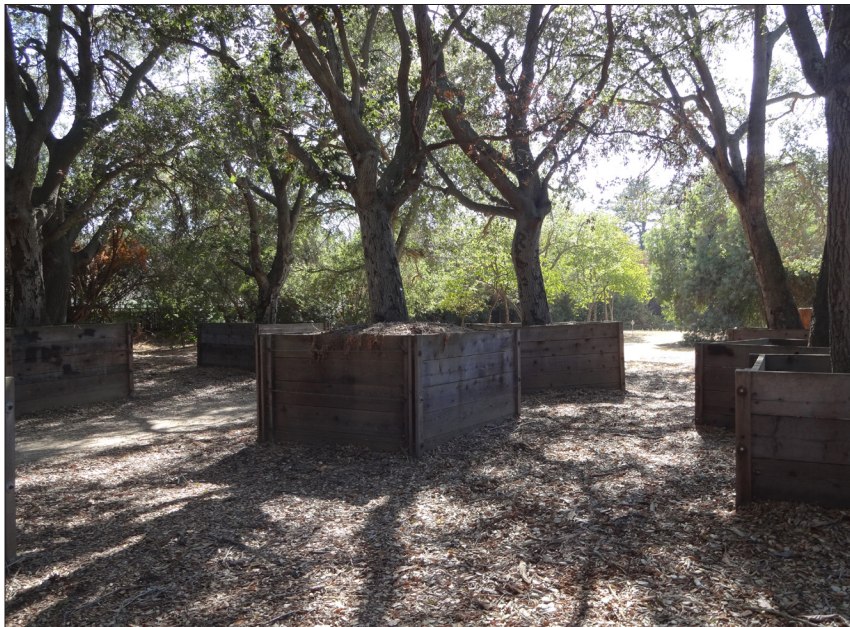
One of the most significant groups of trees occurs between two rows of mature yew trees in the southwest corner of the property. Twenty-three live oak trees in large (8' x 9' x 4'-high) wooden boxes are clustered together in what is known as the "Boxed Tree Forest." (*See photo j*) These extraordinary trees are all large with trunks varying in size from 17" to 35". Their branches form a continuous canopy.

below, photo j: Trees in the Boxed Tree Forest, 2014

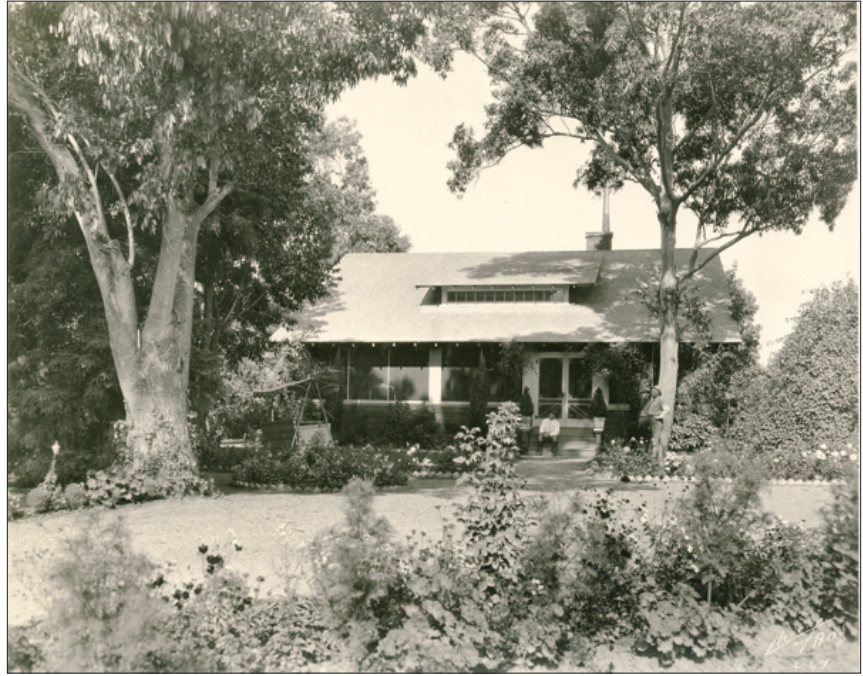
Two photographs labeled 1920s and 21 June 1935 show lush gardens outside a screened-in porch on the east side of the home. (See [photo k](#)) Planting beds filled with perennials and low shrubs are edged with a rickrack of bricks. There are potted topiary at either side of the porch, a lawn and a covered swing in the garden. Paths are topped with gravel. A 1932 photo of the north side of the home shows a Libocedrus (currently Calocedrus decurrens) in the foreground and lush plantings of trees, shrubs and vines surrounding the house. On the 1936 plan, the President's house, labeled "Mrs. Roeding Sr Res" shows 17 individual trees planted around all side of the home in an informal pattern. Species included: 3 eucalyptus, 1 Librocetrus, 2 date palms, 1 Euonymus, 1 redwood, 1 Grevillea, 2 pines, 1 Maytenus, 1 deciduous oak, 1 Lyonothamnus and 2 elms.

above, photo k: East-facing side of the President's House with mature trees and gardens, 1920s.

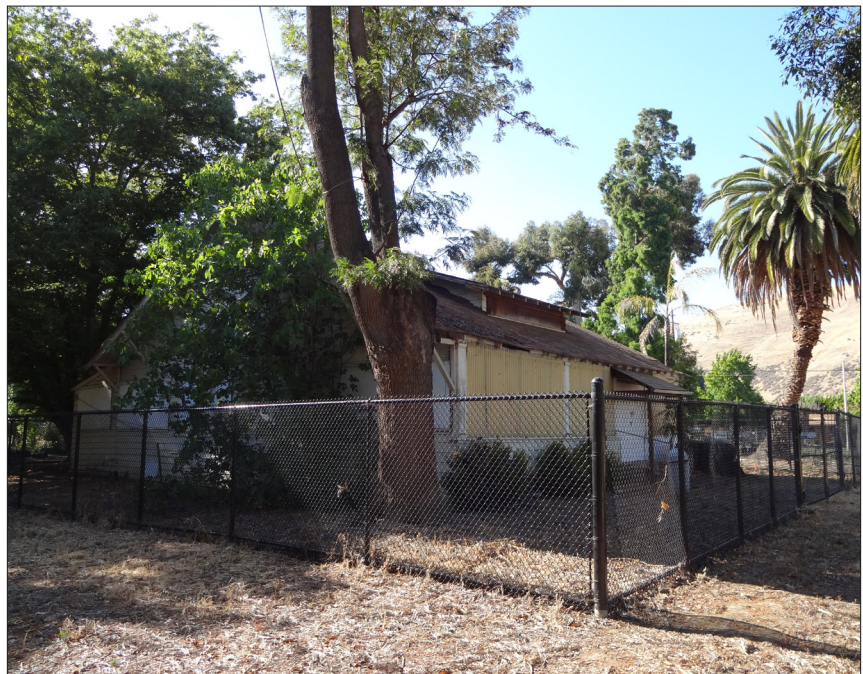
Today, there is a large tree stump at the northeast corner of the home, three mature trees and a row of foundation shrubs on the east side. (See [photo l](#))

below, photo l: East-facing side of the President's House with mature trees and foundation shrubs, 2014.

- CR 7. The project sponsor shall plant ornamental gardens around the President's House, the Vallejo Adobe, the Office, the office lawn, and in the area west of Nursery Avenue where the tulip festival used to take place. These gardens shall incorporate a variety of species known to have existed in this area during the period of significance, and may include varieties that were developed and sold by California Nursery. These garden beds may also include new varieties that have been developed since the end of the period of significance. New varieties must be permanently identified as recent hybrids and may occupy not more than 20 percent of the ornamental garden square footage. Roses shall be included in the President's House gardens and may be included in other gardens.

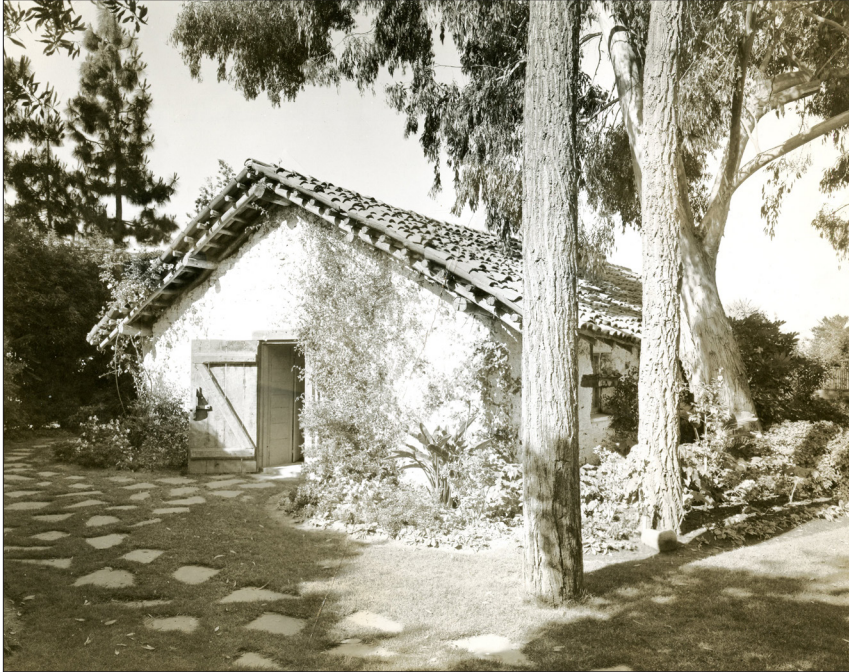
Historic photos taken ca. 1920 and 1940 show a variety of mature trees and dense shrubbery around the Adobe. (See photo m) Vines are growing up and onto the roof. In the more recent image, the foundation plants have been trimmed and the lawn has a path of stepping stones leading to the door on the east side. The 1936 plan shows a *Pittosporum eugenioides* hedge surrounding the Adobe, a group of 3 pines and and 3 individual trees.

Today, the gardens around the Adobe look much as they did in the 1940s. The evergreen hedge has been replaced with a 5-foot ornamental iron fence with 16-inch square masonry pilasters.

above, photo m: Vallejo Adobe surrounded by mature trees and shrubs, 1930s and 1940s
below, photo n: 1947 view of the south side of the Roeding Residence.

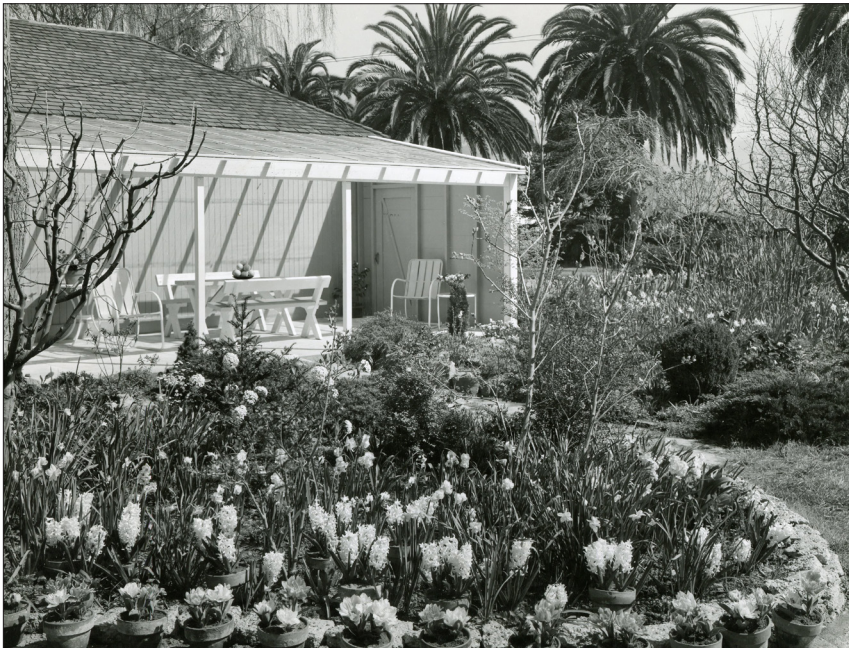
The 1936 plan shows the Roeding residence surrounded by hedges on the north, east and south sides. (see plan 1) Informal groupings of trees include: Cedar atlantica, redwood, oak, eucalyptus, cedars and pines. A driveway and turn-around into the backyard branches off the unnamed Lane. A 1947 photo of the Roeding Residence shows a covered patio on the south side of the home with white patio furniture. (See photo n) It is early spring, before the fruit trees have bloomed, and a large half circle planting bed is filled with hyacinth, daffodils and other bulbs, as well as a variety of low, evergreen shrubs. The row of date palms at the nursery's east property line can be seen in the background. There is a lawn and gravel paths.

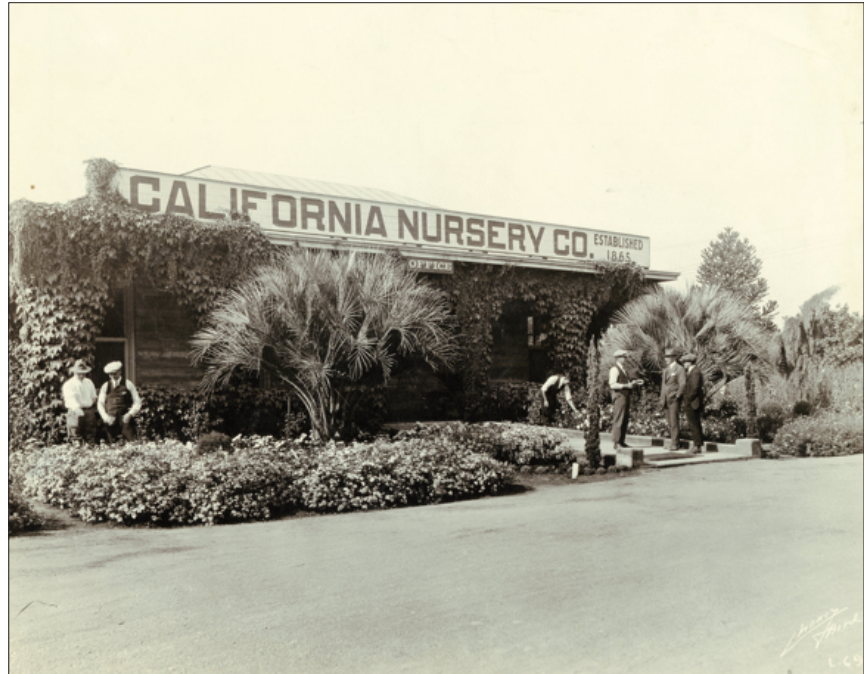
A 1910 photo of the office shows that the ivy had grown thick and was hanging off the building. There were low foundation shrubs and a lawn across the front of the building edged with a crenellated line of brick. In a 1923 photograph the lawn had been replaced with low shrubs and the palms had grown a little. Two small Italian cypress had been added at the pilasters. (See photo o) In 1954, the pilasters, brick edge and Italian cypress were removed and brick planters lined the entry walk to the office. Today, the terraced brick planters remain. (See photo u)

above, photo o: Nursery Office plantings, low shrubs, young palms and small Italian cypress, 1923

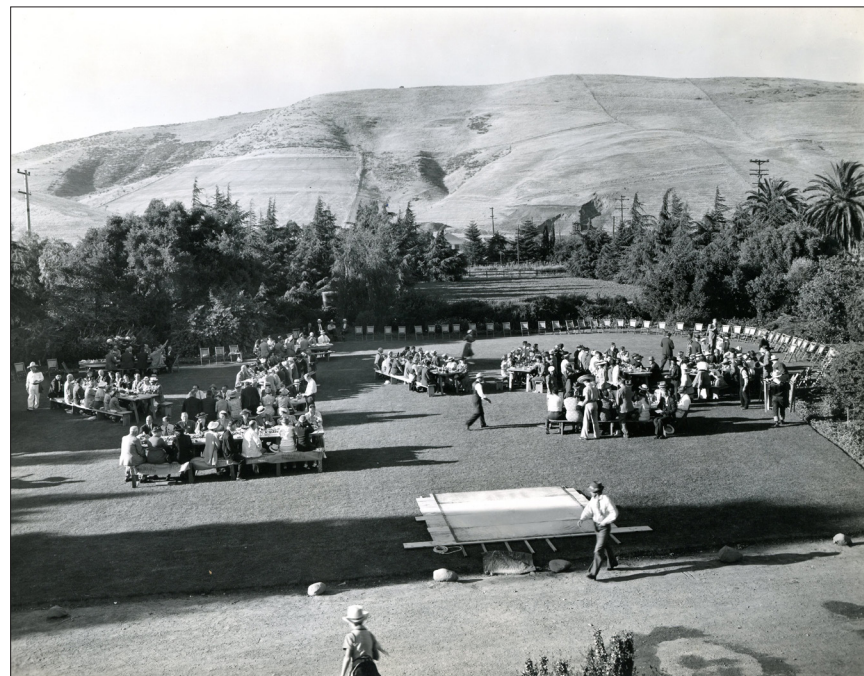
The office and adjacent lawn was the venue for large events that occurred at the nursery. Historic photos show large gatherings of the American Association of Nurseryman picnicking on the lawn. (See photo p) Because this was the nursery's "living room" it was the most extensively landscaped space on the grounds. An early photo of the office illustrates the newly-planted gardens on the north side and a curving-drive approach. There was a gate and large timber wood and wire fence along Niles Boulevard. Newly planted trees along the edge of the drive are less than two feet tall. The building with its arched façade was covered with Boston ivy and there were two young palms at either side of the entry walk. The front walk was lined by a low concrete curb that terminated at the entry drive with low pilasters.

below, photo p: American Association of Nursery men picnicking on the office lawn, surrounded by shrubs and large trees, 1939

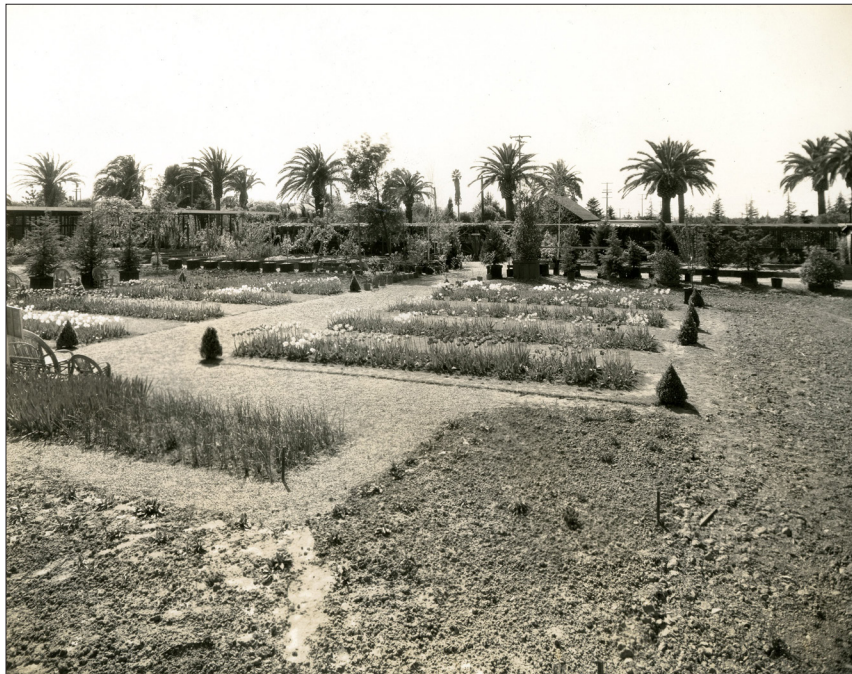
For more than 30 years, starting in the 1930s, the Nursery hosted an annual bulb festival. The event took place from the middle of March to mid April. As many as 100,000 people would visit the garden each year to see the displays of tulips and other bulbs. A 1932 photo shows newly built formal beds laid out parallel to Nursery Avenue. (See photo q) There are four rectangular beds on either side of a central gravel path. Two-foot high conifers marked the corners of the beds and curved-backed rattan chairs were placed at the ends of beds. Each bed included multiple varieties of bulbs. The date palms and office are visible in the background of the photograph.

photo q: Newly built beds for the Bulb Festival, 1932

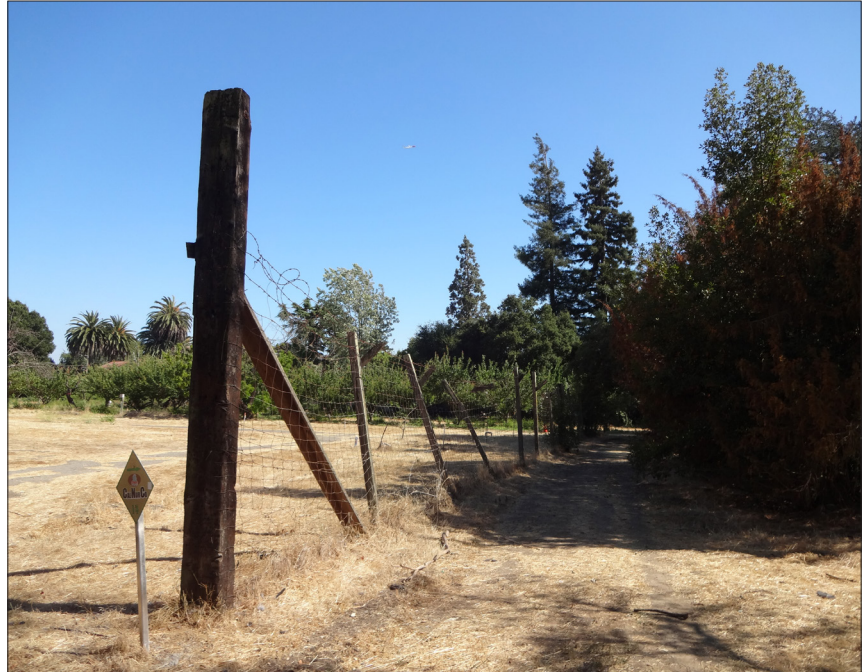
At various places throughout the property remnant pieces of historic fencing remain. These remnants vary in style. Near the current apricot orchard the 8-foot high fence consists of 4x4 wood posts with 7"x12" creosote-soaked posts and braces at each end. Attached to the posts is wire mesh with a six inch grid. *(See photo r)*

above, photo r: Remnants of historic fence near the apricot orchard, 2014

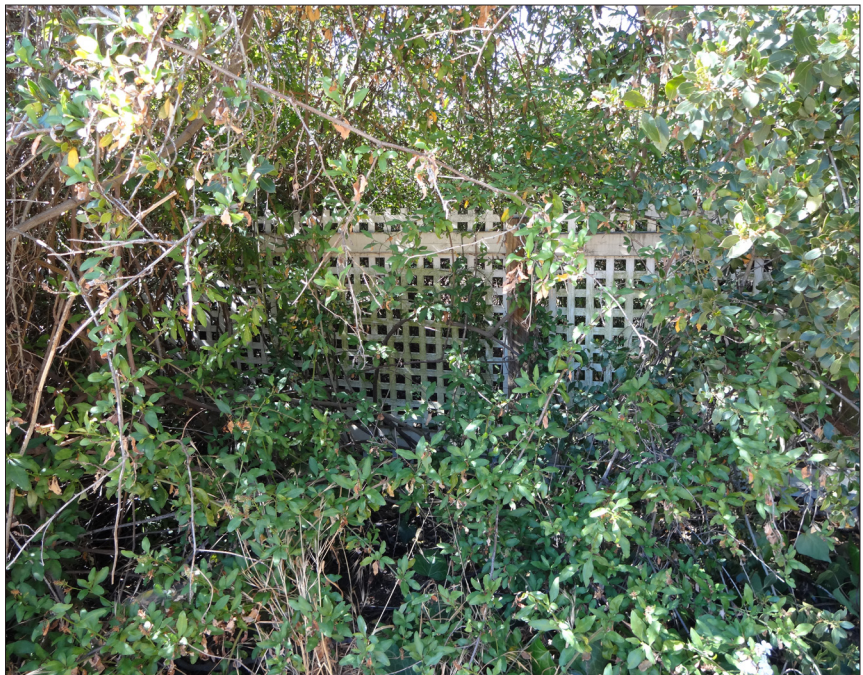
At the Roeding Residence the perimeter fencing is four feet high. A portion of the fence that runs east-to-west on the south side of the property is plastic lattice with 4x4 posts. *(See photo s)* Along the west

below, photo s: Plastic fence on the south side of the Roeding Residence, 2014

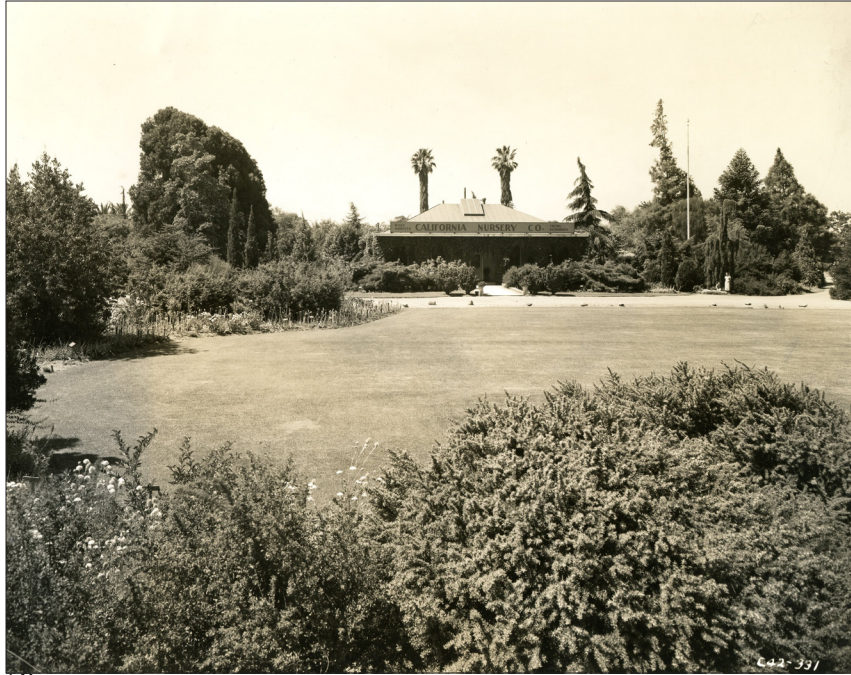
There is a 50-foot wooden flagpole with a metal brace and concrete footing near the Changing Room that can be seen in a photo labeled 1938-39. This photo shows the front of the office, the lawn and surrounding gardens. (See photo t)

above, photo t: The office flag poles can be seen at the top right in the photo, 1938-39
below, photo u: Brick planters at the Nursery Office, 2014

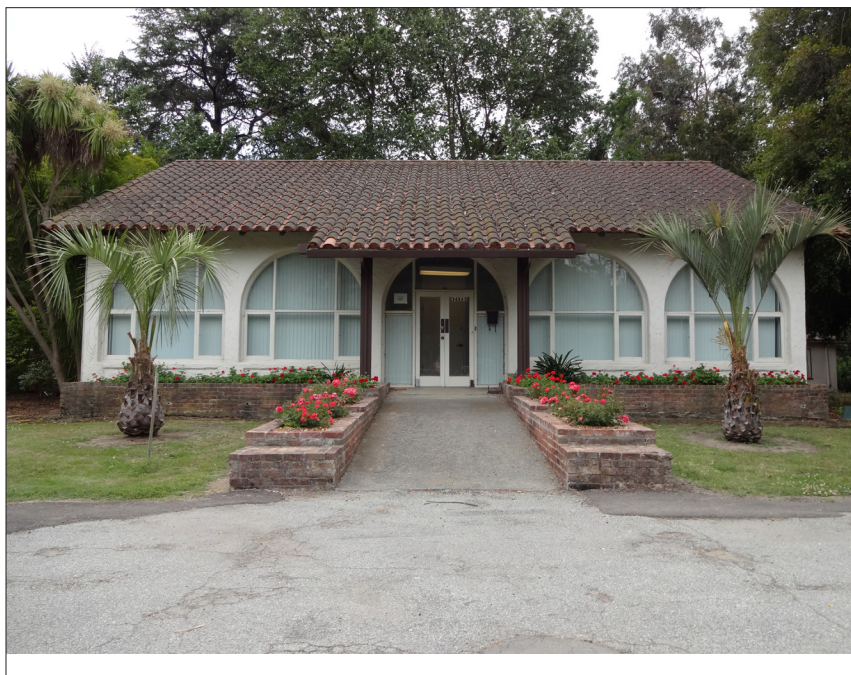
Today, access to the Office is from the north side via a ramp. At either side of the ramp there are 40-inch wide stepped brick planters filled with shrub roses. Twenty-six-inch high brick planters across the front of the building contain geraniums and Kaffir lily (*Clivia miniata*). This brick work was added ca. 1954.¹² (See photo u)

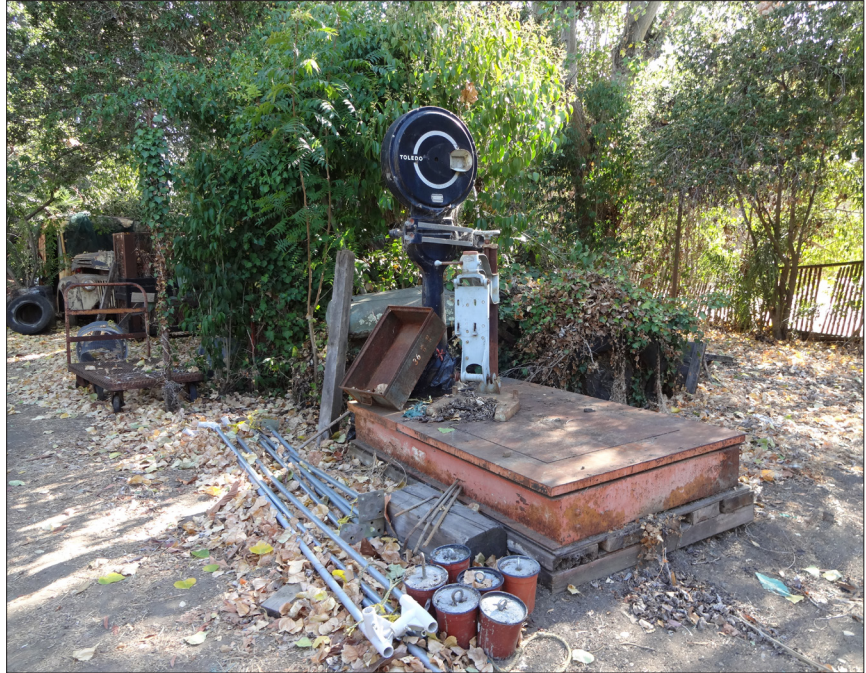
above, photo v: Example of nursery equipment used in nursery operation and now stored nearby, 2014

Many of the pickup trucks and other equipment used as part of the nursery operations is stored adjacent to the park site and some will be incorporated into the interpretive displays. These items include weighing scales, weights, tractors, cultivating attachments, a wheeled and motorized spray tank and hose, rolling carts for moving supplies, bins for storing materials, planting pots, and a variety of hand tools. [\(See photo v\)](#)

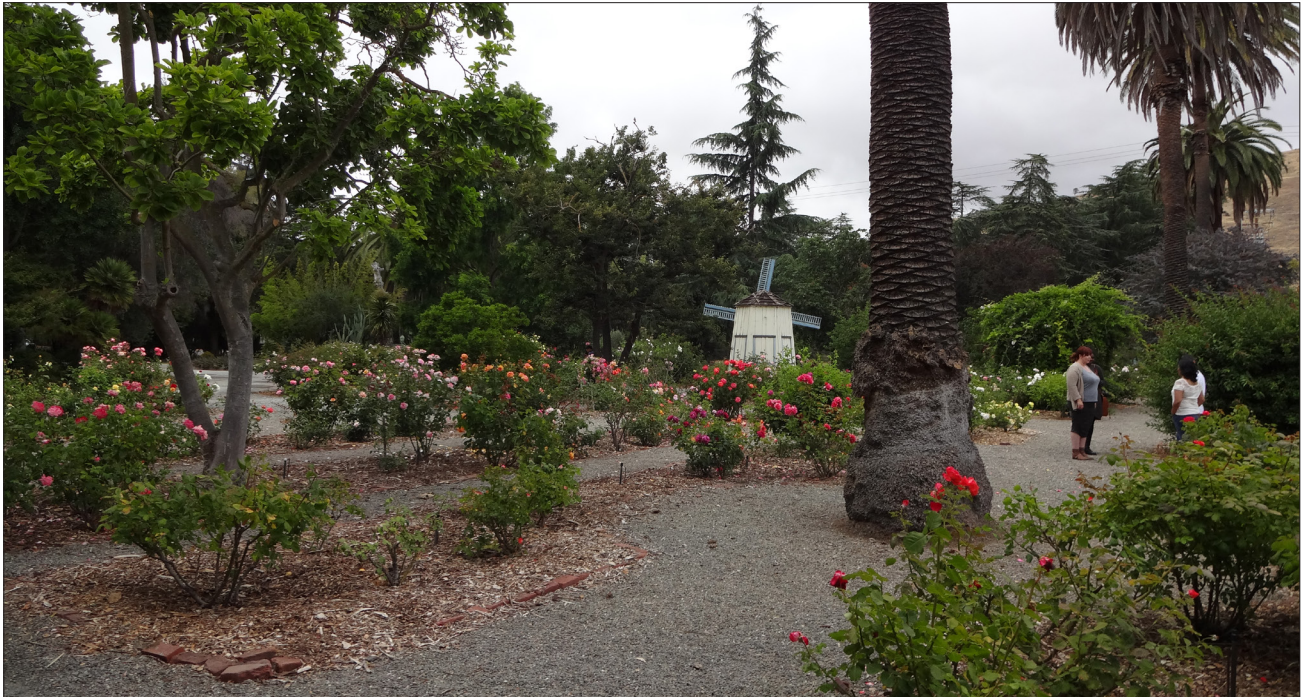
below, photo w: Existing rose garden and windmill, 2014

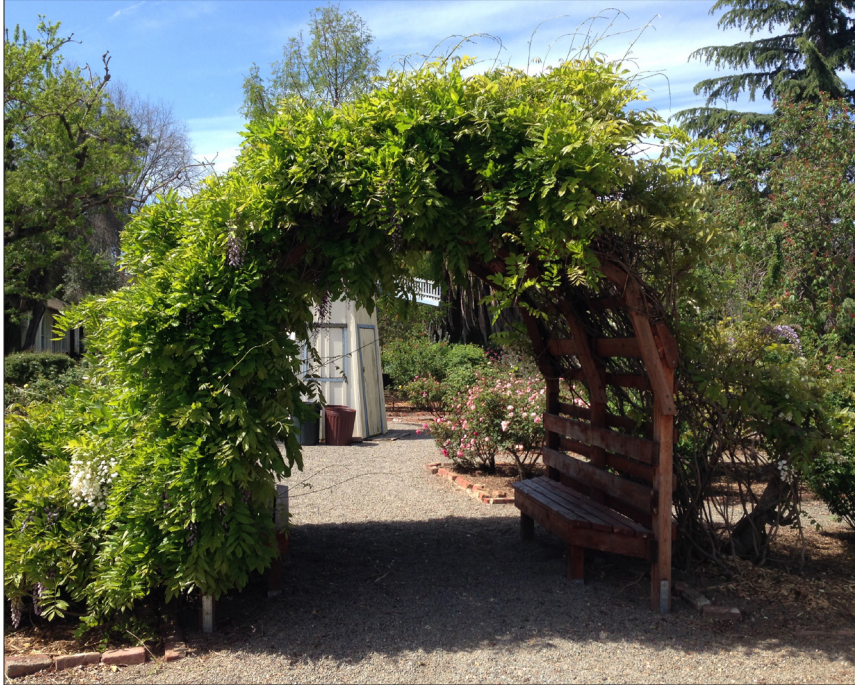
photo x: New trellis in the Rose Garden, 2014

Today, the beds are edged with brick and paths are topped with pea gravel. The current beds were laid out in the early 1970s. A wisteria vine-clad trellis with benches is a relatively recent addition. [\(See photo x\)](#)

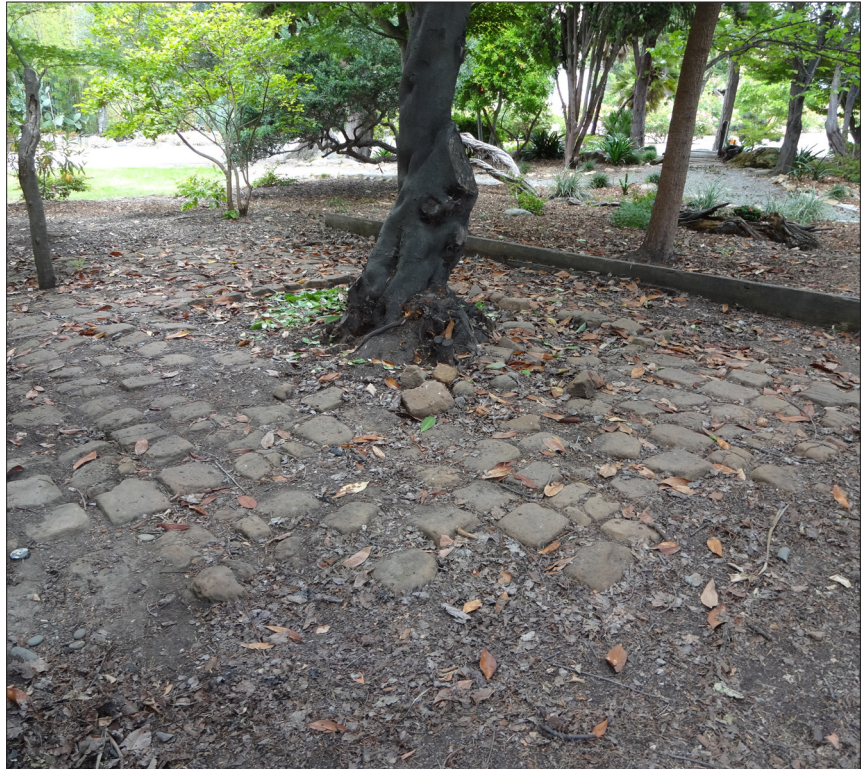
On the east side of the Office there is an 11-foot by 20-foot area paved with emulsified adobe brick surrounding a small Japanese maple and an English Laurel. These pavers were used to build a scaled model of the Vallejo Adobe as part of the nursery's exhibit at the 1939 World's Fair on Treasure Island.¹⁴ The city used the pavers to build this patio. (See [photo y](#))

above, photo y: Adobe brick pavers near the office, 2014

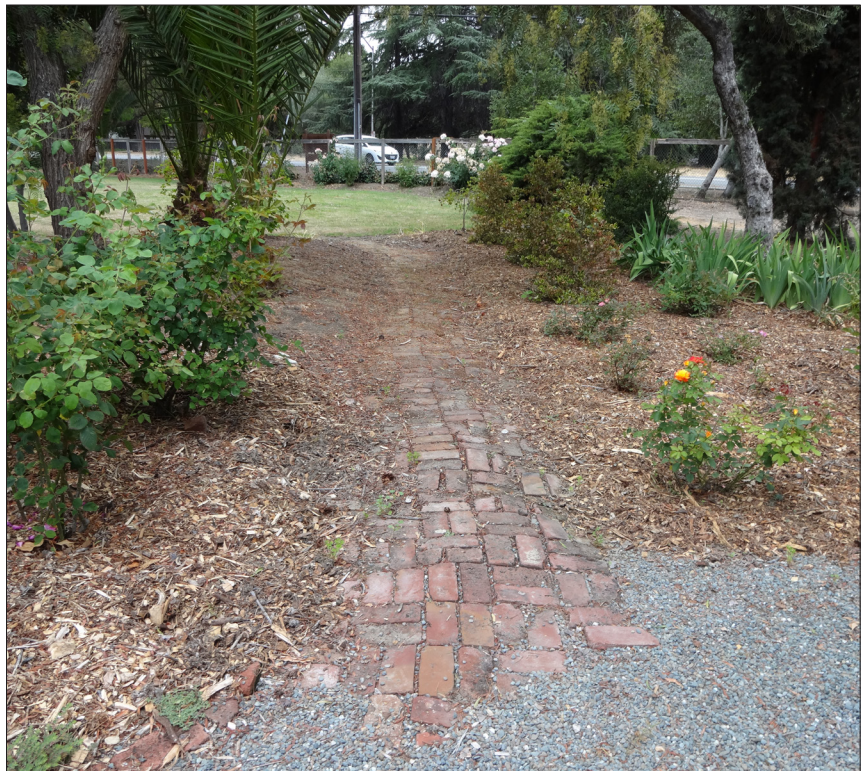
Within the garden area between the Office Lawn and the rose garden there is a 30-foot long and 45-inch wide brick path. The bricks are set on sand and the path has a slight crown and no distinct edge. (See [photo z](#)) These bricks were originally salvaged from San Francisco after an earthquake in 1886, according to Bruce Roeding.

below, photo: Brick path between the office lawn and cactus rockery, 2014

- CR-15 The project sponsor shall include a minimum of 3 Smyrna fig trees within the orchard.
- CR-16 The project sponsor shall retain some of the brick from the path between the office lawn and cactus rockery, and some of the granite curbs, and incorporate them into the final plans, for interpretive purposes.

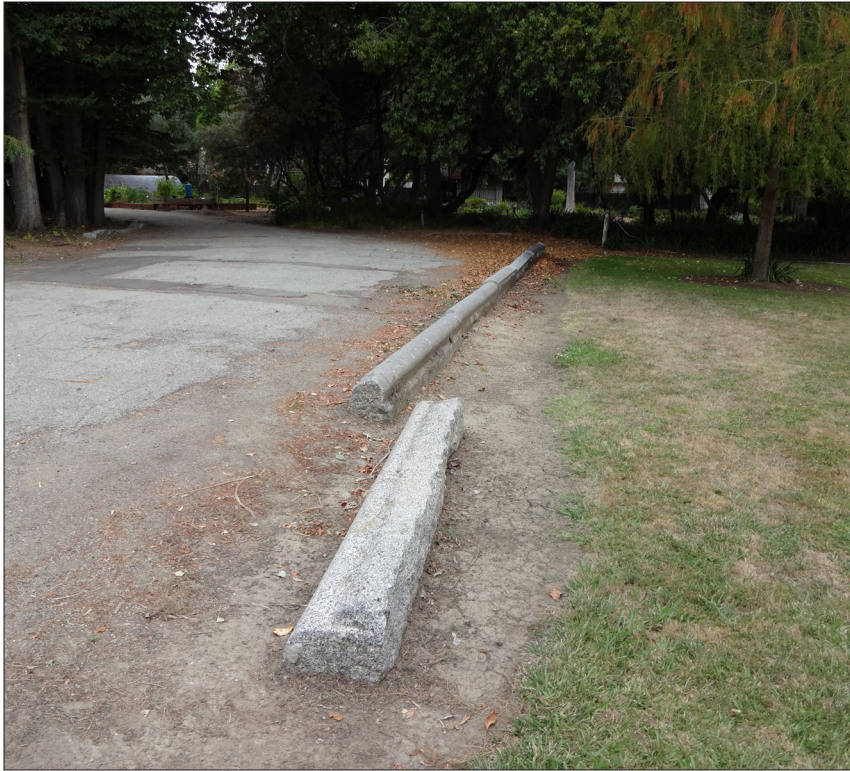
Outside the office there are thirteen granite curbs varying in length from 3 feet to 10 feet. These were installed by the city after the period of significance. The granite curbs are used to define the edge of the drive that leads to the Office. Historically, broadly-spaced boulders served this function as can be seen in various photographs from the period. *(See photo aa)* Originally, these curbs came from a historic church in the Irvington District.

above, photo aa: Granite curbs at the lawn, 2014
below, photo bb: Concrete fountain, 2014

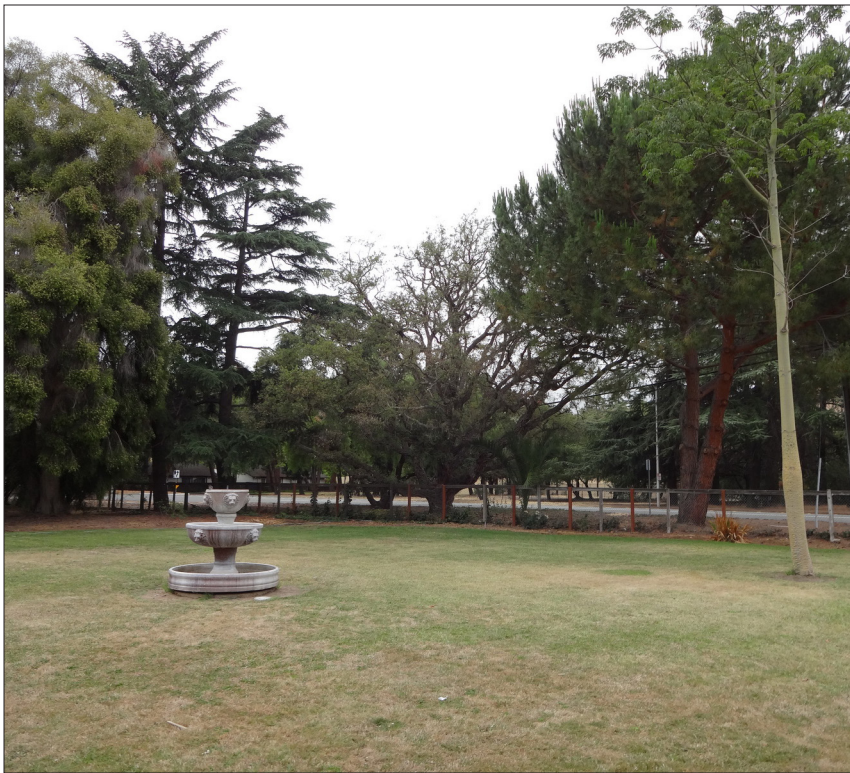
In the middle of the lawn, on the north side of the Office, there is a three-tiered precast concrete fountain that was installed by the city. It measures 5 feet, 2 inches high and is 5 feet, 6 inches in diameter. *(See photo bb)*
