Blacow Elementary School Fremont School Traffic Safety Assessment Technical Memo

December 2017

Prepared by Alta Planning + Design

Blacow Elementary School

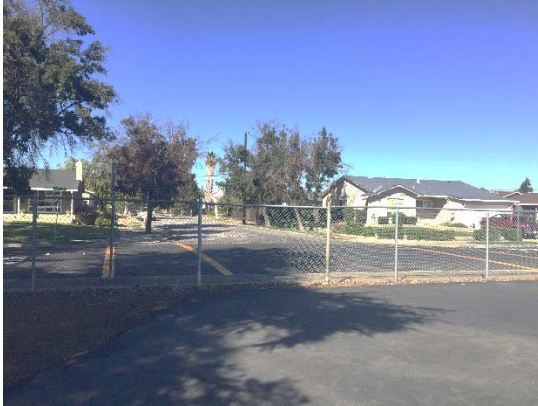
- ◆ There are currently three transverse crosswalks at the intersection of Hilo Street and Besco Drive. There were high levels of pedestrian traffic crossing Hilo Street along the designated crosswalks.
- ◆ The more westerly crosswalk across Hilo Street does not have a curb ramp connecting to the sidewalk.
- ◆ Audit participants observed vehicles speeding on Besco Drive, most likely because it is a connection to Stevenson Boulevard. Vehicles were observed doing U-turns in the Hilo Street/Besco Drive intersection.

Left: View from school courtyard at the intersection of Hilo Street and Besco Drive.

- Install high visibility crosswalks and advance stop pavement markings at all approaches
- 3 Hilo Street/Besco Drive**
- Install high visibility crosswalks and advance stop pavement markings at all approaches

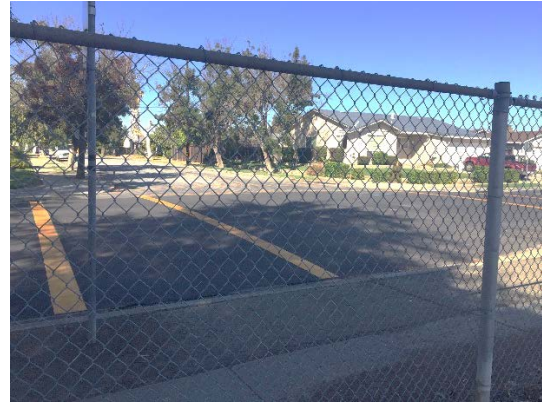
Right: Sidewalk on Hilo Street without curb ramp.

- Install curb ramp on Hilo Street curb
- 4 Blacow Park**
- Explore connection between Blacow Park and rear entrance to Blacow Elementary to open new walking routes to school for families

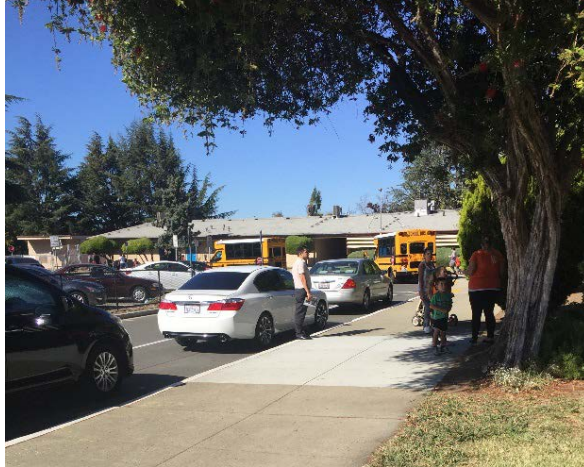
Drop off loop after Wednesday dismissal.

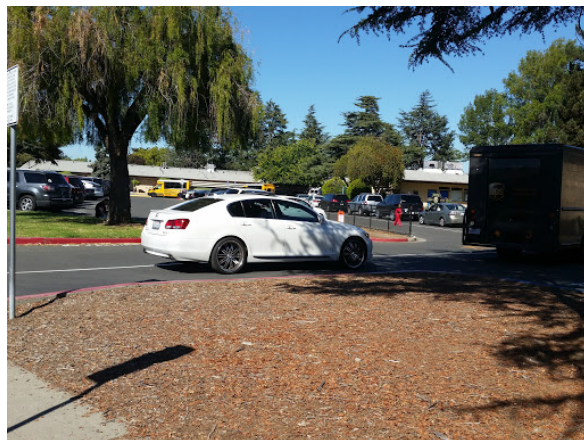
- ◆ Cars sometimes parked in front of red curb by entrance of drop off loop. Cars parked in front of red curb made entering the drop off loop more difficult, especially for the small buses that use the drop-off loop.

Vehicle parked in front of red curb by drop-off loop entrance.

- 6 Drop-Off Loop**
- Install R26S "No Stopping" Sign and stripe diagonal hatching along existing red curb to discourage parking
- 7 Drop Off Loop Exit**

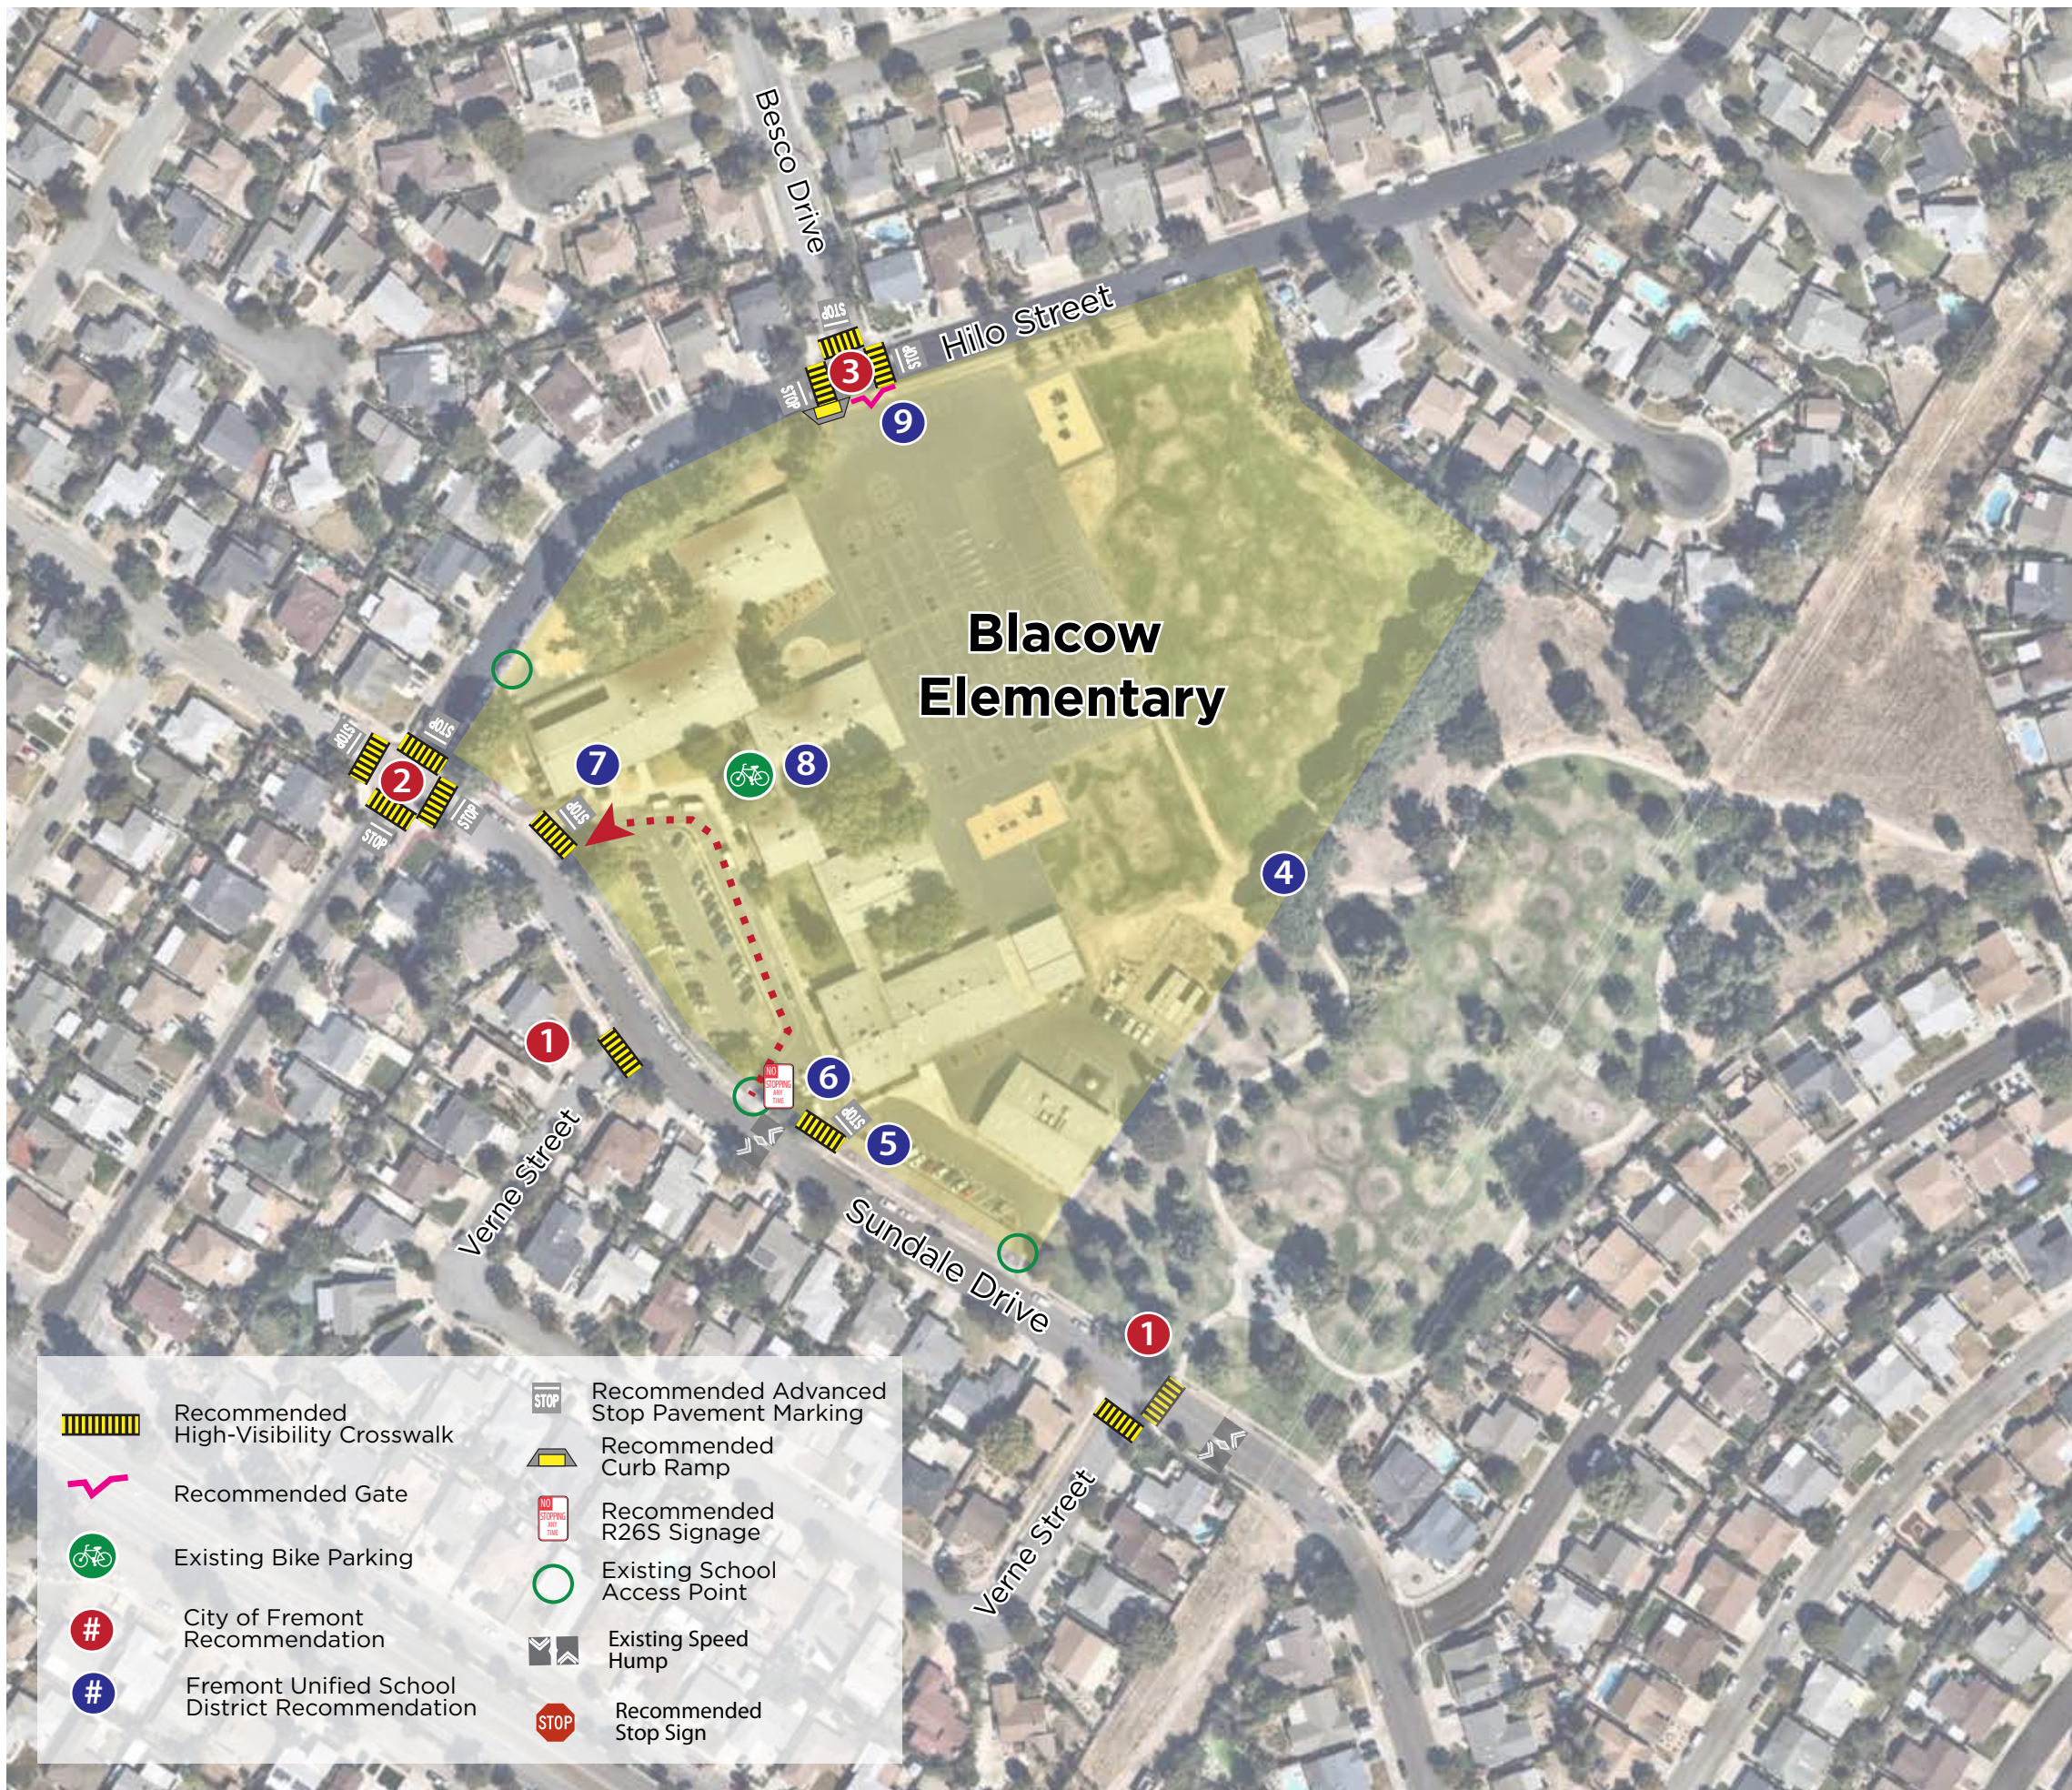
Safe Routes to Schools Improvement Plan

- 1 Verne Street/Sundale Drive**
- Install high visibility crosswalks across both Verne Street approaches to Sundale Drive
- 2 Sundale Drive/Hilo Street**

- 5 Bus Drop-Off Lot/Sundale Drive**
- Upgrade crosswalk to high visibility crosswalk across parking lot exit and move back placement of advanced stop pavement marking

- Upgrade crosswalk to high visibility crosswalk and move back placement of advanced stop pavement marking
- 8 Bicycle Parking**
- Consider installing cage around existing bicycle parking for additional security

- 9 Hilo Street/Besco Drive**
- Consider adding school gate near intersection to be used at school dismissal to promote parents picking up students on Hilo Street east of intersection
