**Irvington High School**  
**Fremont School Traffic Safety Assessment**  
**Technical Memo**

# Irvington High School

A Traffic Safety Assessment was conducted at Irvington High School during the morning arrival on Thursday, November 2, 2017. The assessment was attended by representatives from the City of Fremont, Alta Planning + Design, and Irvington High staff.

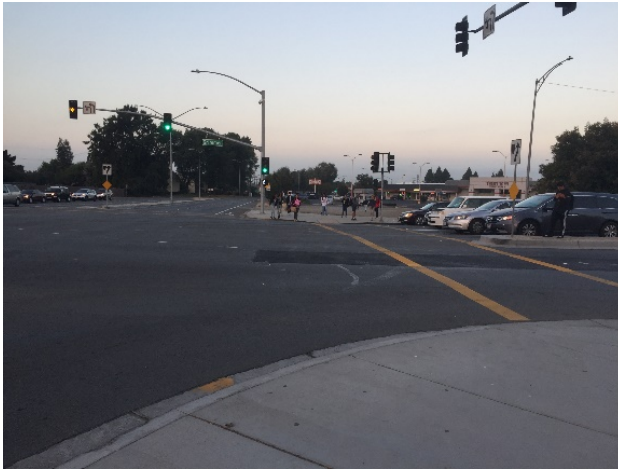
### 1. Grimmer Boulevard & Grimmer Boulevard/Blacow Road

- ◆ There is a gas station at the southeast corner of the Grimmer Boulevard/Blacow Road intersection and multiple cars were observed cutting through the gas station to get from Grimmer to Blacow and avoid the intersection.

*Left: The Blacow Road/Grimmer Boulevard intersection from the southeast corner.  
Right: Grimmer Boulevard south of Blacow Road (looking south) immediately after the AC Transit bus alighted students short of the formal stop.*

- 1 Grimmer Boulevard/Blacow Road & Grimmer south of Blacow Road**
  - The City and School District should coordinate with AC Transit and consider relocating the NB bus stop for route 623 on Grimmer Boulevard to the far (school) side of the intersection

- Upgrade existing transverse crosswalks to high visibility crosswalks
  - Widen sidewalk using existing landscaped parkway to accommodate high pedestrian volumes

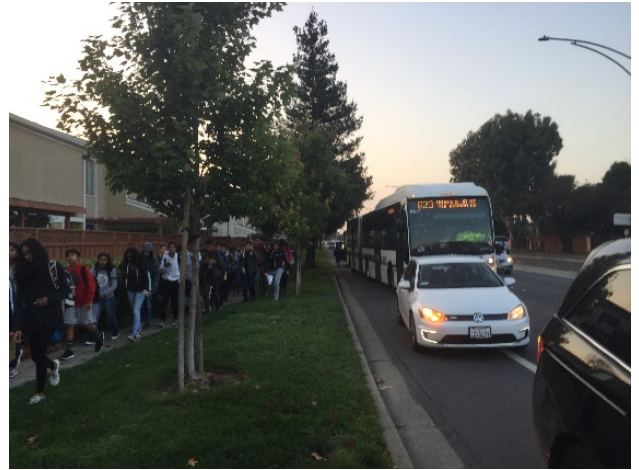
- ◆ AC Transit has a stop for route 623 near the intersection, but due to the congestion, each of the observed runs alighted students before the actual stop. It would have taken the bus several minutes to slowly reach the stop. There are a significant number of students who use these buses.

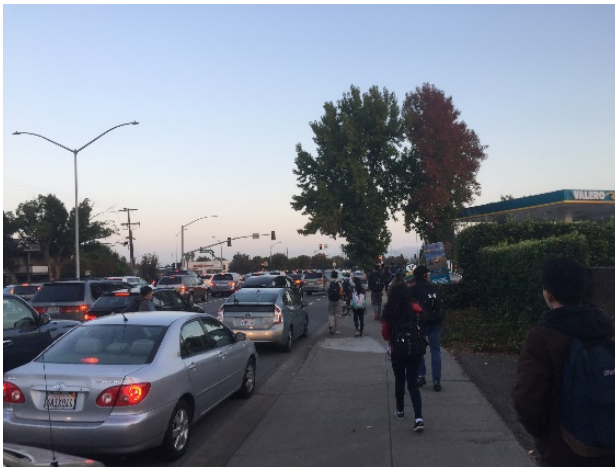
- ◆ The bike lane/curb space was observed to be consistently blocked by cars pulling to the curb to drop off students.
- ◆ Bicyclists attempting to cycle along Grimmer Boulevard either had to weave through traffic or dismount and walk on the sidewalk. There are too many pedestrians for students to ride their bike on the sidewalk.

*Left: Grimmer Boulevard, looking towards the Blacow Road intersection.  
Right: The nearside AC Transit stop next to the gas station.*

- Upgrade existing Class II bike lanes to Class IV separated bikeways
- 2 Blacow Road**
  - Upgrade existing Class II bike lanes to Class IV separated bikeways

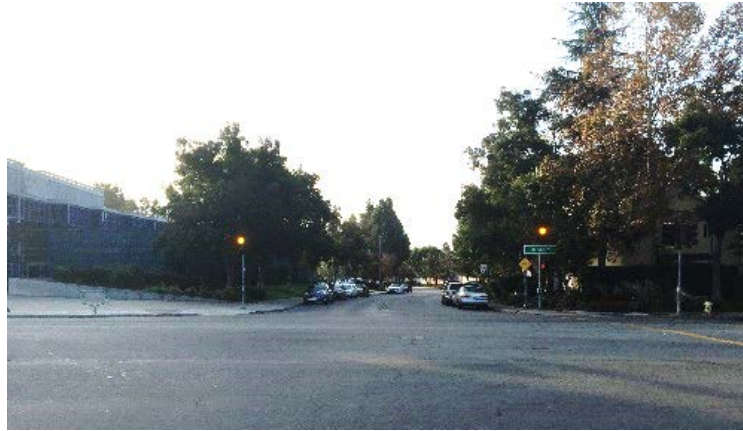
- ◆ This intersection is signalized and has a marked transverse crossing across Blacow Road.
- ◆ Walk audit participants observed that cars regularly encroach on the crossing, stopping in the pedestrian ROW. This was especially true for cars turning left from Greenpark Drive onto Blacow Road.

*Looking south from the school at the Blacow Road/Greenpark Drive intersection.*

- Widen sidewalk using existing landscaped parkway to accommodate high pedestrian volumes
- 3 Blacow Road/Greenpark Drive**
  - Install advance stop pavement markings at the eastbound approach

- Enhance the existing crosswalk across Blacow Road to high visibility
- 4 Blacow Road/Sherwood Street**
  - Install advance stop markings at the southbound approach

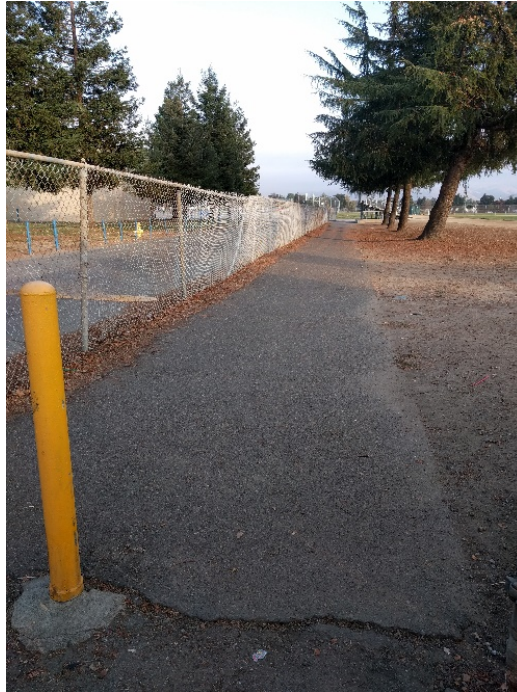
- ◆ Carol Avenue provides an alternative drop-off location to the main school entrances along Blacow Road. The Carol Avenue entrance is underutilized; walk audit participants and school staff reported that a relatively small number of students enter campus from the back.
- ◆ There are three existing speed humps along Carol, in addition to two transverse crosswalks at the Thurston Street intersection
  - The speed hump pavement markings do not currently meet CA MUTCD standards
- ◆ Currently there is a dirt pathway that links Carol Avenue to main section of campus through the athletic fields

- Walk audit participants and school staff reported that during inclement weather the path is muddy and unusable.

*The school-side of the field path. The paved path transitions to dirt further north.*

- 8 Field Pathway**
  - Upgrade existing dirt path to crushed gravel or other weather resistant surface

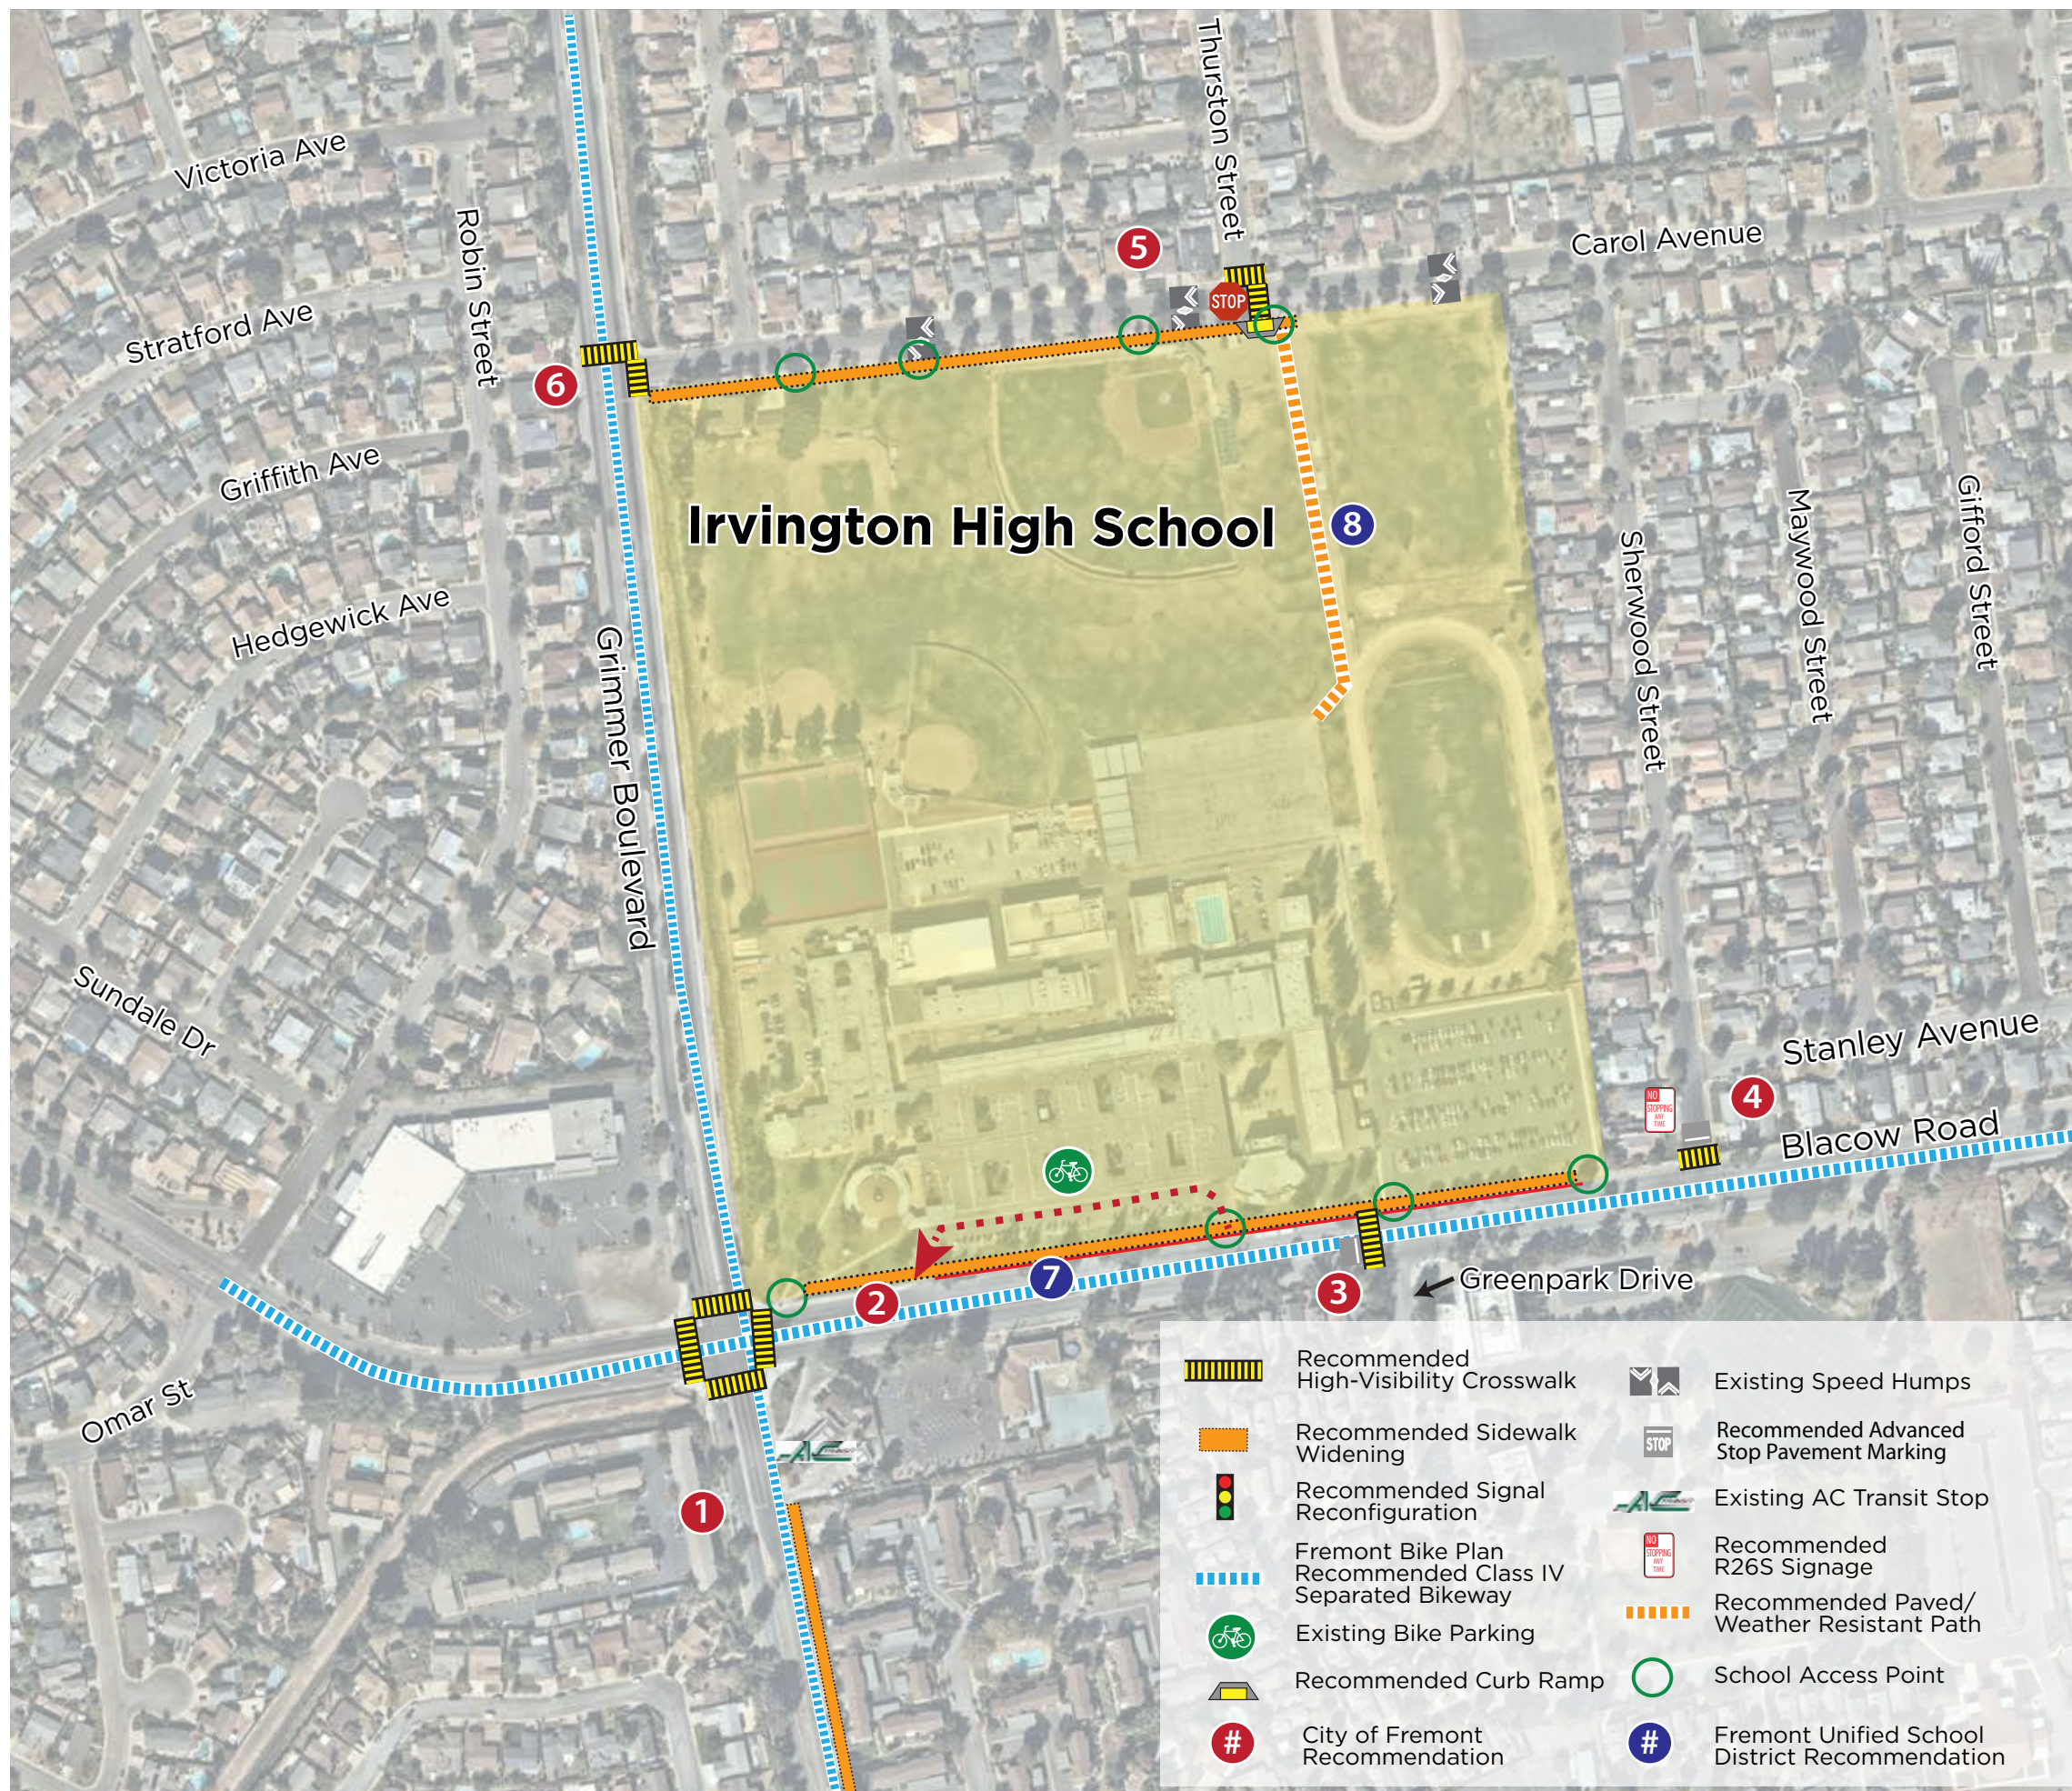
## Safe Routes to Schools Improvement Plan

- Enhance existing transverse crossing to high visibility crossing
  - Trim vegetation around both student parking lot driveways
  - Consider restricting parking near intersection approach to allow for a formal second lane or a defacto turn lane
