Mission Valley Elementary School Existing Conditions Summary

January 2019

Prepared by Alta Planning + Design

A School Safety Assessment (SSA) was conducted at Mission Valley Elementary School during the morning arrival on Tuesday, April 10, 2018. The assessment was attended by representatives from the City of Fremont, Fremont Police Department, Alta Planning + Design, and Mission Valley Elementary staff.

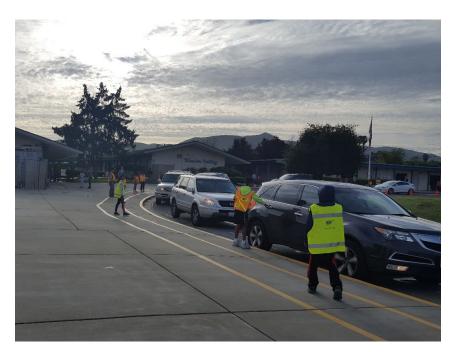
- The school sets up a system of cones around the drop-off loop and exit that
 encourages families driving to take a right into the drop-off loop and exit the loop to
 the right.
- If efficiently utilized, 10-12 cars can use the drop-off loop at a time.
- Student volunteers were at the drop-off loop during morning drop off. SSA
 participants observed that when student valet volunteers were present and opening
 doors, the drop-off loop worked efficiently. Student volunteers were mostly stationed
 at the front of the drop-off loop and drivers pulled up only as far as the student
 volunteers were posted.
- In summer 2018, new curb ramps were installed in the drop-off loop to improve accessibility.

Student volunteers open vehicle doors in the drop-off loop.

- Work with student drop-off volunteers to teach them to stand closer to the end of the drop-off loop to encourage vehicles to use the full length of the passenger drop-off zone.

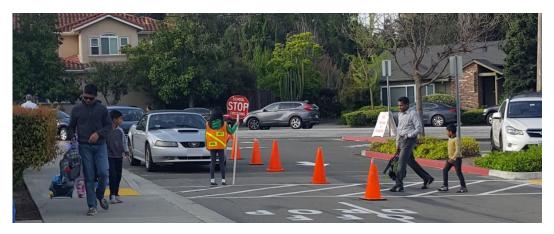
- There is one crosswalk in the drop-off loop near the loop's entrance. Student safety patrol volunteers used their "stop signs" to remind vehicles to yield to crossing families and students.
 - Students are not allowed to cross elsewhere in the parking lot except to access the handicap spaces.

A student safety patrol reminds vehicles to yield to families walking in the drop-off loop crosswalk.

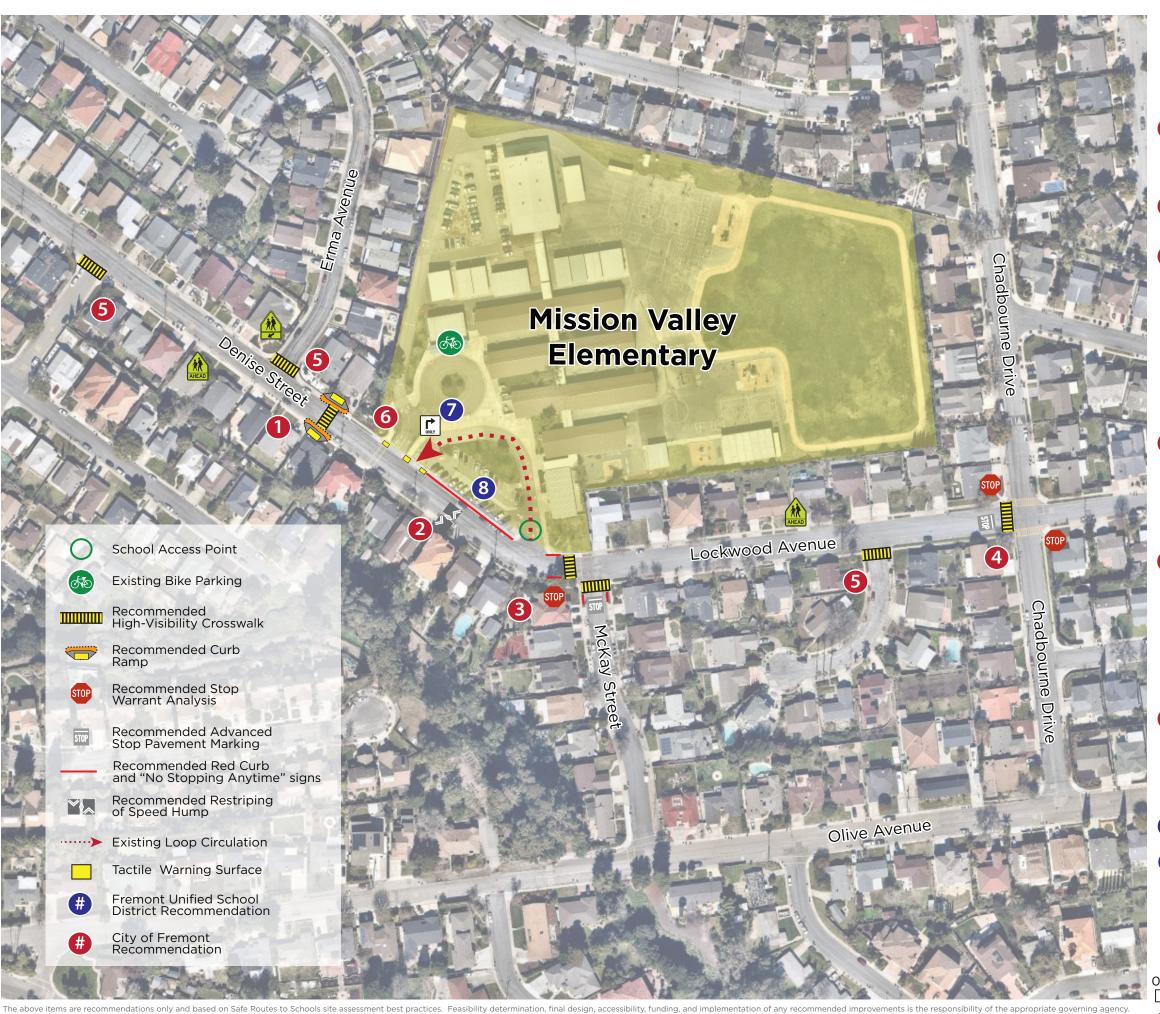
Safe Routes to Schools Improvement Plan

- **Denise Street Crosswalk**
 - Collect school peak hour traffic data at Denise Street/Erma Avenue & Denise Street/Exit Driveway.
 - Based on the aforementioned data, relocate the existing crosswalk across Denise Street.

- **Denise Street**
 - Restripe speed hump with CA MUTCD compliant striping
- Denise Street/McKay Street
 - · Upgrade two existing transverse crossings to high-visibility crossings. Designate red curb or install "No Stopping Anytime" signs on the north and west approach to improve visibility of pedestrians in the crosswalk.

- Install advanced stop pavement markings on the McKay Street approach.
 - Conduct a stop warrant analysis to look at feasibility of a three way stop at the intersection. If appropriate, install stop signs and advanced stop pavement markings on Denise Street and Lockwood Avenue approaches.

- Chadbourne Drive/Lockwood Avenue
 - Install high-visibility crosswalk and an advanced stop pavement marking on the northern leg of Lockwood Avenue.
 - Conduct a stop warrant analysis to look at feasibility of a four way stop at intersection. If appropriate, install stop signs and advanced stop pavement markings on Chadbourne Drive approaches.

- Denise Street Lockwood Avenue Install high visibility crosswalks at the southern approach at the Anderson Avenue and Carpenter Court and at the northern approach at Erma Avenue.

- At the Erma Avenue approach, install a School
 - Assembly B Sign.
 - On Denise Street, west of Emera Avenue, replace the existing school zone sign with School Assembly D

- On Lockwood Avenue, east of McKay Street, install a School Assembly D Sign.
- Denise Street Northern Driveway
 Install tactile warning surfaces at both sides of the loop-exit and bus/faculty parking lot driveway.
 Place an additional tactile warning surface in the

- middle of the driveway (in front of the sidewalk area between the two uses) creating a pedestrian refuge
- Valet Drop-off Exit Driveway
 Install right turn only signs at the valet exit driveway.

- **Denise Street**
 - Install red curb and "No Stopping Anytime" signs between the two drop-off loop driveways to maintain good sight distance, maintain orderly traffic movement along the frontage of the school, and encourage more walk and bikes trips at the main entry points to the school.
