**Appendix B:  
Tree Inventory**

Tree Inventory and Construction Guidelines  
Lot at S. Grimmer Boulevard and Fremont Boulevard  
Fremont, CA

Submitted to:  
Lennar  
c/o: Chad Kiltz  
6111 Bollinger Canyon Road, #550  
San Ramon, CA 94583

Prepared by:  
Samuel Oakley  
ISA Certified Arborist WE-9474A  
ASCA Registered Consulting Arborist #556

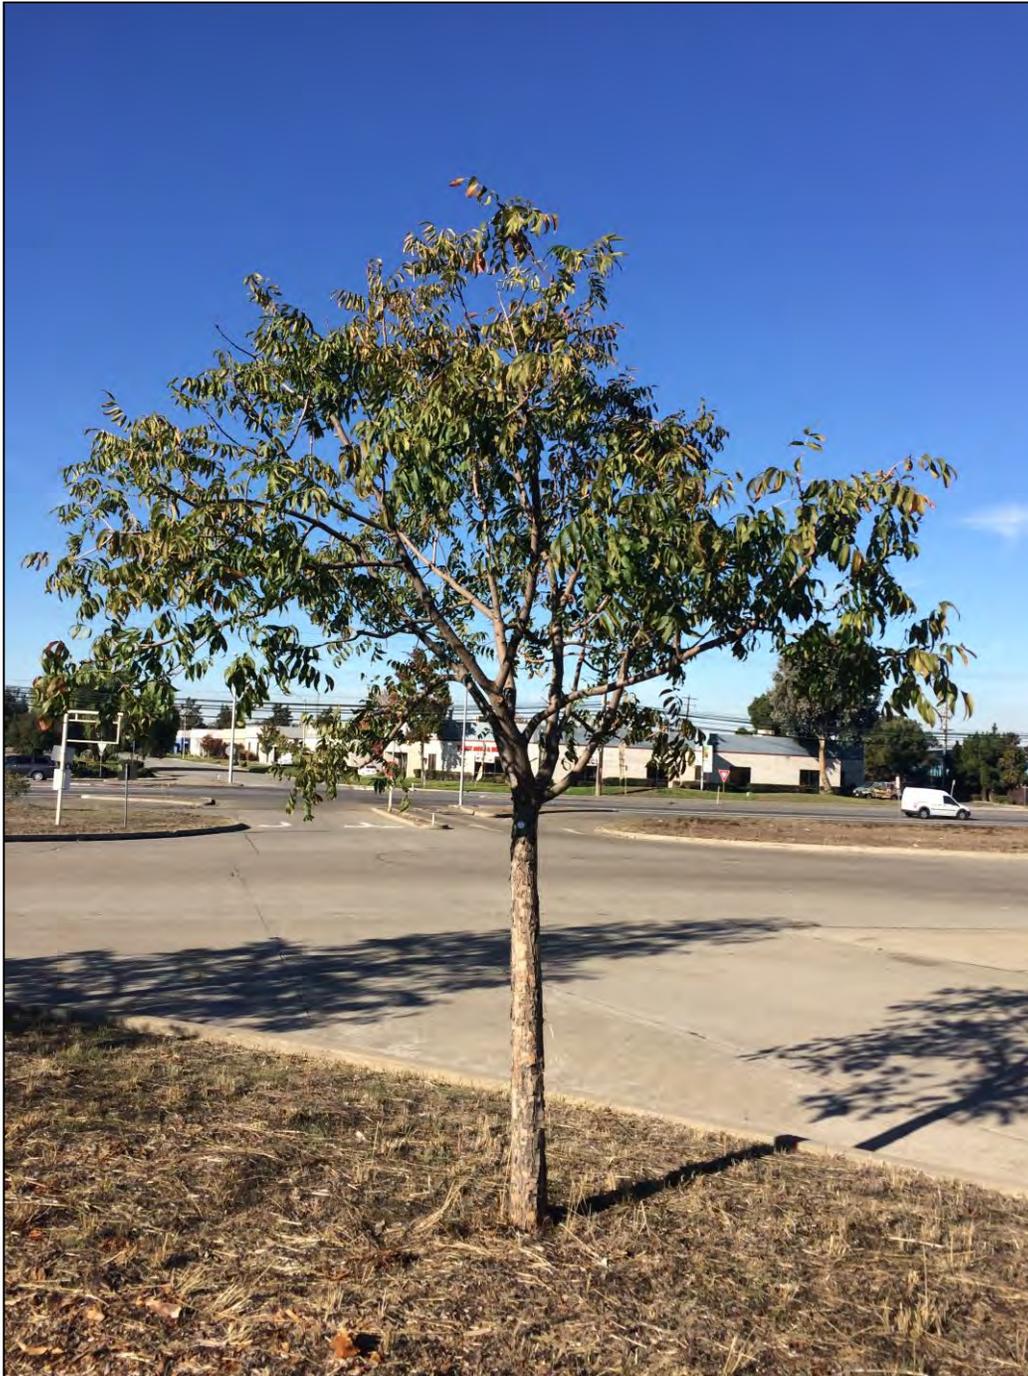
Figure 14: Tree #18

Tag	Common Name	Species	Diameter (inches)	Height (feet)	Canopy (feet)	Overall Condition	Comments
16	Coast Live Oak	<i>Quercus agrifolia</i>	27	30	40	Good	Leaning; Fungal infection; Thinning canopy; Poor pruning cuts
17	Chinese Pistache	<i>Pistachia chinensis</i>	6	10	10	Poor	Slight lean; Basal pruning cuts
18	Chinese Pistache	<i>Pistachia chinensis</i>	6	10	10	Poor	Slight lean; Basal pruning cuts
19	Coast Redwood	<i>Sequoia sempervirens</i>	9	20	10	Poor	Stunted growth; Water-stressed; Low canopy density
20	Chinese Pistache	<i>Pistachia chinensis</i>	6	10	10	Poor	Thinning canopy; Poor structure
21	Chinese Pistache	<i>Pistachia chinensis</i>	8	15	20	Poor	Major trunk wound; Poor pruning cuts; Leaning
22	Coast Redwood	<i>Sequoia sempervirens</i>	13	35	15	Poor	Stunted growth; Water-stressed; Low canopy density
23	Coast Redwood	<i>Sequoia sempervirens</i>	13	35	15	Poor	Stunted growth; Water-stressed; Low canopy density

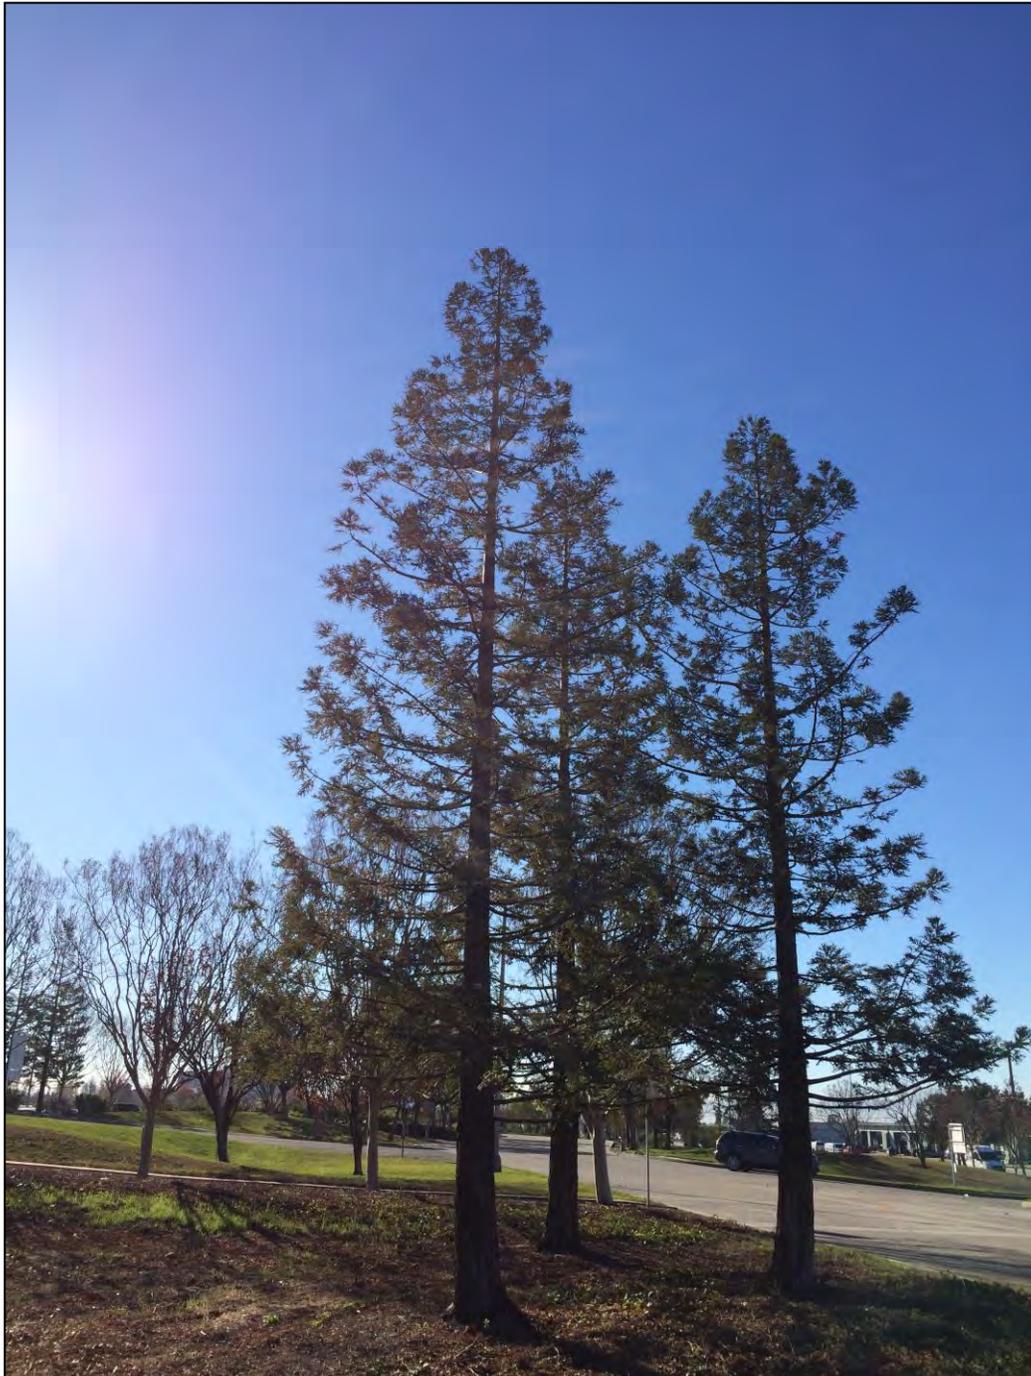
Figure 30: Trees #34, #35, and #36

Tag	Common Name	Species	Diameter (inches)	Height (feet)	Canopy (feet)	Overall Condition	Comments
35	Coast Redwood	<i>Sequoia sempervirens</i>	13	30	20	Poor	Stunted growth; Water-stressed; Low canopy density
36	Coast Redwood	<i>Sequoia sempervirens</i>	15	30	20	Poor	Stunted growth; Water-stressed; Low canopy density
37	Coast Redwood	<i>Sequoia sempervirens</i>	7	15	10	Poor	Stunted growth; Water-stressed; Low canopy density; Leaning
38	Coast Redwood	<i>Sequoia sempervirens</i>	8	20	10	Poor	Stunted growth; Water-stressed; Low canopy density
39	Coast Redwood	<i>Sequoia sempervirens</i>	16	35	20	Poor	Stunted growth; Water-stressed; Low canopy density
40	Coast Redwood	<i>Sequoia sempervirens</i>	11	25	15	Poor	Stunted growth; Water-stressed; Low canopy density
41	Coast Redwood	<i>Sequoia sempervirens</i>	10	15	10	Poor	Stunted growth; Water-stressed; Low canopy density; Leaning
42	Coast Redwood	<i>Sequoia sempervirens</i>	11	25	15	Poor	Stunted growth; Water-stressed; Low canopy density; Leaning
