RODRIGUES FARMHOUSE PROPERTY  
41948 MISSION BOULEVARD  
PROPOSED PROJECT IMPACT ANALYSIS  
FREMONT, CA  
[17267]  
PREPARED FOR:  
CITY OF FREMONT

MARCH 23, 2018

## I. INTRODUCTION

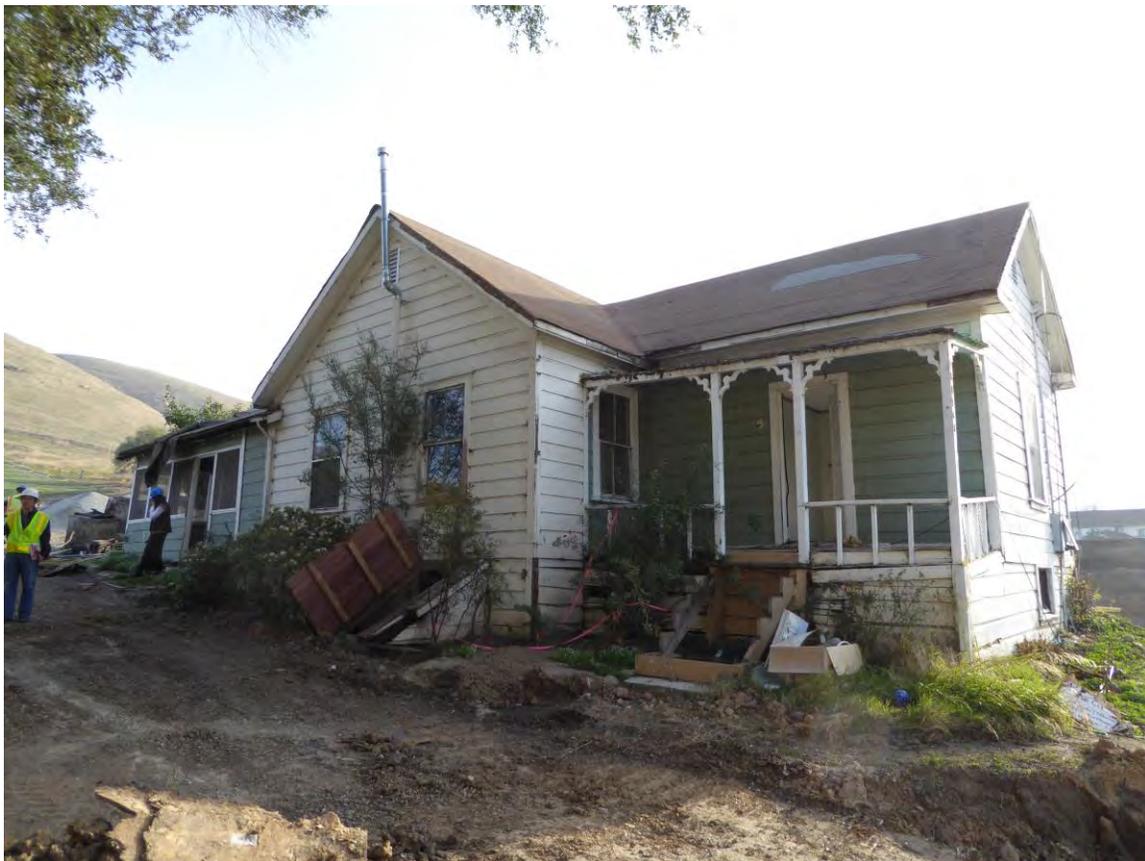
Figure 1. Rodrigues Farmhouse property, 41948 Mission Boulevard, showing north and west facades.

The Rodrigues Farmhouse at 41948 Mission Boulevard sits on a 5.06-acre parcel that is located on the northeast side of Mission Boulevard, between Mission Cielo Avenue to the north and Fazenda Street to the south (**Figure 1**). The one-story residence features a rectilinear plan and was originally constructed in 1896. The historic property also includes a tankhouse and a pumphouse-over-well that are clustered in a “house yard.” A shed-and-storage building at the rear of the yard has been demolished.

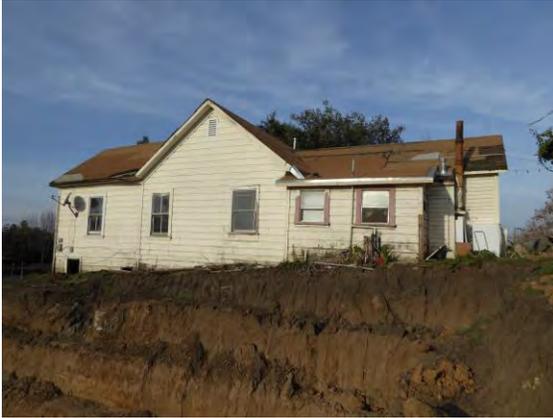
Figure 2. South façade.

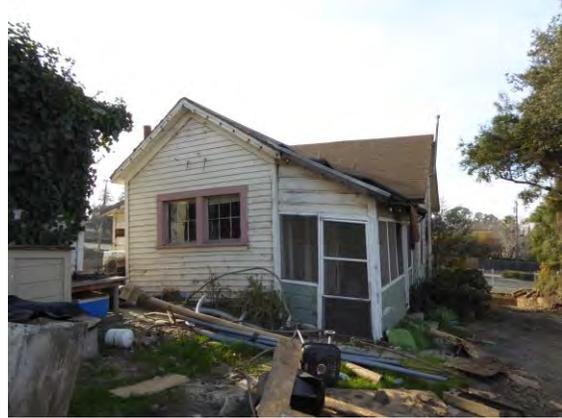
Figure 3. Rear (east) façade, showing enclosed back porch.

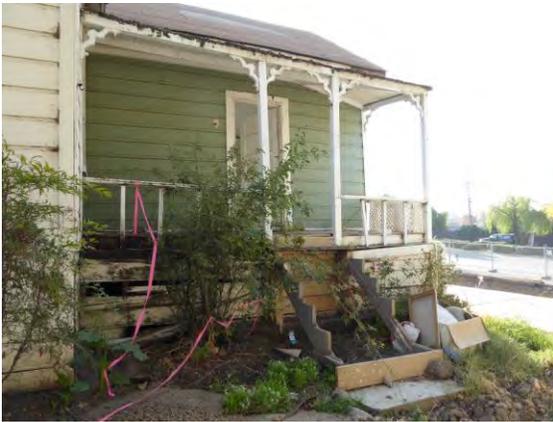
Figure 4. Front porch on the north façade.

The front and rear porches are in poor condition. The front porch will be rebuilt to match the existing. The door will be replaced with a new 3-foot wide door. The scrollwork (jigsaw) brackets will be removed, reconditioned, and reused based on conditions. The railing and posts will be removed, dimensioned, and replicated. New stair treads and stringers will be installed. The rear porch will be demolished due to the new rear addition.

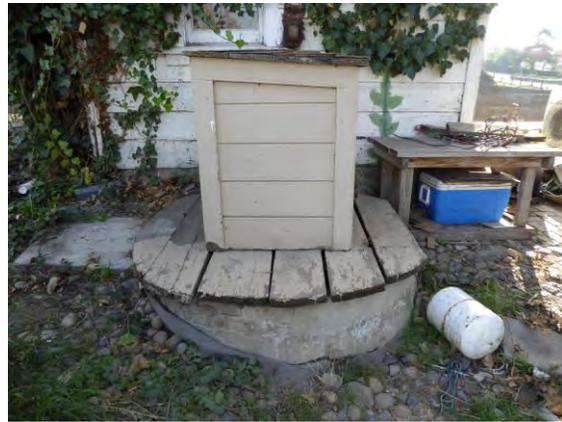
Figure 5. Pumphouse-over-well at the rear of the farmhouse.

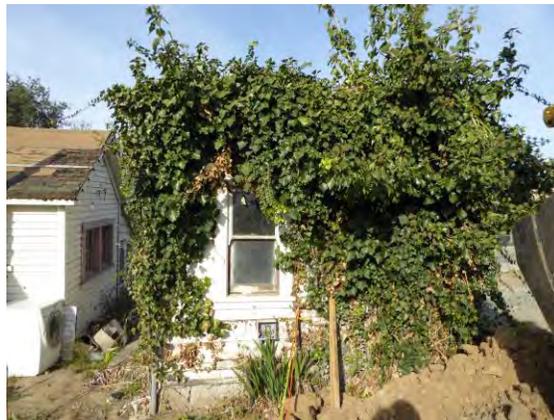
Figure 6. South façade of tankhouse, which is covered with ivy.

The tankhouse will be rehabilitated as an office studio and relocated approximately 20 feet to the south. It will remain to the rear of the farmhouse and maintain its current orientation. Materials will be retained and restored as much as possible, or replaced in kind if the level of deterioration requires it.

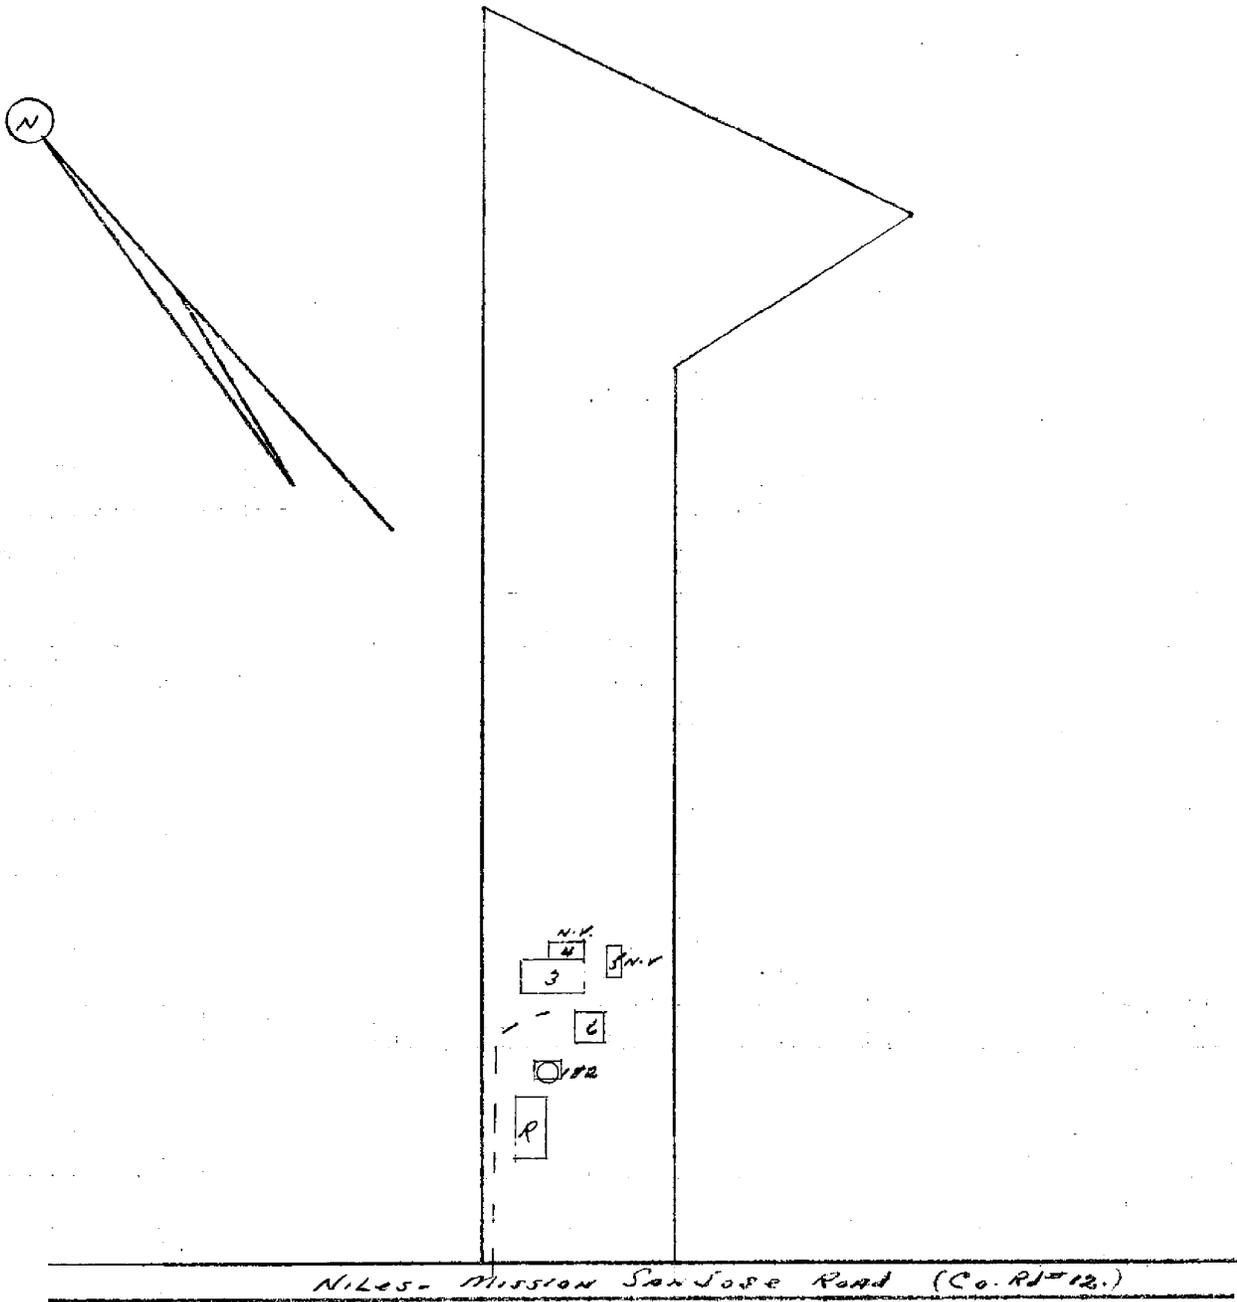
Plan of parcel with buildings and structures (key on p. 2).

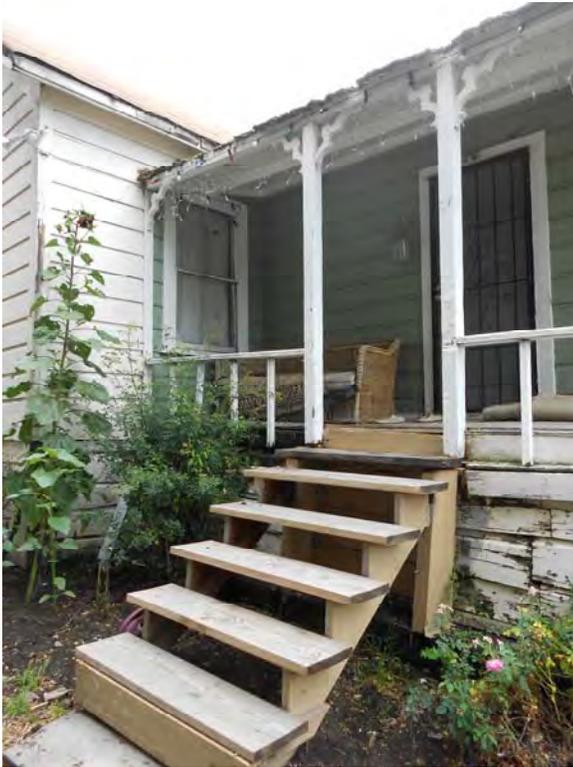
5) Farmhouse main porch detail, view east, 15 May 2015, #11.43.18.

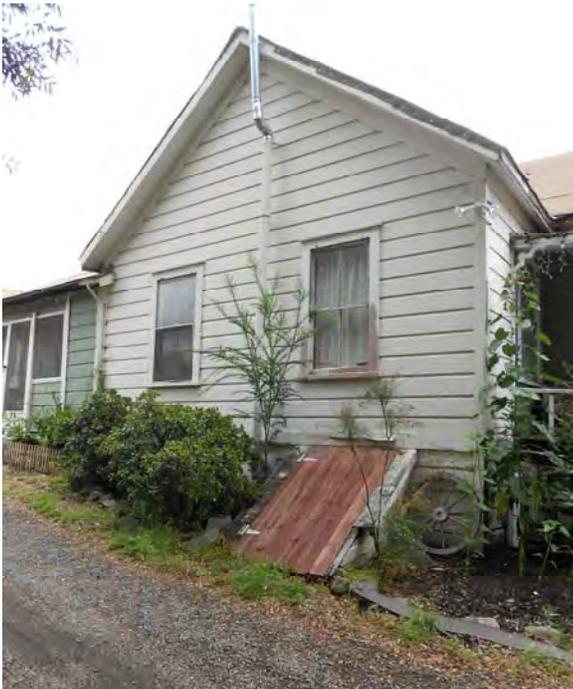
6) Farmhouse central wing detail, view east, 15 May 2015, #11.43.29.

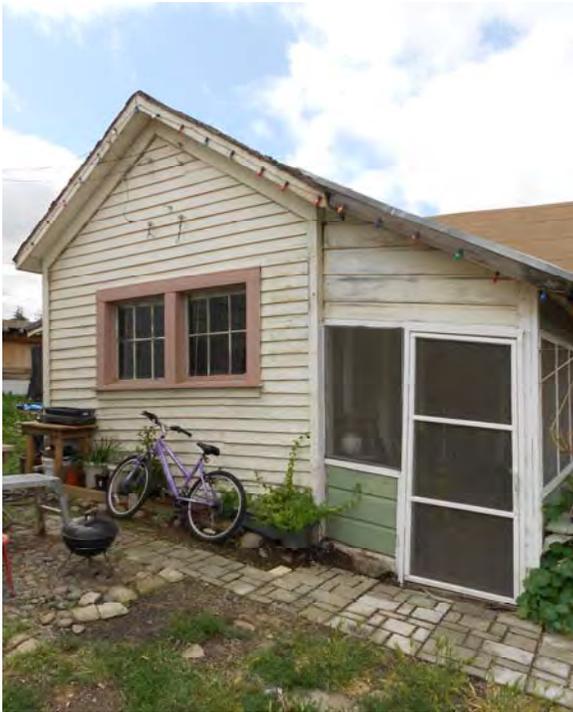
7) Farmhouse rear wing and porch detail, view south, 15 May 2015, #11.44.07.

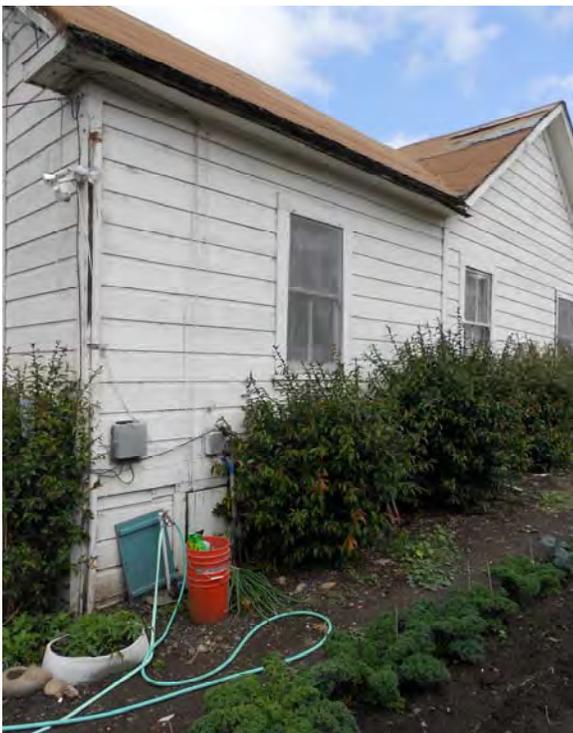
8) Farmhouse detail showing siding, windows, and eaves; view north, 15 May 2015, #12.03.29.

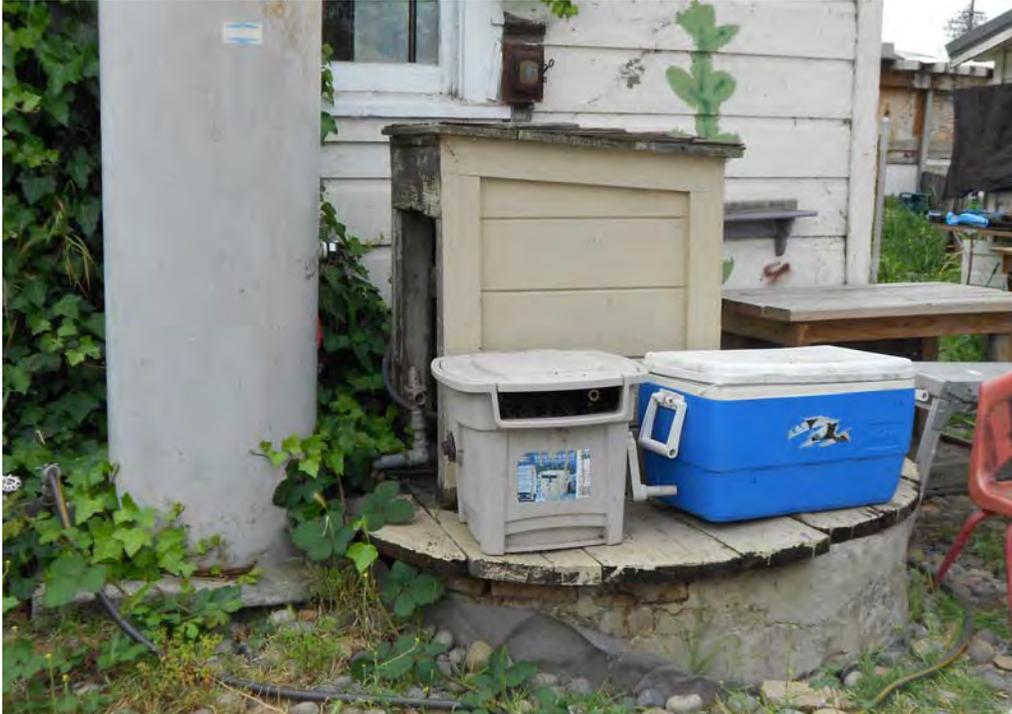
11) Pumphouse-over-well with tankhouse behind, view southeast, 15 May 2015, #12.23.29.

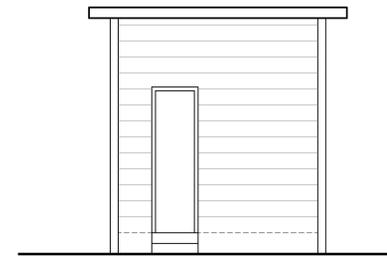
① EXISTING REAR ELEVATION  
WATER TANK

NO CHANGES ARE PROPOSED TO THE ELEVATIONS. PRESERVE EXISTING MATERIALS. REPLACE ONLY DRY ROTTED WOOD WITH LIKE MATERIAL AND FINISH.

WOOD SASH WINDOWS AND WOOD DOORS TO BE RESTORED.

The tankhouse is a one-story wood structure (4x6 posts) on a concrete foundation, clad in channel rustic siding (9 inches exposed). Its flat roof originally supported a 2,000 gallon redwood water tank. The structure occupies a square footprint, ten feet on a side.

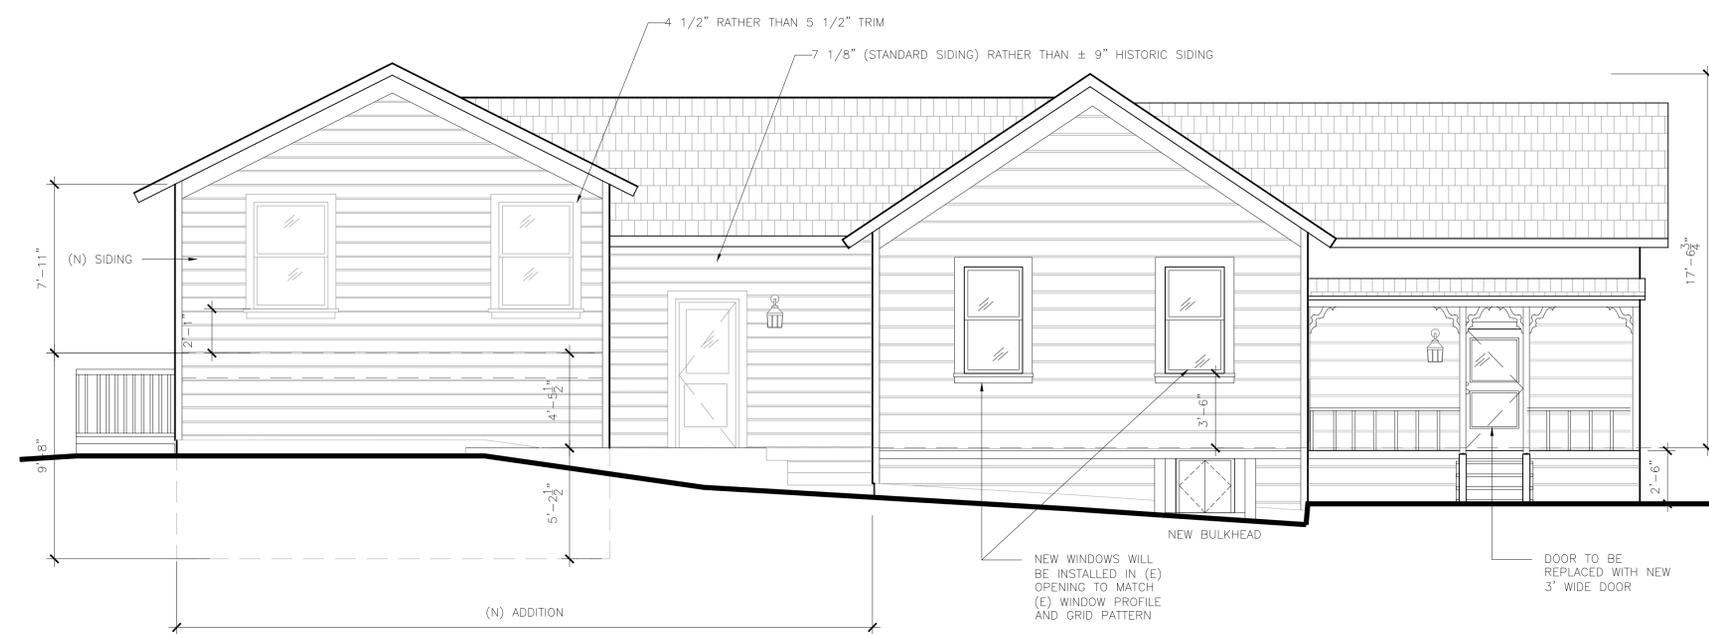
② PROPOSED NORTH ELEVATION SCALE : 1/4"=1'-0"

NOTE:  
NEW WINDOWS WILL BE INSTALLED IN (E)  
OPENING TO MATCH (E) WINDOW PROFILE  
AND GRID PATTERN

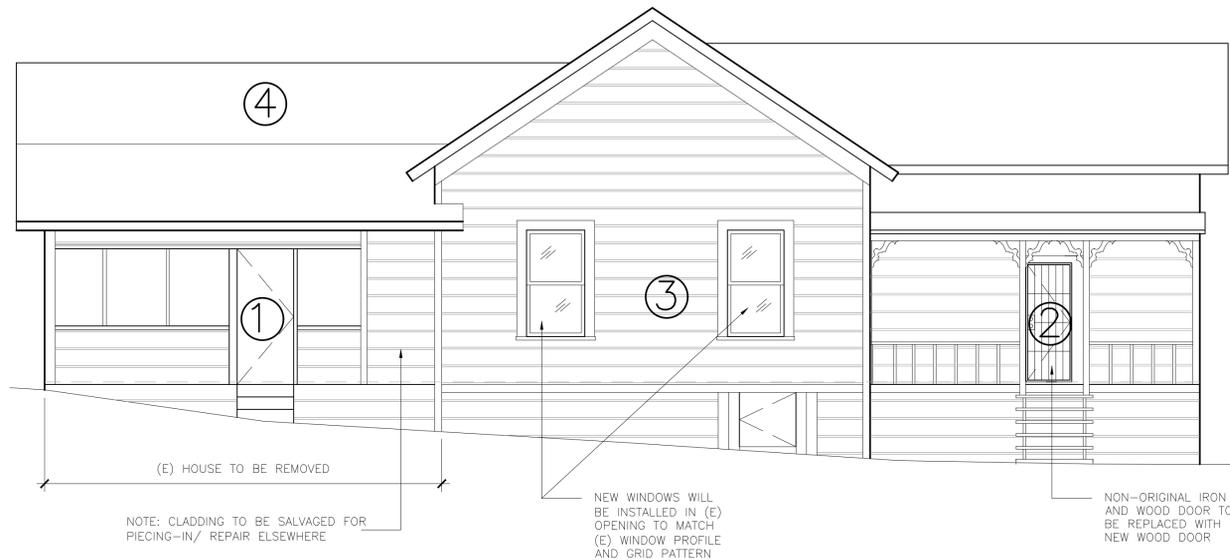
① EXISTING NORTH ELEVATION — MAIN HOUSE

1. ADDITION TO BE REMOVED

3. DETERIORATING SIDING TO BE REPLACED AS NEEDED. PRESERVE EXISTING MATERIALS. REPLACE ONLY DRY ROTTED WOOD WITH LIKE MATERIAL AND FINISH

2. FRONT PORCH AND STEPS TO BE REPAIRED AND REPLACED AS NEEDED. STEPS ARE NON-HISTORIC NEW FRONT 3' WIDE DOOR IN (E) LOCATION

4. NON-HISTORIC ROOFING TO BE REPLACED

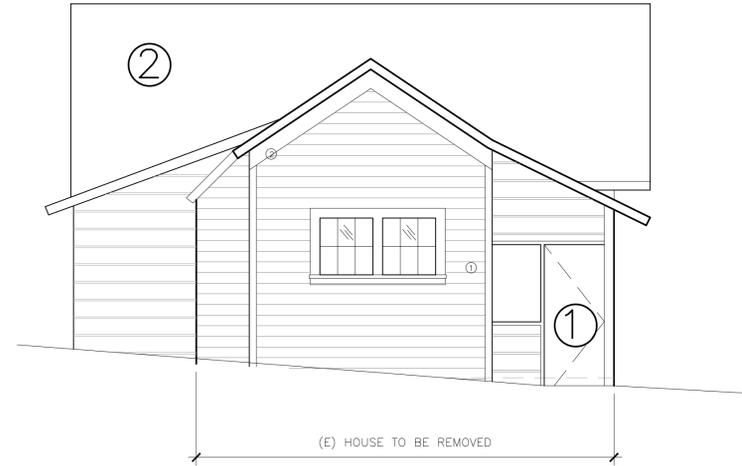
① EXISTING EAST ELEVATION – MAIN HOUSE

1. ADDITION TO BE REMOVED

2. NON-HISTORIC ROOFING TO BE REPLACED

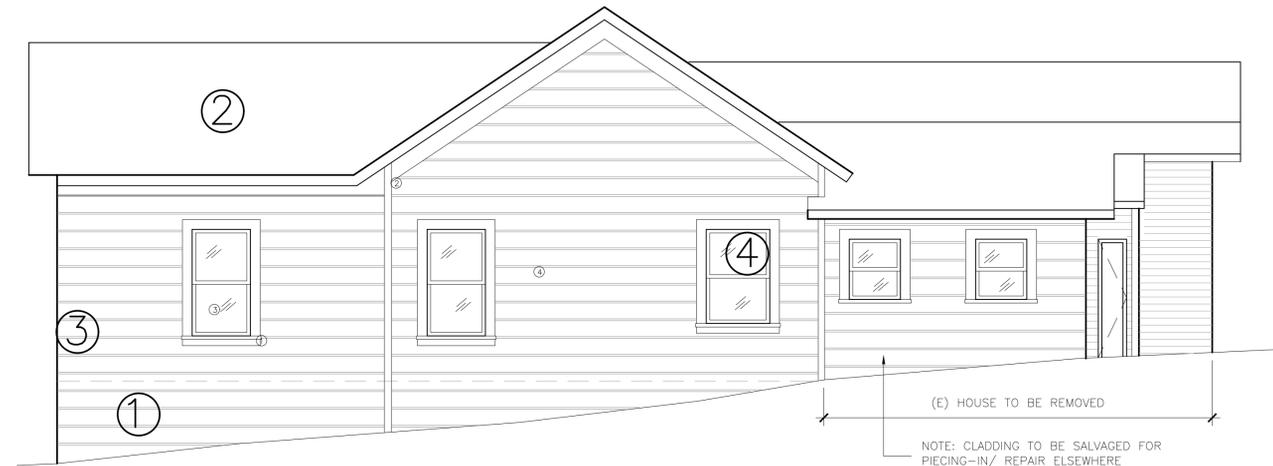
① EXISTING SOUTH ELEVATION – MAIN HOUSE

1. DETERIORATING SIDING TO BE REPAIRED AND REPLACED ONLY WHERE DRY ROT IS PRESENT

2. NON-HISTORIC ROOFING TO BE REPLACED

3. NON-HISTORIC ELECTRICAL EQUIPMENT TO BE REMOVED

4. NON ORIGINAL WINDOW TO BE REMOVED

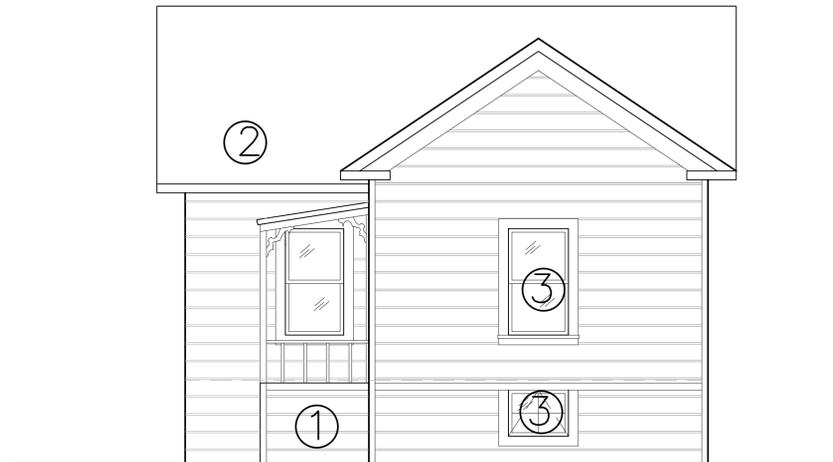
① EXISTING WEST ELEVATION – MAIN HOUSE

1. DETERIORATING SIDING TO BE REPAIRED AND REPLACED AS NEEDED

2. NON-HISTORIC ROOFING TO BE REPLACED

3. NEW WINDOWS WILL BE INSTALLED IN (E) OPENING TO MATCH (E) WINDOW PROFILE AND GRID PATTERN

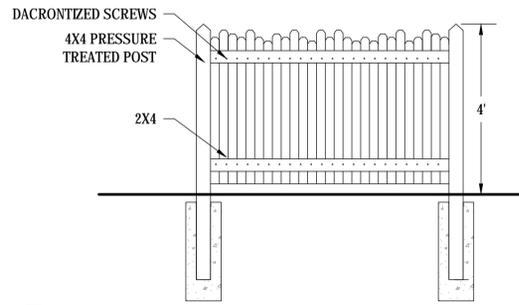
1 GRAPE STAKE SOLID FENCE  
SCALE: 1/2"=1'-0"

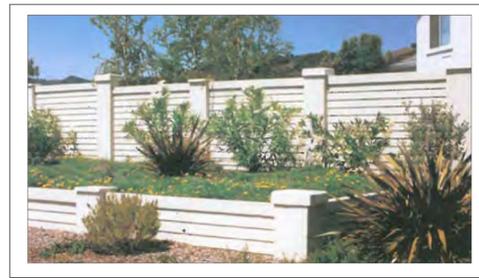
SIERRA CLASSIC SHIPLAP SOUNDWALL WITHOUT COLUMN CAPTOLS  
MODEL: CL-SHP

2 6' PRECAST WALL OLDCASTLE  
SCALE: NTS

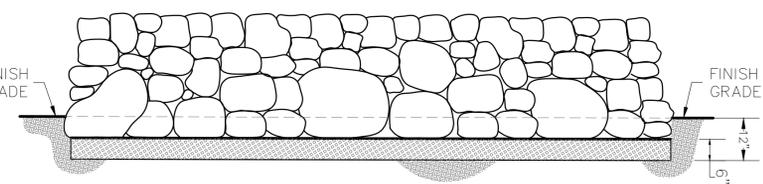
6 STONE WALL (FOR REQUIRED TERRACING OF BIOTREATMENT AREA) MORTARED  
SCALE: 1"=1'-0"

- WALL ROCK TO BE AN AVERAGE SIZE OF 12" UP TO WHEEL BARROW SIZE OR LARGER AT BASE. PREDOMINANCE OF ROCK AT BASE TO BE A MINIMUM OF 12" IN SIZE.
- BASE ROCKS TO BEAR ON COMPACTED CLASS 2 PERMEABLE MATERIAL.
- ROCK TO BEAR ON MINIMUM OF TWO ADJACENT ROCKS.
- ROCKS TO BEAR ON AT LEAST THREE CONTACT POINTS (TWO FRONT AND ONE REAR).
- CAP ROCK MIN. 12" IN ONE DIMENSION.
- CONSTRUCT DURING DRY SEASON.
- CONTRACTOR RESPONSIBLE FOR TEMPORARY EXCAVATION STABILITY.
- NO ROCKS SHALL COME LOOSE IN KICK TEST.
- MAXIMUM 36" WALL (30" WITHOUT MORTAR) WITH A MAXIMUM BACKSLOPE INCLINE OF 3:1. HIGHER WALLS OR STEEPER BACKSLOPE WILL REQUIRE LARGER STONES OR GEOSYNTHETICALLY REINFORCED BACKFILL TO BE DESIGNED BY GEOTECHNICAL ENGINEER.
- RELEASE POINT IN WALL TO BE PROVIDED AT 3" ABOVE LOW POINT.

THIS IS NOT AN ENGINEERED PLAN. THE UNIQUENESS OF MATERIALS AND NATURE OF A STRUCTURE OF THIS TYPE RENDER IT UNQUANTIFIABLE. THE INSTALLER MUST INTERPRET THE DETAILS AND SPECIFICATION AS MINIMUM REQUIREMENTS IN THE CONSTRUCTION OF EACH WALL FOR THE SITE SPECIFIC SITUATION.
