EVANS & DE SHAZO
ARCHAEOLOGY HISTORIC PRESERVATION

**HISTORIC RESOURCE EVALUATION
OF THE 1882 GALLEGOS HOUSE AND
SECRETARY OF THE INTERIOR
STANDARDS REVIEW FOR THE
PROPOSED PROJECT LOCATED AT
830 WITHERLY LANE, FREMONT,
ALAMEDA COUNTY, CALIFORNIA**

October 9, 2018

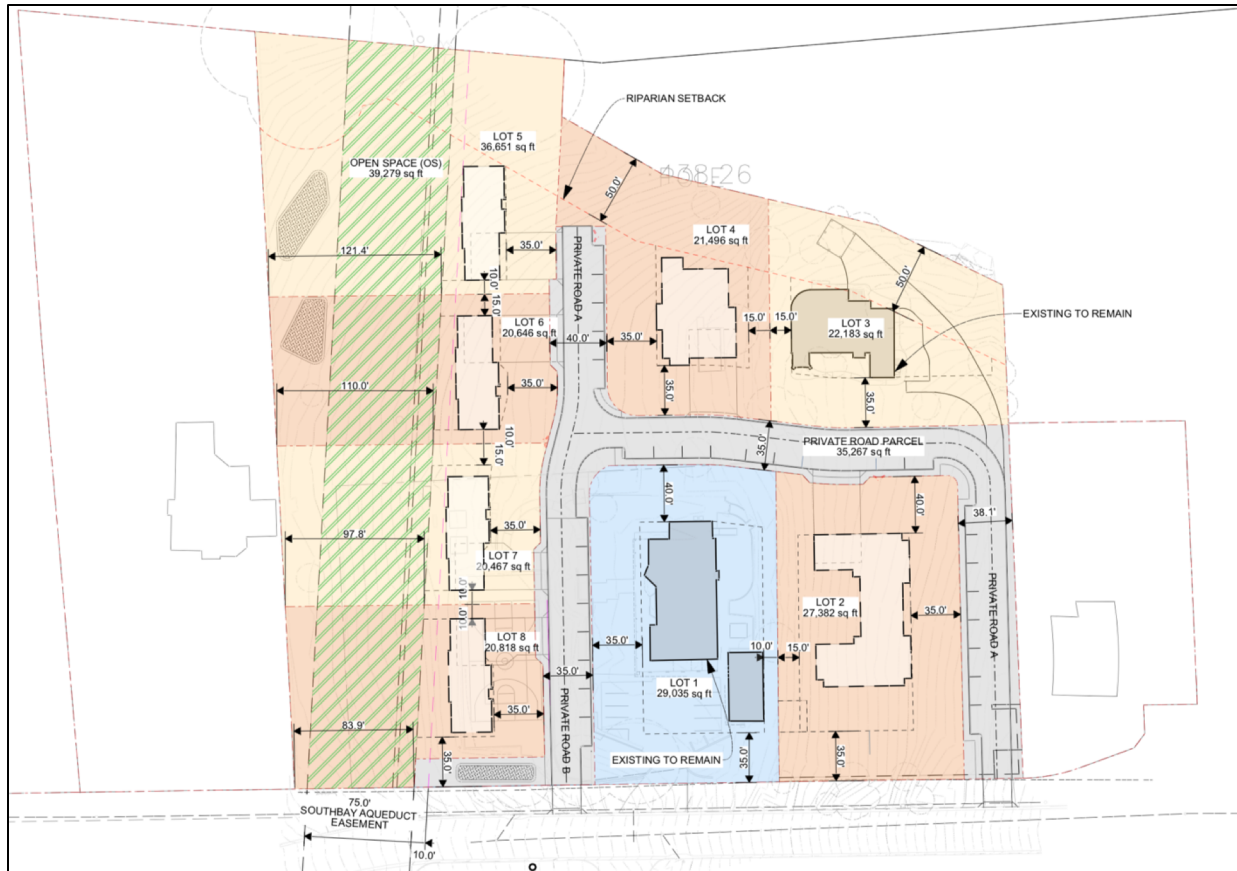
Figure 2: Site plan showing all the proposed development and subdivision of the adjacent three parcels to create eight separate parcels for potential construction of six new single-family houses, and a private road parcel.

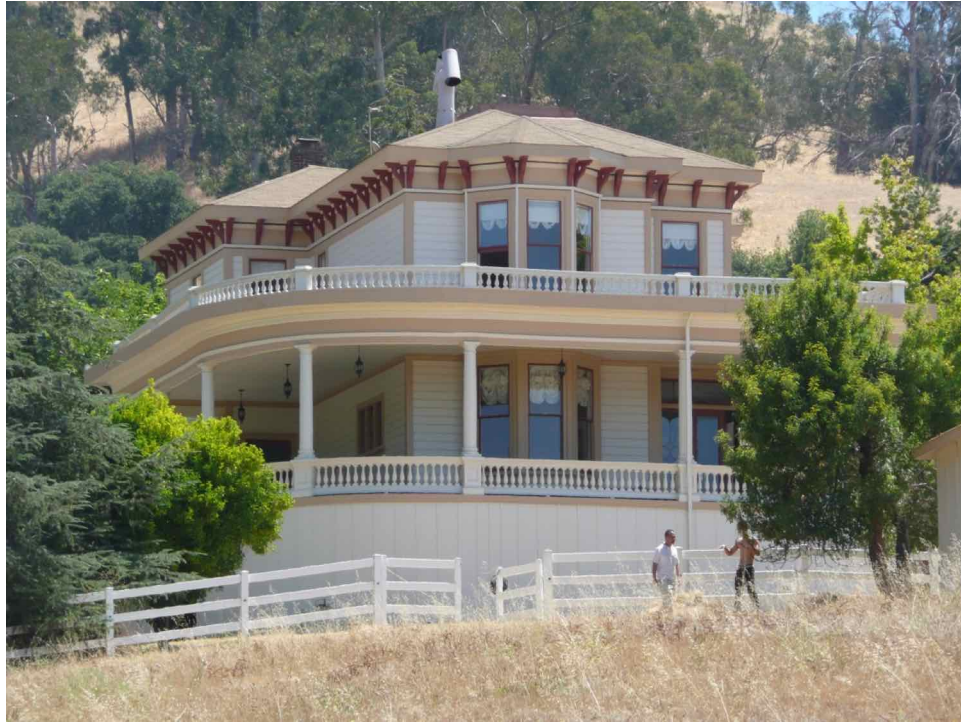
Figure 7: 1882 Gallegos House, showing the north and west elevations from the western portion of the parcel, facing east.

The **west elevation** is dominated by the building’s curved, wraparound veranda and second-story balcony (Figure 7). The veranda has elements of the Colonial Revival style, and consists of a low, turned balustrade, with piers located at regular intervals serving as bases for unfluted Tuscan columns that support the second story balcony (Figure 8). The floor of the veranda consists of wood boards, while the ceiling of the veranda consists of narrower, wood beadboard (Figure 9). The second story balcony consists of a similar turned balustrade, although there are notable differences in the size and exact design of the balusters between the veranda and the second story balcony.

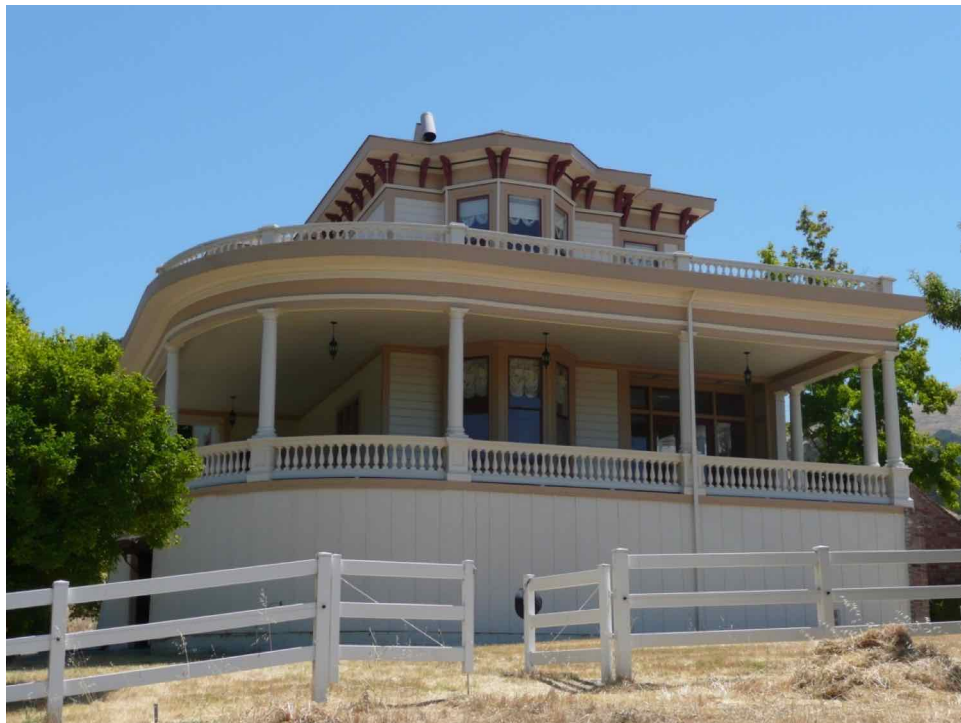
Figure 8: West elevation, showing veranda, facing east.

The first story of the west elevation contains the main entry to the house, which is located in a recess and consists of double wood doors with nearly full-length glazing flanked on either side by sidelights with wood bulkheads, as well as three transom windows. The sidelights exhibit lead comes shaped to produce ovular and round patterns, while the comes in the transom windows display intersecting parabolic designs. The side walls and ceiling of the main entry recess consist of a rectangular wood panel design. To the north of the main entry is a canted bay window that consists of three double-hung wood windows with wood surrounds and a paneled wood bulkhead.

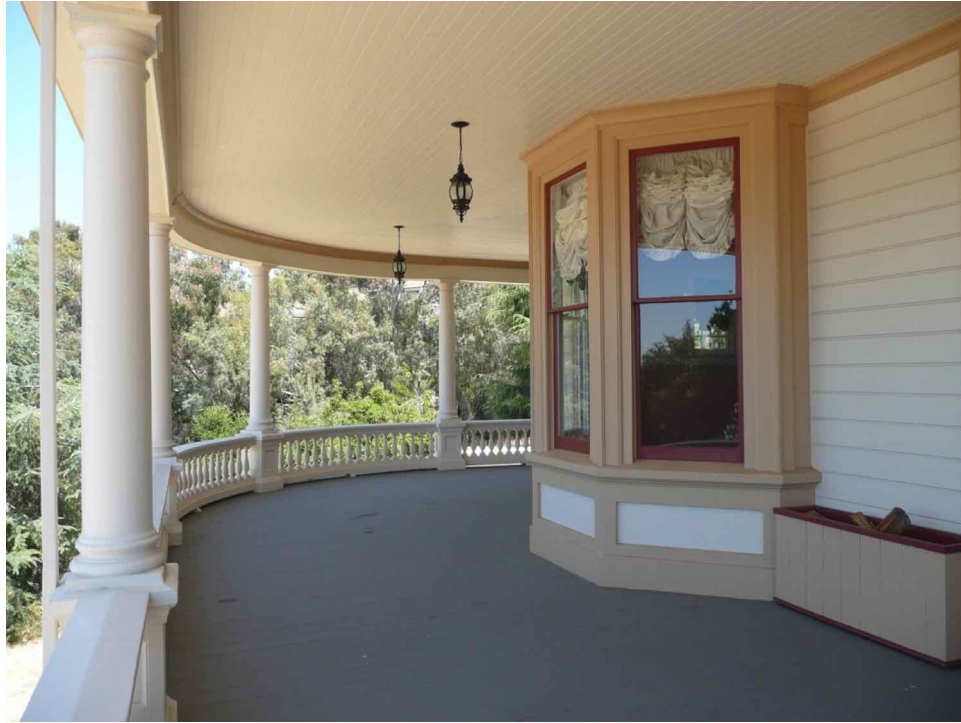
Figure 9: Bay window at west elevation from wraparound veranda, view northeast.

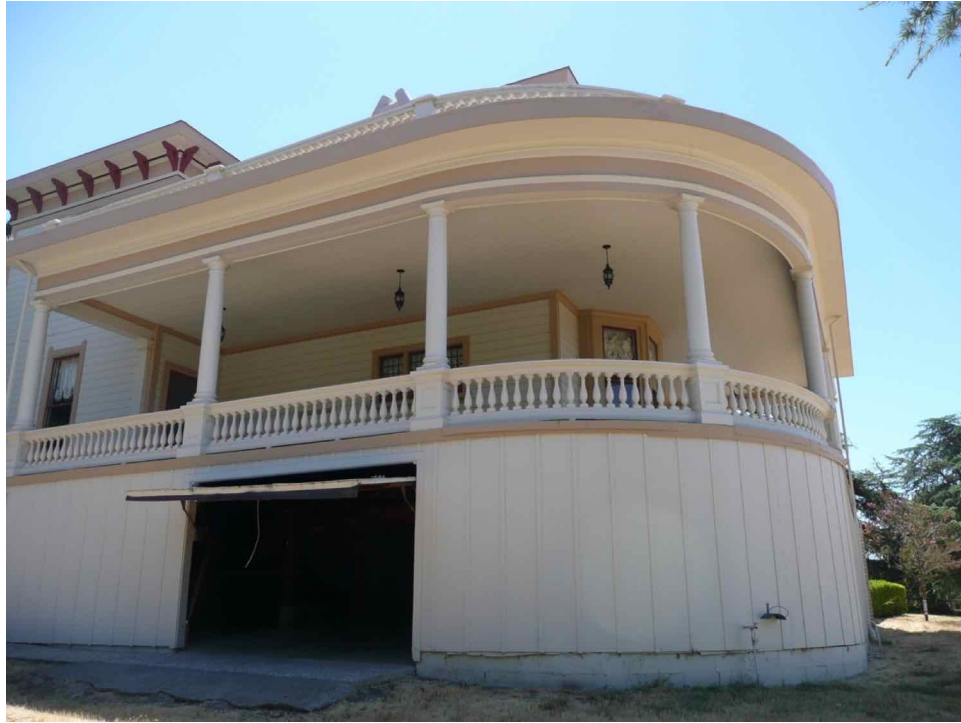
Figure 10: Wraparound veranda at north elevation, showing overhead garage door, facing southeast.

Similar to the west elevation, the **north elevation** is marked by the projecting wraparound veranda and second-story balcony. At this elevation, a contemporary overhead garage door provides access to the garage and basement area below the first story of the house (Figure 10). There is a set of contemporary stairs along this elevation, directly to the east of the wraparound porch, that provides access from the rear portion of the paved driveway near the 1978 Detached Carport Structure to the porch (Figure 11). The outer string of the stairs is clad in the same plywood as the veranda skirt and there is a contemporary wrought iron handrail.

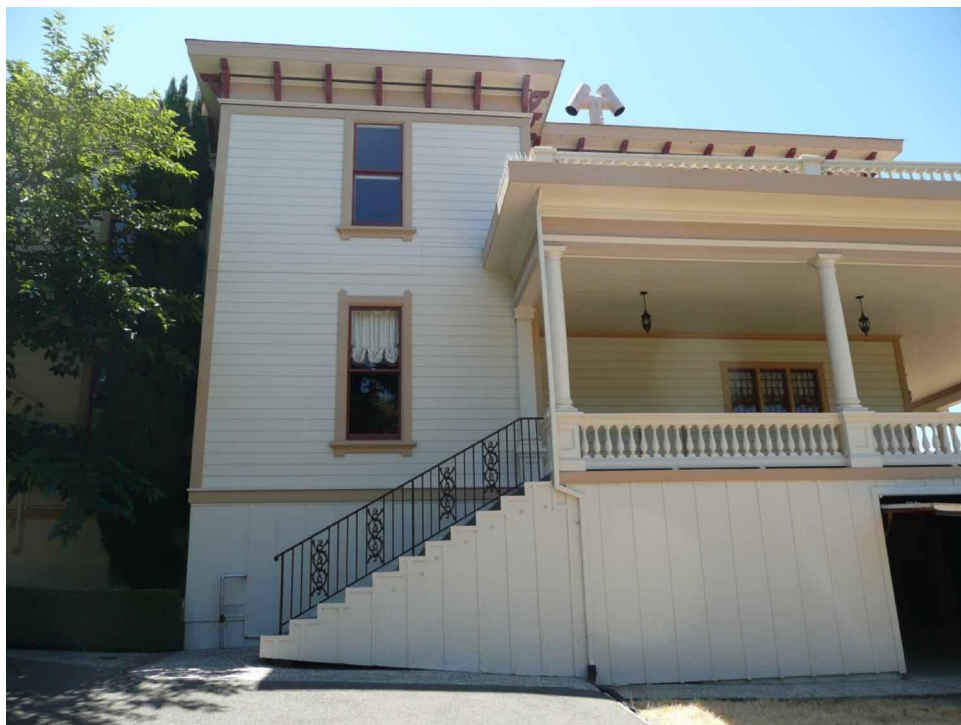
Figure 11: North elevation, showing wraparound veranda at right and projecting bay at center-left, facing south.

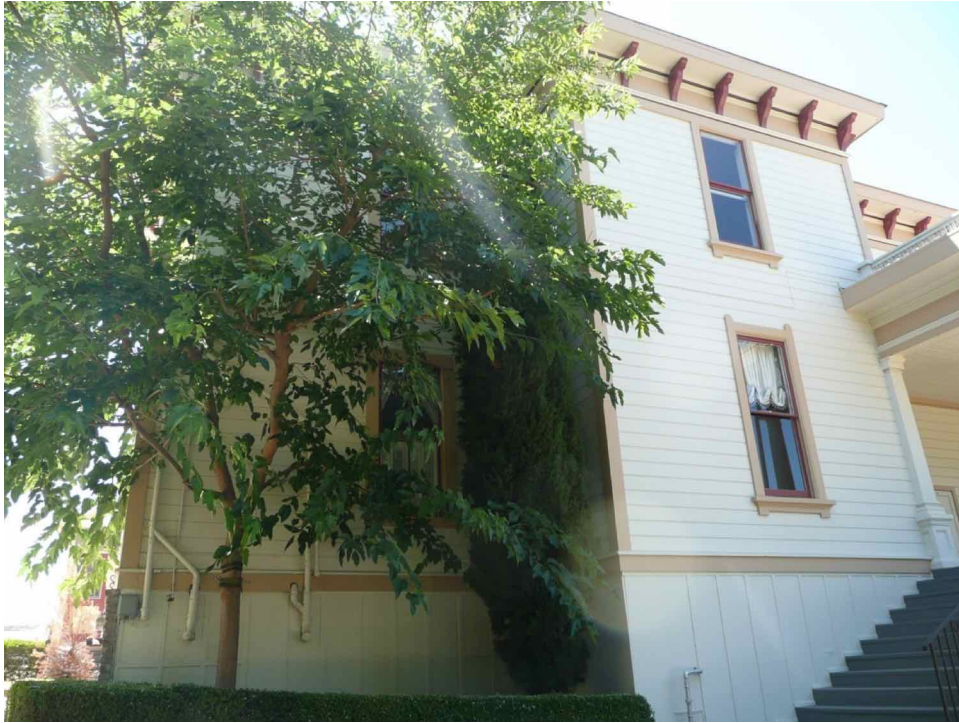
Figure 12: North elevation, showing projecting bay at right and veranda at far right, view south.

Behind the veranda at the first story is a triplet 20-light wood windows situated in a wood frame that appear to have once been casement sashes (visible in Figure 12), but now appear to be inoperable. Directly to the east of this window triplet is a small, hinged wood door that opens downward to expose a wood wall with electrical outlet. It is likely that this door once provided access to a cavity or other storage area located at the interior, but details regarding its use could not be verified.

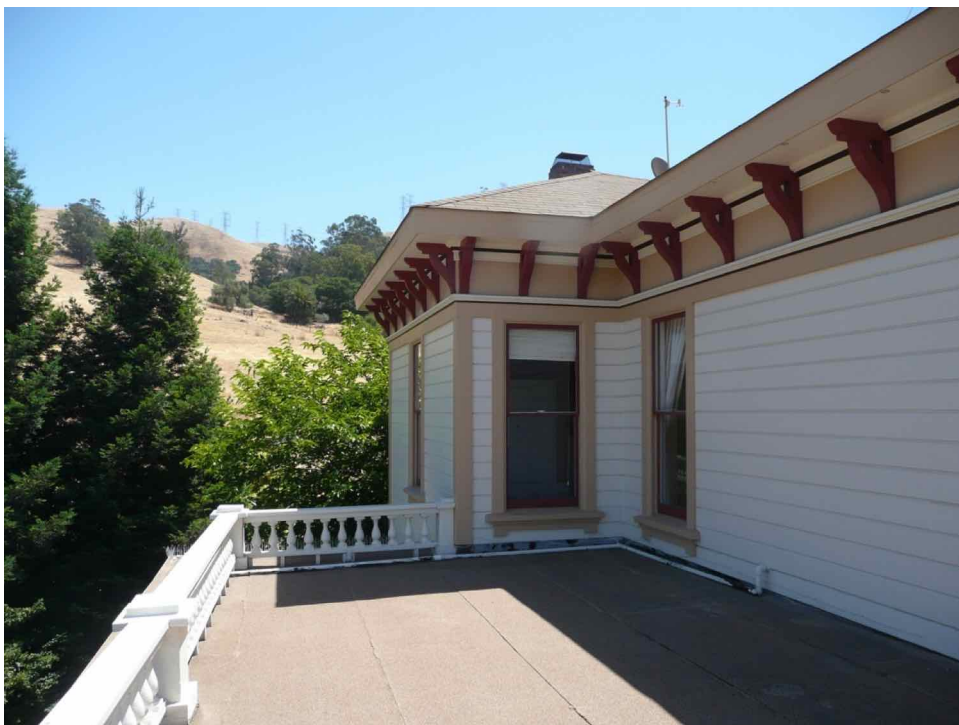
Figure 13: North elevation, showing second story fenestration from second-story porch, facing east.

To the east of the veranda is a two-story rectangular bay that projects from the remaining north elevation of the building (Figure 13). This bay consists of the same board-and-batten plywood water table as that which occurs at the veranda skirt, with horizontal wood cladding at the first and second stories that is typical of other elevations. Within this bay is a double-hung wood window at the first story aligned with a double-hung wood window at the second story—both with wood surrounds that show some decorative woodwork. To the east of this bay, near the northeast corner of the building, is another “stack” of double-hung wood windows in wood frames with wood surrounds, along with an oculus window with similar wood surround.

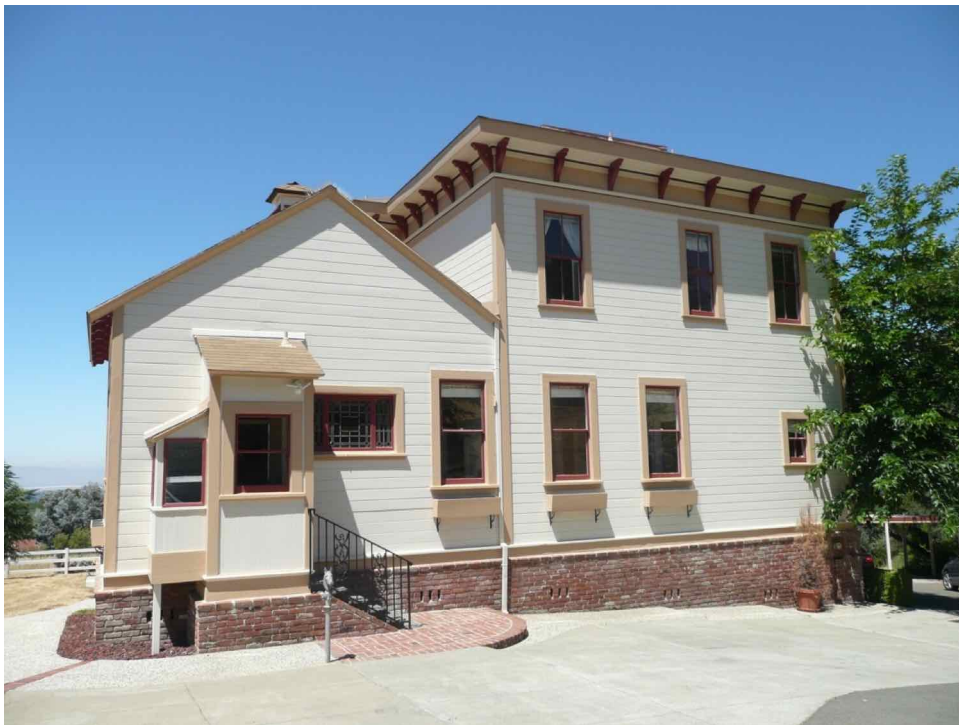
Figure 14: East elevation, showing gabled addition at left and main two-story massing at right, facing west.

The rear, **east elevation** consists of the main two-story massing of the house as well as the one-story gabled addition (Figure 14). The brick veneer water table is present along this elevation, and is marked by groupings of three openings in the brick that appear to provide ventilation to the basement. The fenestration at the main two-story massing is asymmetrical, and consists of some windows that appear to differ in width and sash design among each other, though all appear to be double-hung wood windows set in wood frames with wood surrounds. At the first story, fenestration consists of two, one-over-one double-hung windows, with a smaller two-over-two double-hung window near the northern corner of this elevation. At the second story, fenestration consists of three two-over-two double-hung windows, with the southernmost of the three windows exhibiting a slightly wider frame. Directly below the two larger windows at the first story are contemporary planter boxes attached to the exterior via a set of contemporary wrought iron brackets.

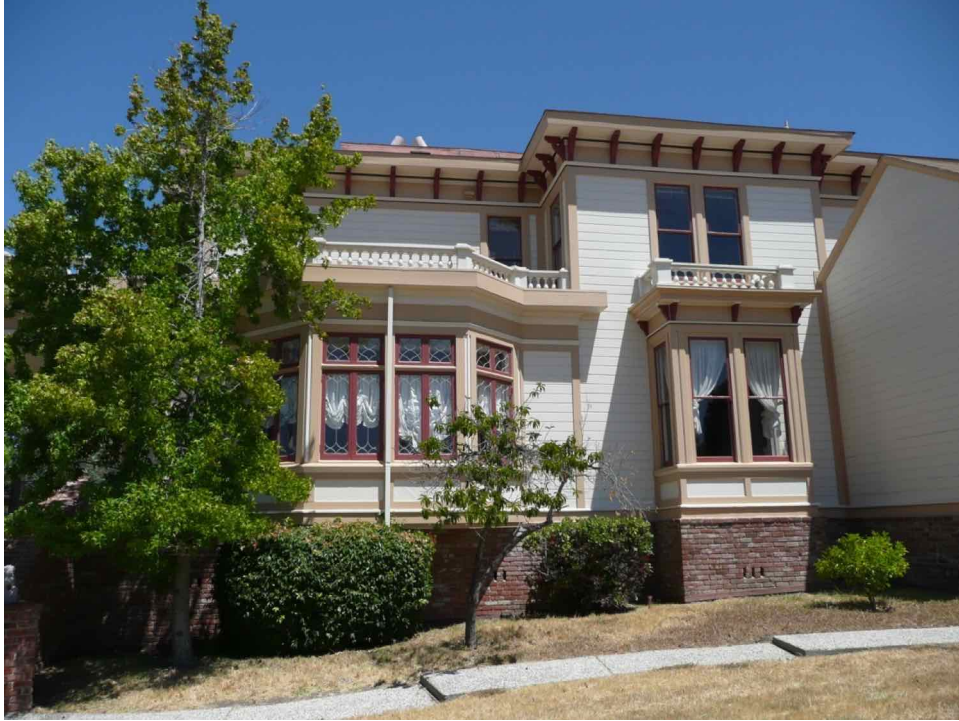
Figure 15: South elevation, showing ca. 1910 canted oriel bay at center-left and projecting bay at center-right, with gabled addition visible at far right, facing north.

The **south elevation** is marked by a contemporary set of brick stairs that lead to the wraparound porch and the main entry at the west elevation (Figure 15). This set of brick stairs is flanked on either side by brick sidewalls that appear to be several wythes deep, and flare outward toward the base of the stairs (Figure 16). The flared brick sidewalls are terminated by two brick piers that are skewed 45 degrees in their orientation, and are capped by cast stone lion statuettes that are temporary, and not physically attached to the brick. The top of the stairs is intersected by a low wrought iron fence with gate that appears to be contemporary in design.

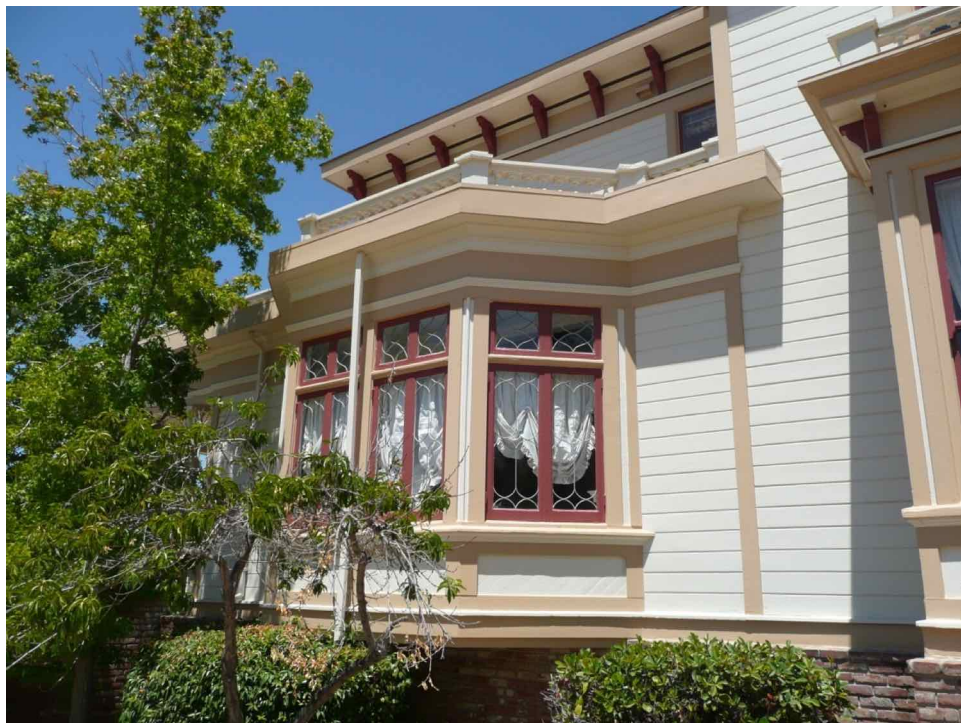
Figure 17: South elevation, showing ca.1910 canted oriel bay, facing northwest.

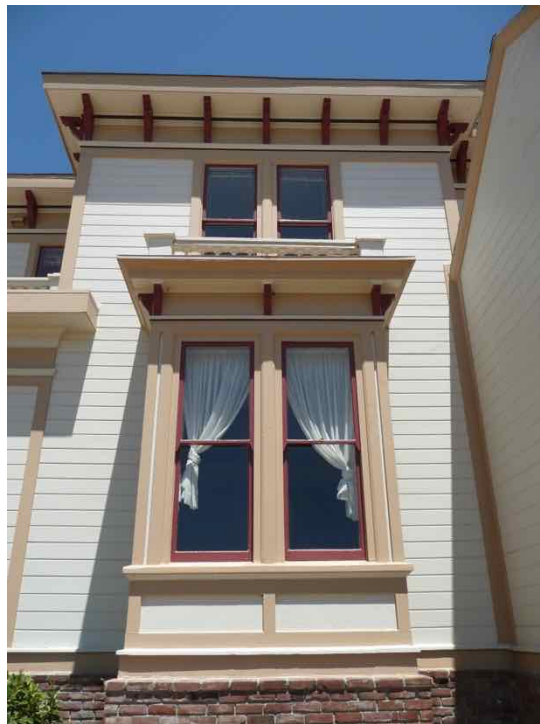
Figure 18: South elevation, showing fenestration at projecting bay, with gabled addition visible at far right, facing north.

The two-story projecting bay at the south elevation consists of a projecting rectangular bay window at the first story, which consists of a pair of double-hung wood windows with a wood paneled “bulkhead” below that displays diagonal-laid wood boards within each “panel,” as well as a small cornice above that displays decorative wood brackets similar to the cornice at the main roofline (Figure 18). Directly above the eave of this projecting bay window is a Colonial Revival-style turned balustrade that is similar in appearance to that which wraps around the second-story porch, and does not appear to be an occupiable space. The second story of the projecting bay consists of a pair of double-hung wood windows in wood frames with wood surrounds.

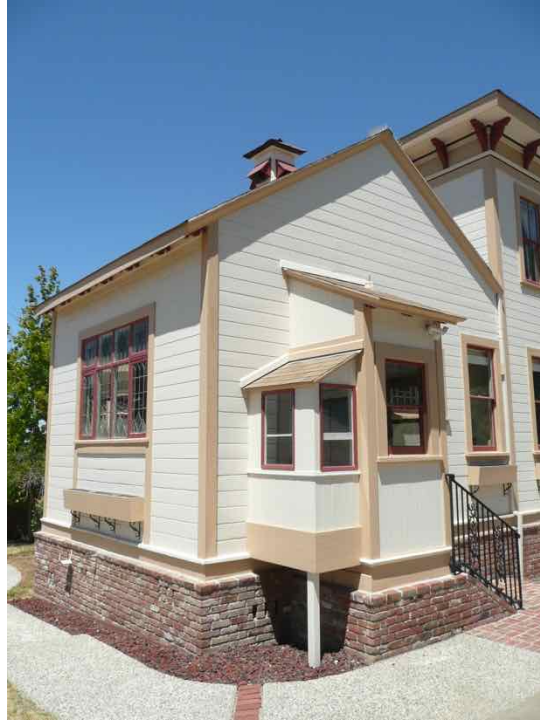
Figure 19: Gabled addition, showing south and east elevations with main two-story massing visible at right, facing northwest.

The **one-story side gabled addition** (gabled addition), previously referred to be a “dependency,”²⁷ appears to have been originally constructed as a subsidiary building and connected to the house at some date after its independent construction (Figure 19). This gabled addition has a gable oriented west-east with very shallow eaves, and is attached to the main two-story massing of the house at the eastern end of the house’s south elevation. The roof of the gabled addition is moderately pitched and also clad in composition shingles and topped by what appears to be a wood-frame cupola with metal vents projecting from each side and a pyramidal roof cap. While the wood siding and brick veneer water table at the gabled addition is identical to the main two-story massing, the gabled addition has a form, design, and massing that is clearly distinct from

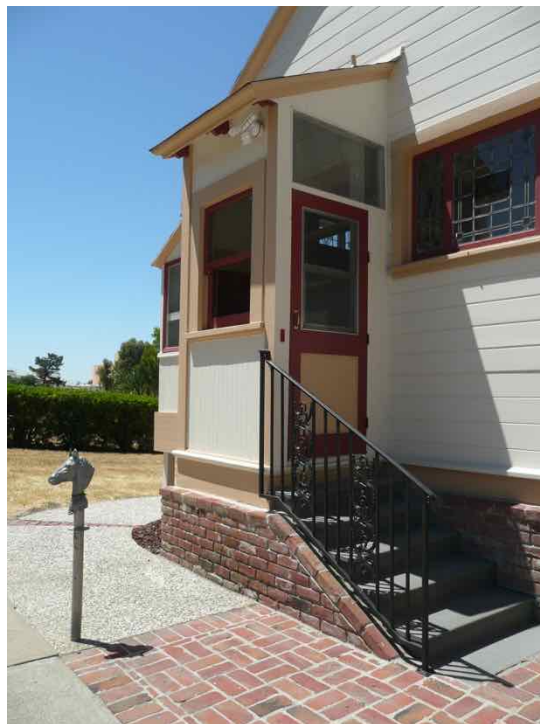
Figure 20: Early shed roof addition (rear entry portico) at east elevation of gabled addition, facing southwest.

The **east elevation** of the gabled addition consists of the rear entry into the house, and consists of a leaded glass wood window that appears to be contemporary, as well as a double-hung wood window (Figure 20). The rear entry is accessed via a set of stairs consisting of composition treads and risers flanked by a single-wythe sidewall. The stairs lead to what appears to be a shed roof addition, likely constructed as an entry portico, which consists of a wood paneled door with operable aluminum single-hung window in the upper one-half facing north, toward the stairs. There is a window-less transom above this entry that is covered with a mesh metal screen. There is a double-hung wood window at the east elevation of this shed roof addition, and what appears to be another shed roof addition subsequently added to the earlier shed roof addition. This later shed roof addition is cantilevered over the ground, supported by a single wood post, and consists of fixed wood windows. The function of this later shed roof addition could not be determined. Both the earlier and later shed roof additions are clad in vertical wood shiplap siding that is narrower than the horizontal siding along the remainder of the gabled addition and main massing of the house.

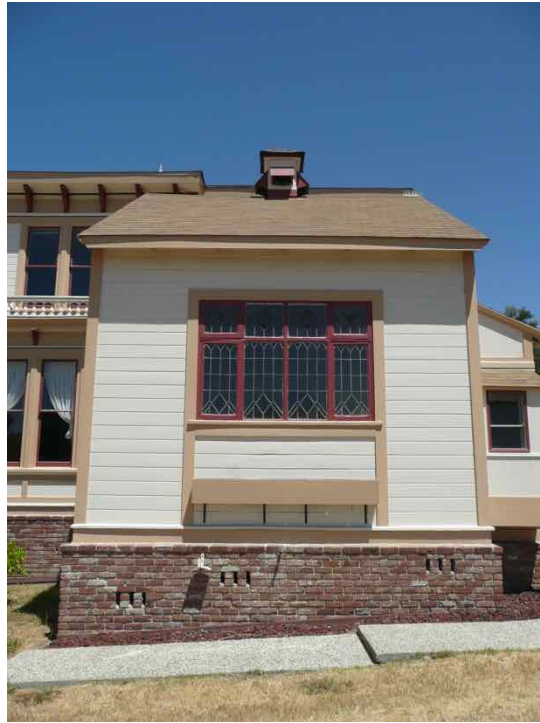
Figure 21: South elevation of gabled addition, facing north.

The **south elevation** of the gabled addition consists of one grouping of four windows, each with a transom above (Figure 21). The end windows and respective transoms are operable as casements, with the others appear to have always been fixed. All windows within this grouping are wood, and have lead came that create rectangular, diamond, triangular, and trapezoidal patterns, with all transoms exhibiting some stained glass in a central motif. There is a contemporary wood planter box below this window, supported by wrought iron brackets.

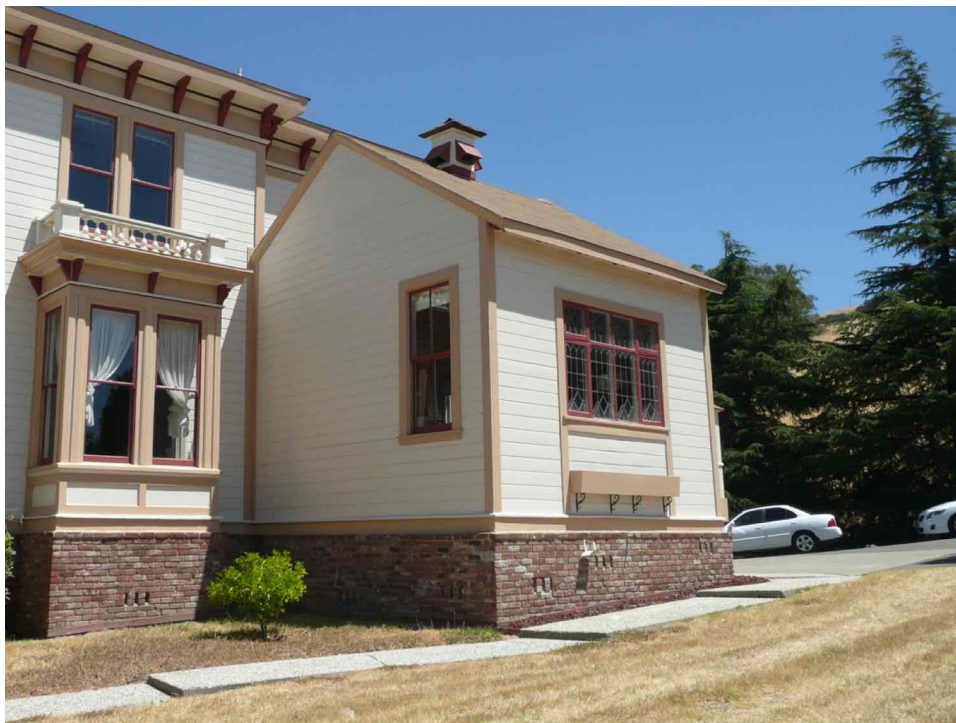
Figure 22: Gabled addition, showing west and south elevations with main two-story massing visible at left, facing northeast.

The **west elevation** of the gabled addition consists of a single two-over-two double-hung window near the southern corner of this elevation (Figure 22).

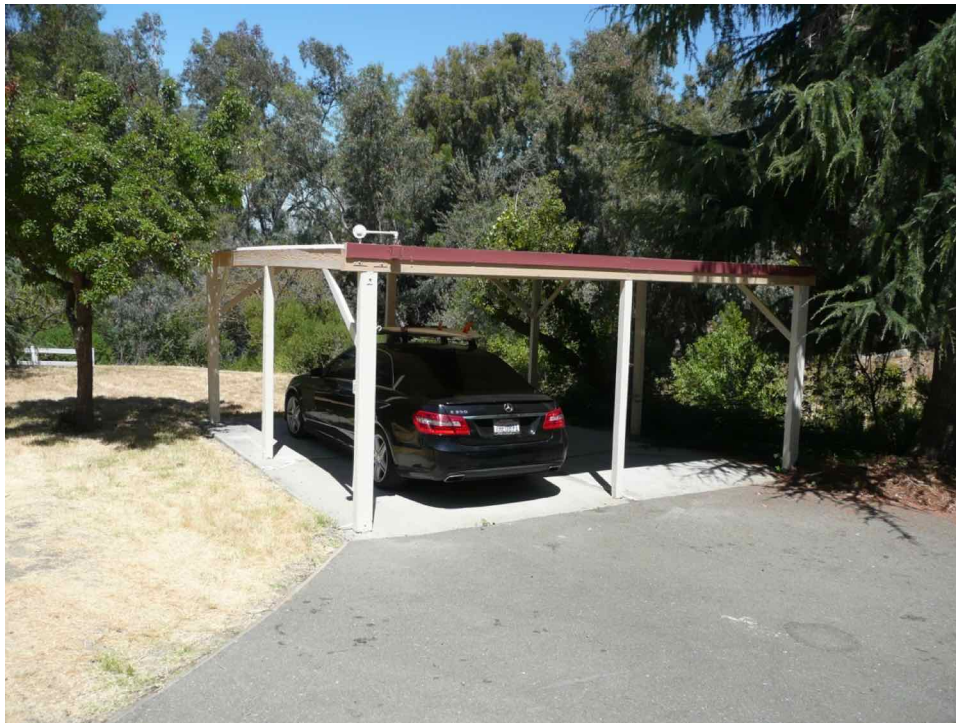
Figure 23: 1978 Detached Carport Structure from north elevation of 1882 Gallegos House, facing northwest.

A contemporary wood framed detached carport constructed in 1978 is located approximately 20 feet from the north elevation of the 1882 Gallegos House. The structure is very simple in its construction, is attached to a large poured concrete pad, and has a nearly flat roof (Figure 23).

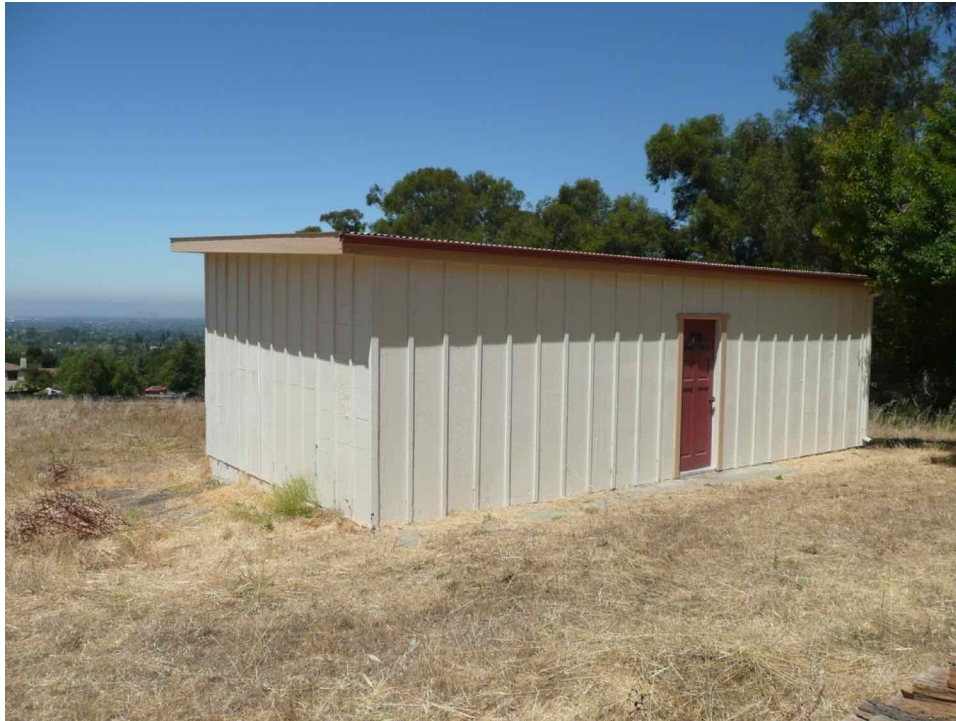
Figure 24: South and east elevations of the contemporary horse tack building, facing northwest.

The contemporary horse tack building is located approximately 45 feet west of the 1882 Gallegos House, and appears to have been constructed in ca. 1975 around the house was relocated, as the horse tack building exhibits the same board-and-batten plywood siding as the veranda “skirt” along the west and north elevations of the house. This rectangular, one-story building is situated on a concrete block foundation, and has a shed roof clad in corrugated metal roofing (Figure 24). Near the center of the east elevation is a

contemporary paneled door with semi-lunar glazing in the upper one-fifth. There is no fenestration at the south elevation. The west elevation consists of two large openings, two sliding doors hung on the same metal track at the southern half of the elevation, and a rectangular opening with clipped corners at the northern half of the elevation (Figure 25). The north elevation consists of a small opening that appears to be approximately 2 feet in width by 3 feet in height.

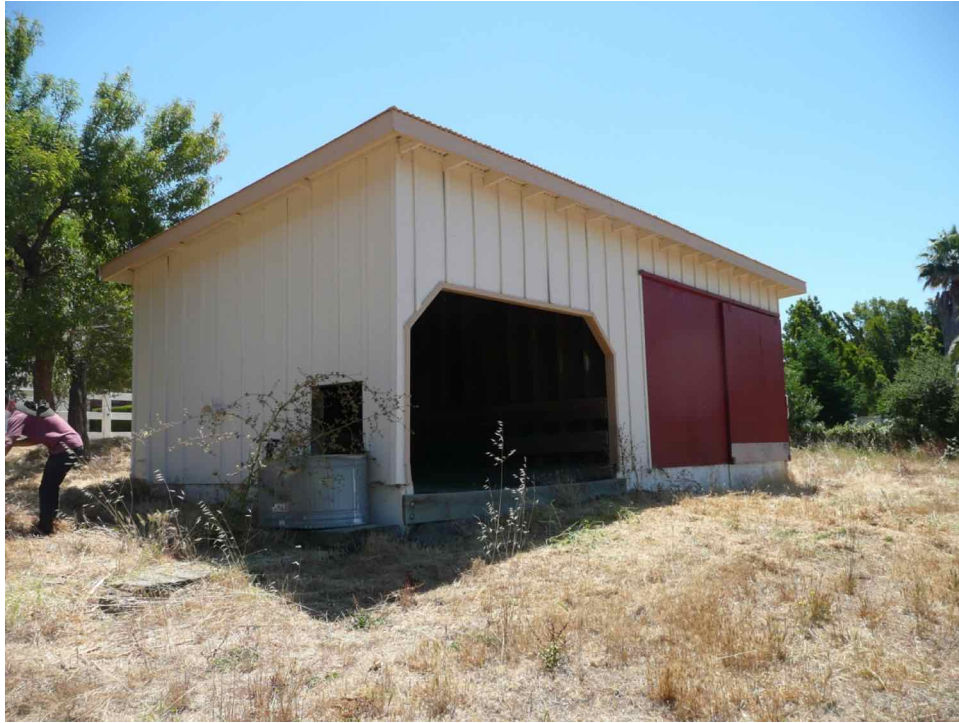
Figure 25: North and west elevations of contemporary horse tack building, facing southeast.

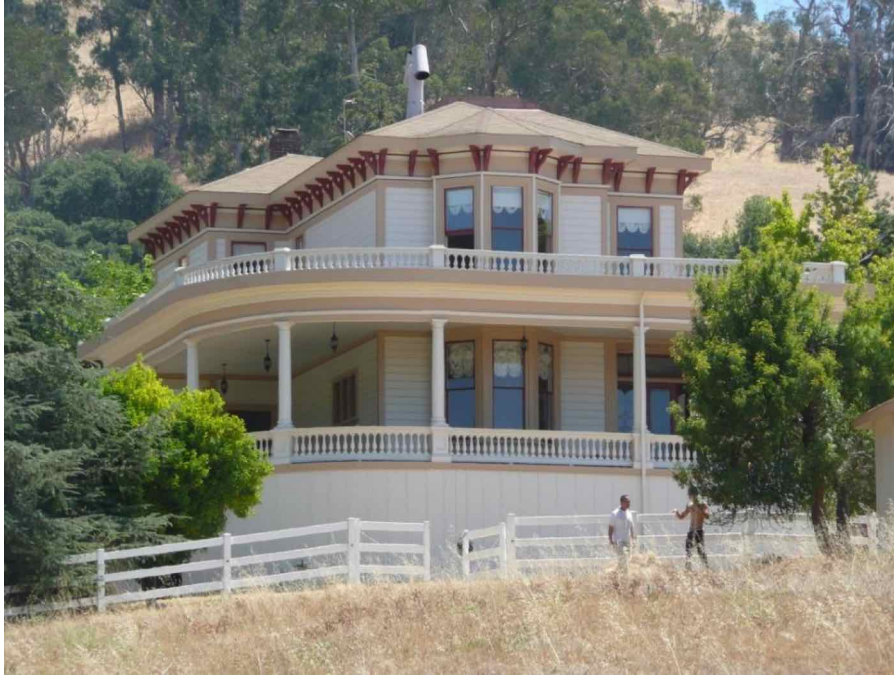
1882 Gallegos House, showing the north and west elevations from the western portion of the parcel, facing east.

The **west elevation** is dominated by the building's curved, wraparound veranda and second-story balcony (Figure 7). The veranda has elements of the Colonial Revival style, and consists of a low, turned balustrade, with piers located at regular intervals serving as bases for unfluted Tuscan columns that support the second story balcony (Figure 8). The floor of the veranda consists of wood boards, while the ceiling of the veranda consists of narrower, wood beadboard (Figure 9). The second story balcony consists of a similar turned balustrade, although there are notable differences in the size and exact

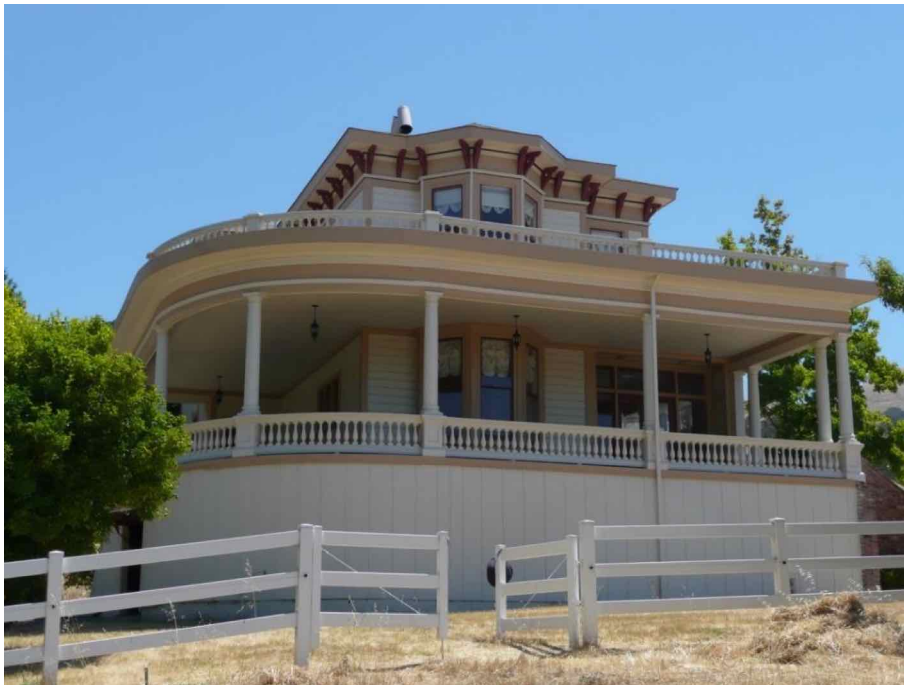
West elevation, showing veranda, facing east.

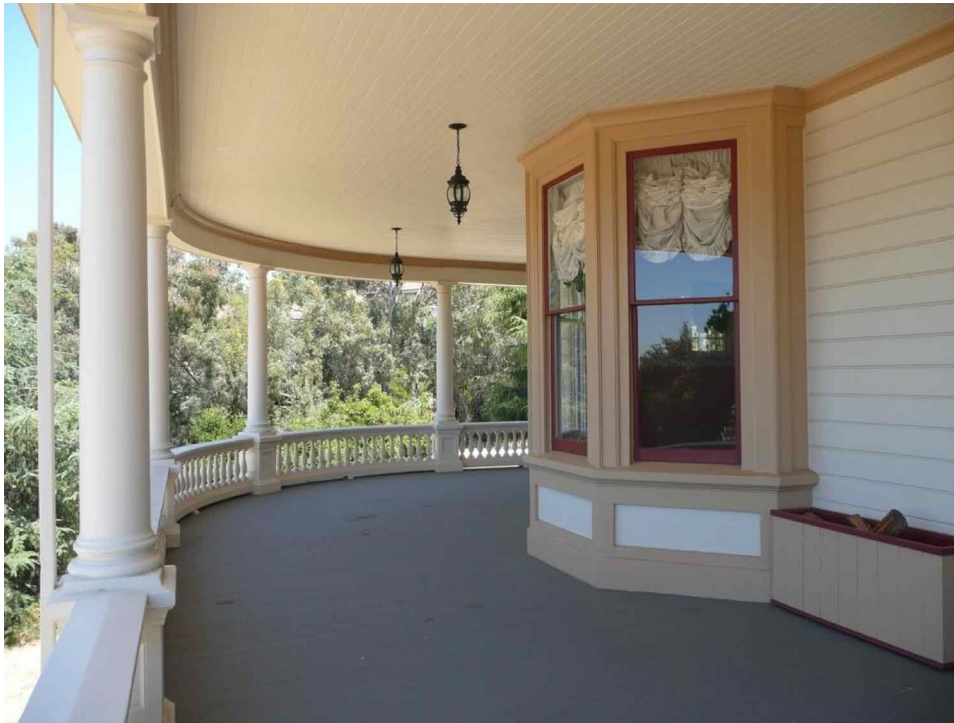
Bay window at west elevation from wraparound veranda, view northeast.

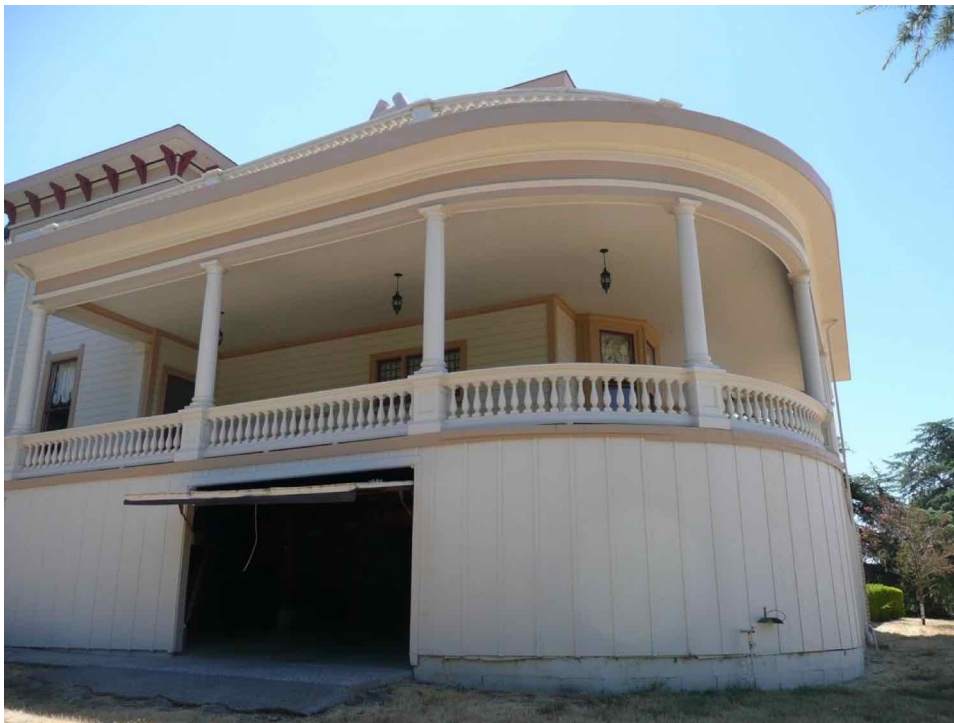
Wraparound veranda at north elevation, showing overhead garage door, facing southeast.

Similar to the west elevation, the **north elevation** is marked by the projecting wraparound veranda and second-story balcony. At this elevation, a contemporary overhead garage door provides access to the garage and basement area below the first story of the house (Figure 10). There is a set of contemporary stairs along this elevation, directly to the east of the wraparound porch, that provides access from the rear portion of the paved driveway near the 1978 detached carport structure to the porch (Figure 11). The outer string of the stairs is clad in the same plywood as the veranda skirt and there is a contemporary wrought iron handrail.

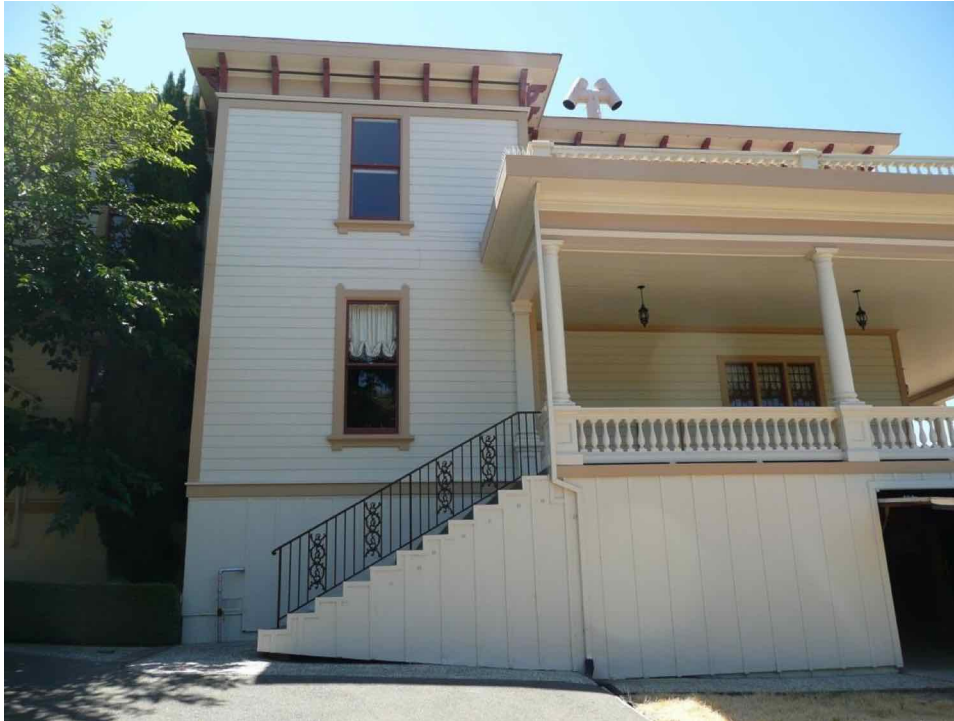
North elevation, showing wraparound veranda at right and projecting bay at center-left, facing south.

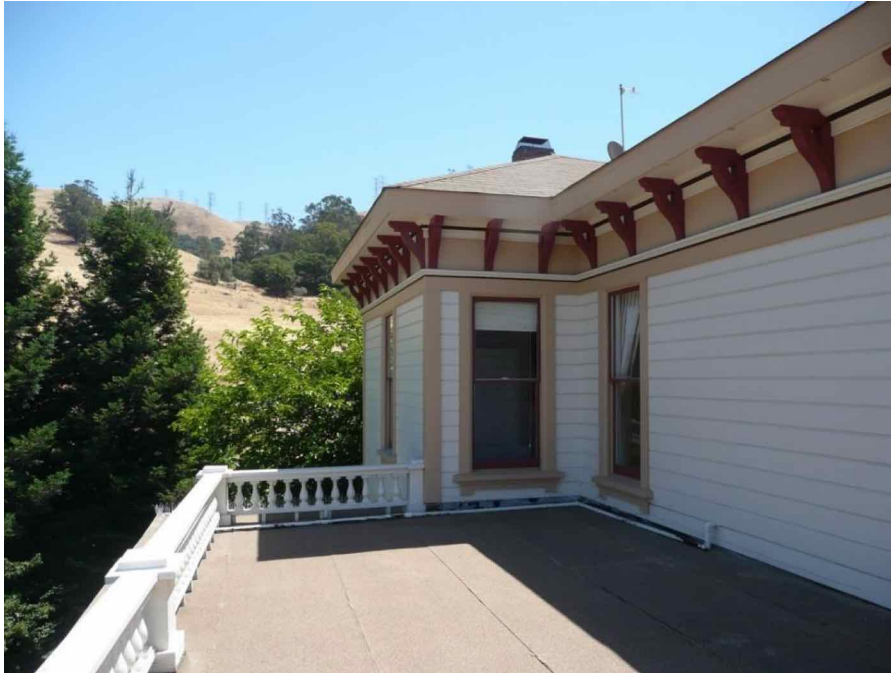
North elevation, showing second story fenestration from second-story porch, facing east.

To the east of the veranda is a two-story rectangular bay that projects from the remaining north elevation of the building (Figure 13). This bay consists of the same board-and-batten plywood water table as that which occurs at the veranda skirt, with horizontal wood cladding at the first and second stories that is typical of other elevations. Within this bay is a double-hung wood window at the first story aligned with a double-hung wood window at the second story—both with wood surrounds that show some decorative woodwork. To the east of this bay, near the northeast corner of the building, is another “stack” of double-hung wood windows in wood frames with wood surrounds, along with an oculus window with similar wood surround.

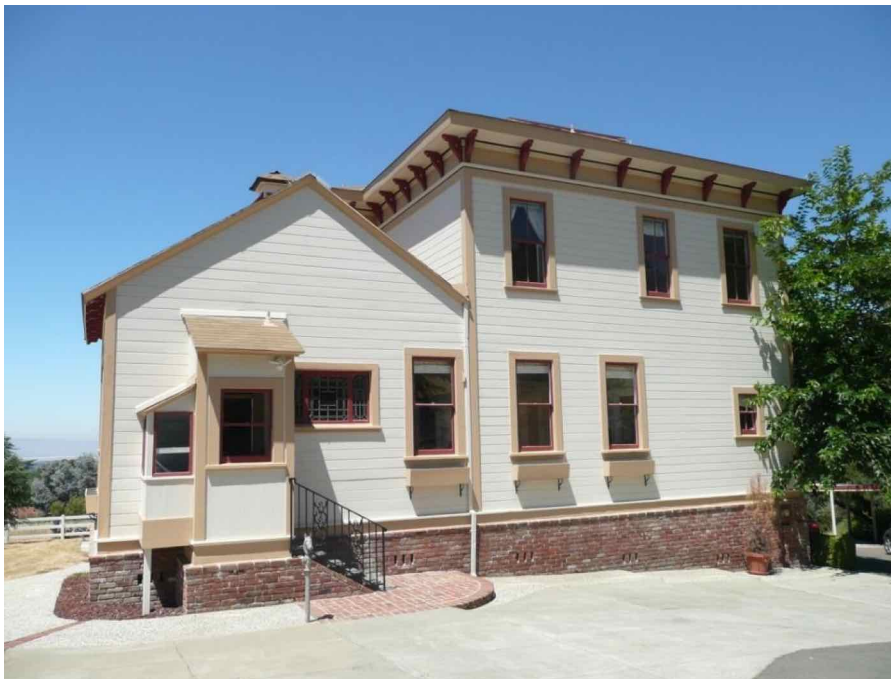
East elevation, showing gabled addition at left and main two-story massing at right, facing west.

The rear, **east elevation** consists of the main two-story massing of the house, as well as the one-story gabled addition (Figure 14). The brick veneer water table is present along this elevation, and is marked by groupings of three openings in the brick that appear to provide ventilation to the basement. The fenestration at the main two-story massing is asymmetrical, and consists of some windows that appear to differ in width and sash design among each other, though all appear to be double-hung wood windows set in wood frames with wood surrounds. At the first story, fenestration consists of two, one-over-one double-hung windows, with a smaller two-over-two double-hung window near the northern corner of this elevation. At the second story, fenestration consists of three two-over-two double-hung

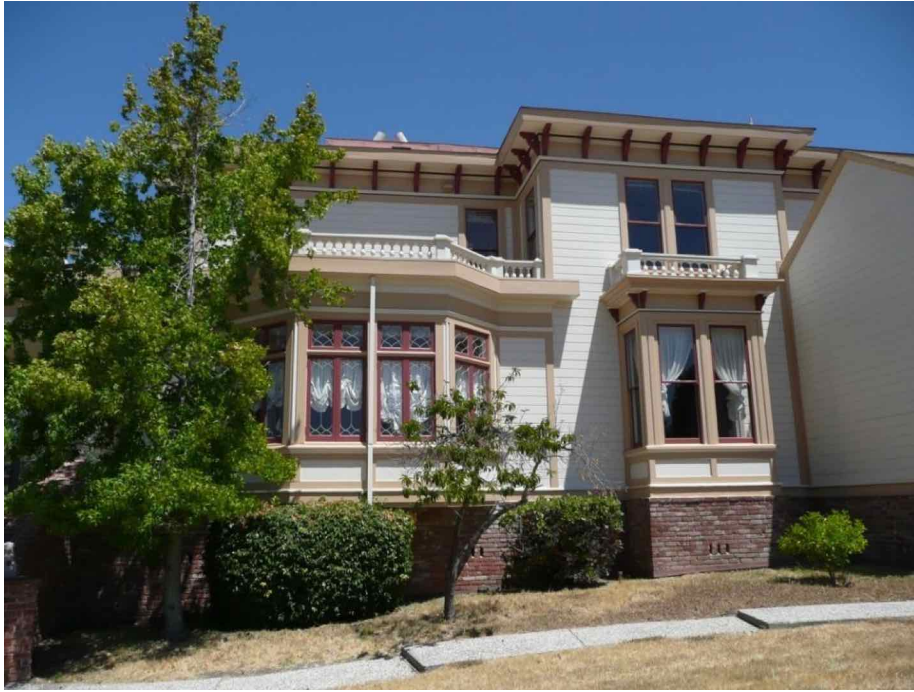
South elevation, showing ca. 1910 canted oriel bay at center-left and projecting bay at center-right, with gabled addition visible at far right, facing north.

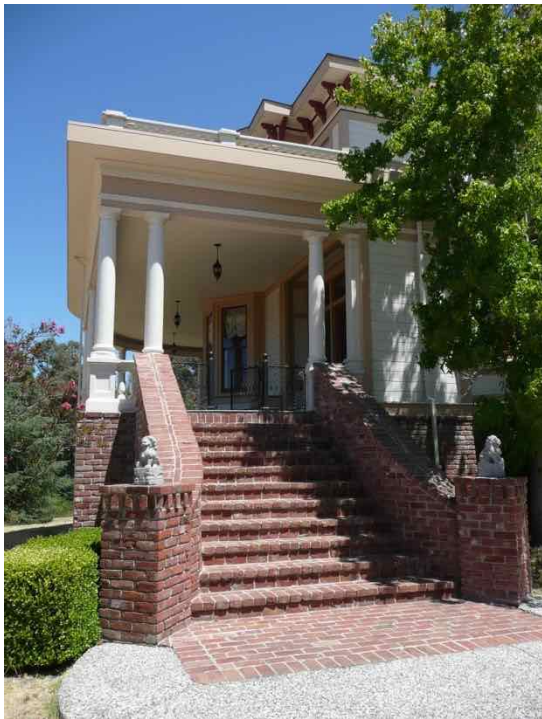
Brick entry stairs to wraparound veranda, facing northeast.
