EVANS & DE SHAZO
ARCHAEOLOGY HISTORIC PRESERVATION

**HISTORIC RESOURCE EVALUATION
OF THE 1882 GALLEGOS HOUSE AND
SECRETARY OF THE INTERIOR
STANDARDS REVIEW FOR THE
PROPOSED PROJECT LOCATED AT
830 WITHERLY LANE, FREMONT,
ALAMEDA COUNTY, CALIFORNIA**

October 9, 2018

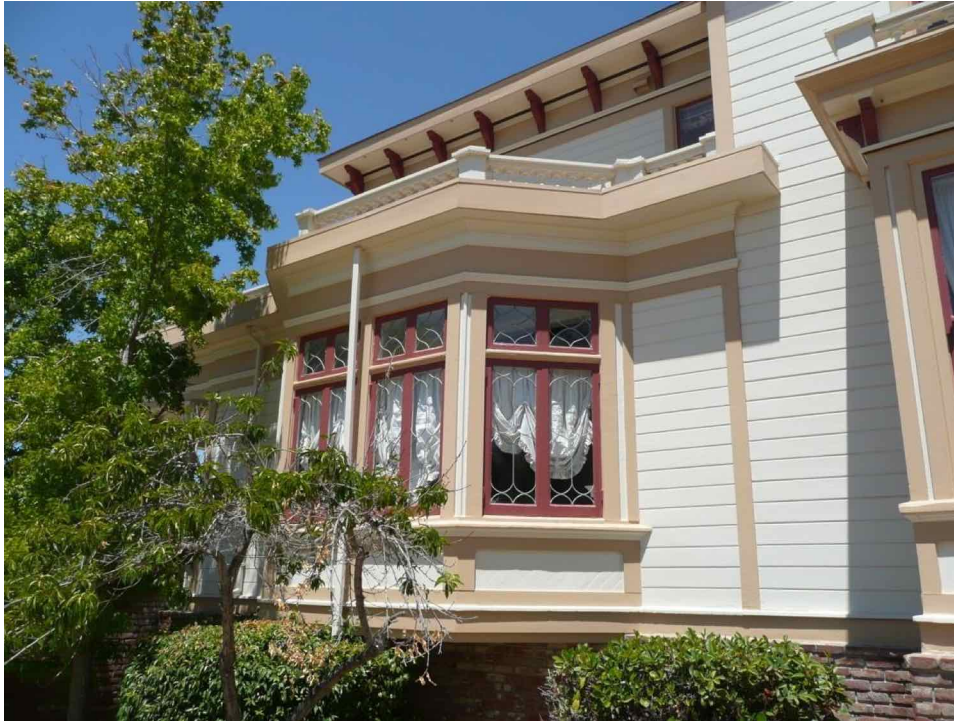
South elevation, showing ca.1910 canted oriel bay, facing northwest.

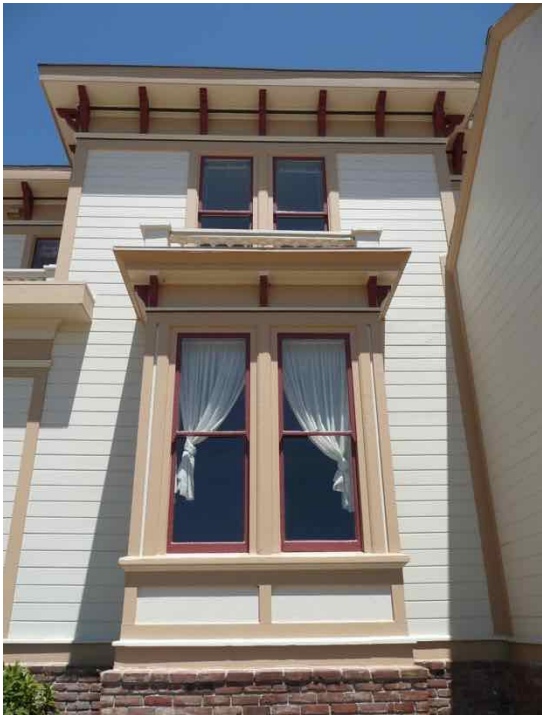
South elevation, showing fenestration at projecting bay, with gabled addition visible at far right, facing north.

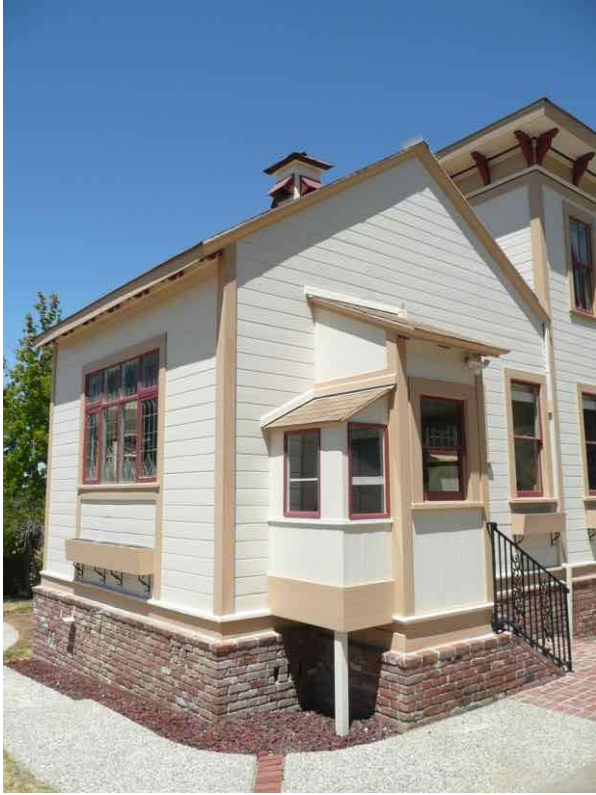
Gabled addition, showing south and east elevations with main two-story massing visible at right, facing northwest.

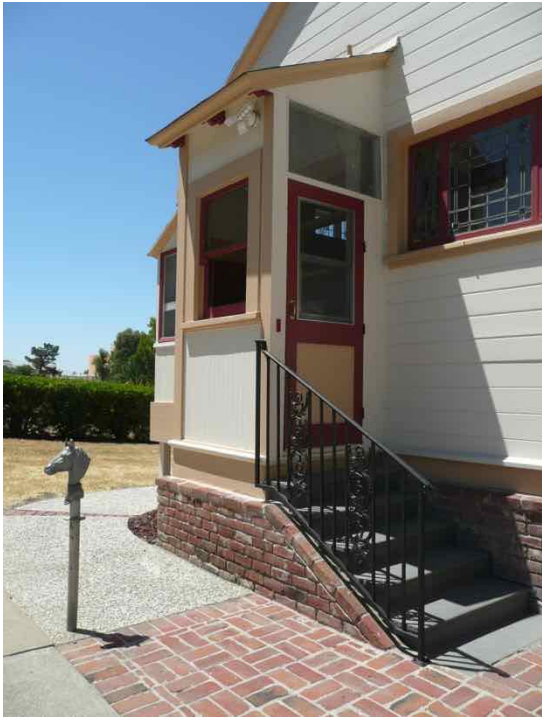
Early shed roof addition (rear entry portico) at east elevation of gabled addition, facing southwest.

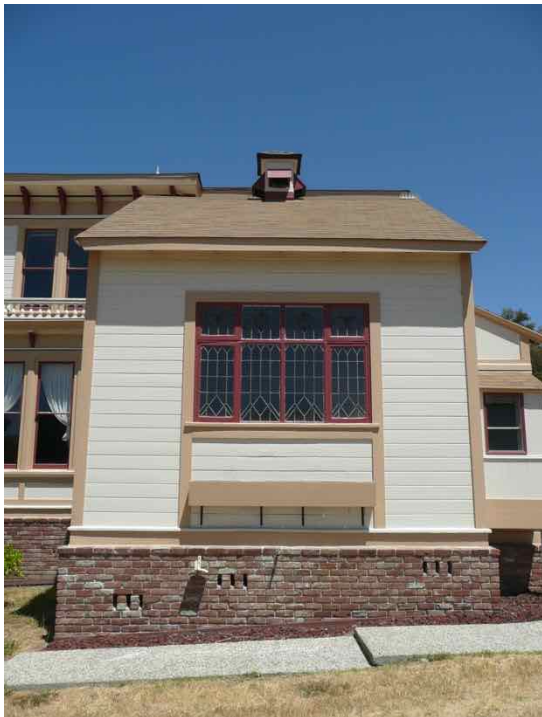
South elevation of gabled addition, facing north.

The **south elevation** of the gabled addition consists of one grouping of four windows, each with a transom above. The end windows and respective transoms are operable as casements, with the others appear to have always been fixed. All windows within this grouping are wood, and have lead comes that create rectangular, diamond, triangular, and trapezoidal patterns, with all transoms exhibiting some stained glass in a central motif. There is a contemporary wood planter box below this window, supported by wrought iron brackets.

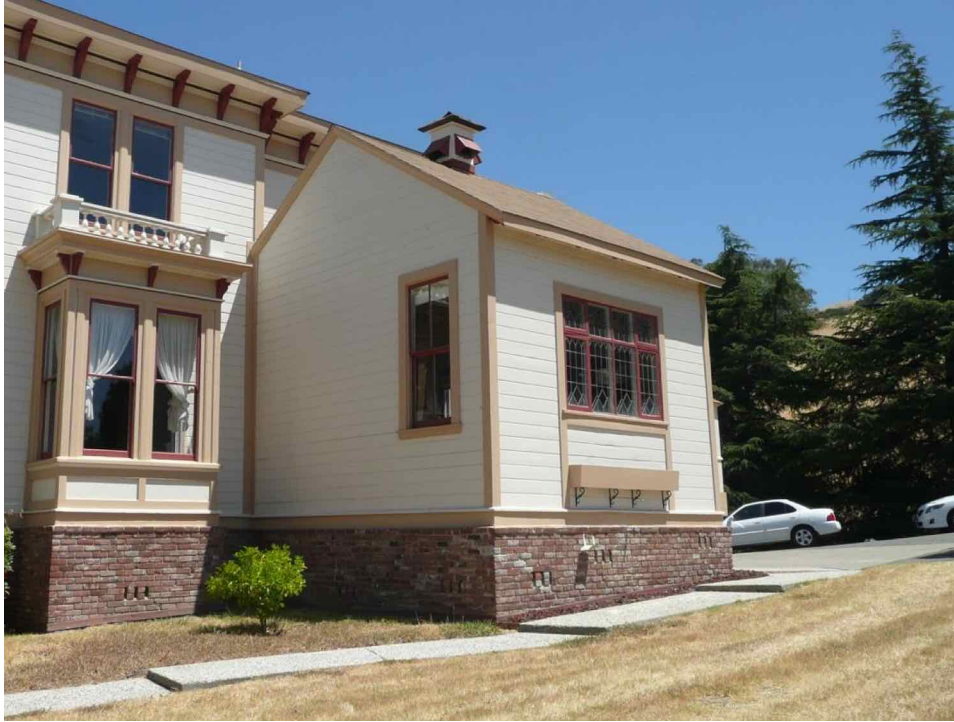
Gabled addition, showing west and south elevations with main two-story massing visible at left, facing northeast.

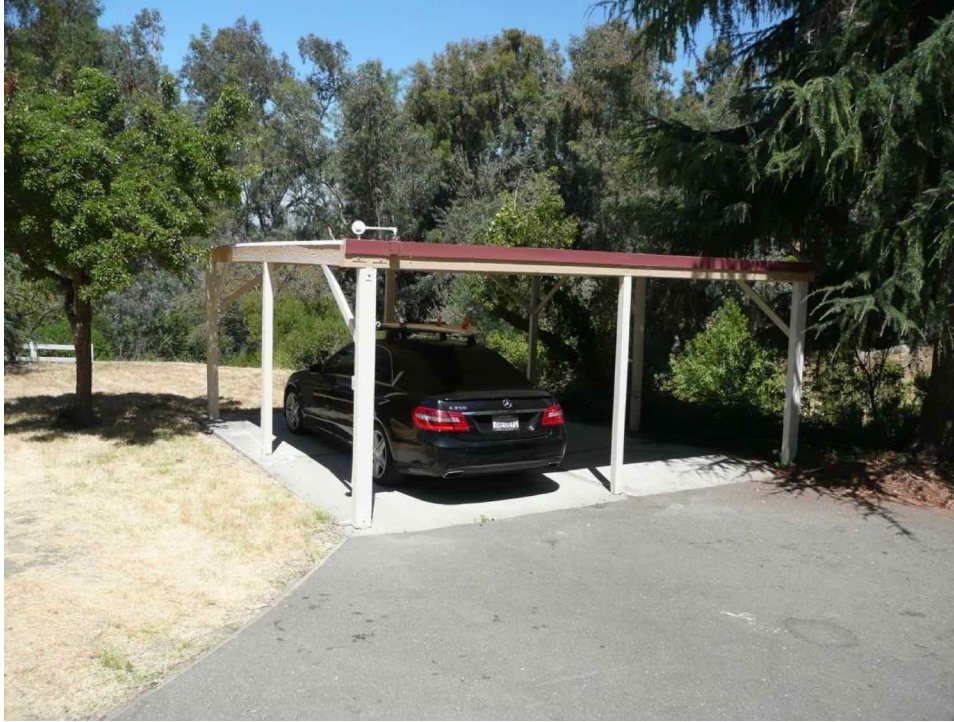
1978 Detached Carport Structure from north elevation of 1882 Gallegos House, facing northwest.

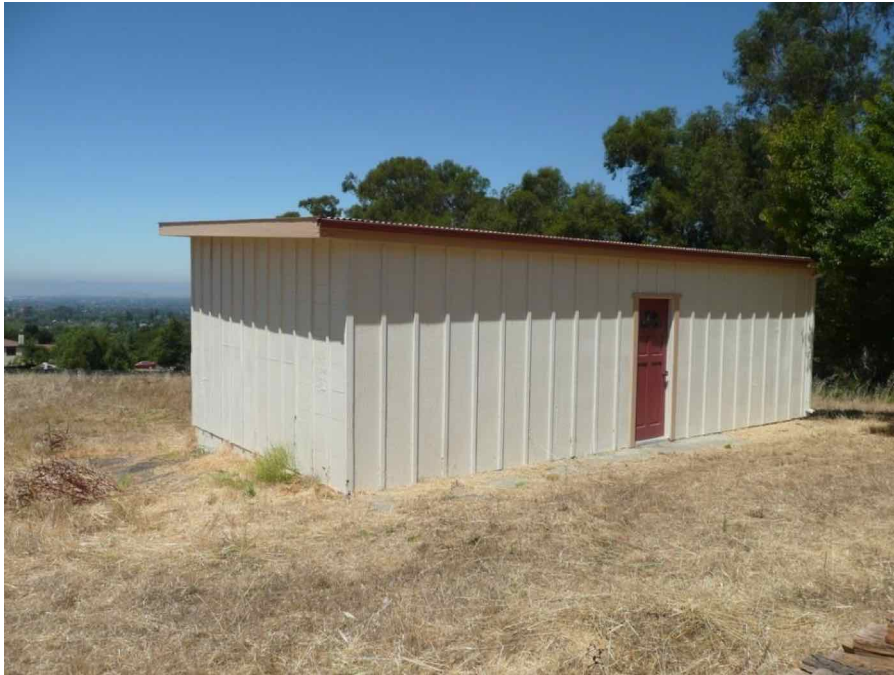
South and east elevations of the contemporary horse tack building, facing northwest.

building exhibits the same board-and-batten plywood siding as the veranda "skirt" along the west and north elevations of the house. This rectangular, one-story building is situated on a concrete block foundation, and has a shed roof clad in corrugated metal roofing. Near the center of the east elevation is a contemporary paneled door with semi-lunar glazing in the upper one-fifth. There is no fenestration at the south elevation. The west elevation consists of two large openings, two sliding doors hung on the same metal track at the southern half of the elevation, and a rectangular opening with clipped corners at the northern half of the elevation. The north elevation consists of a small opening that appears to be approximately 2 feet in width by 3 feet in height.

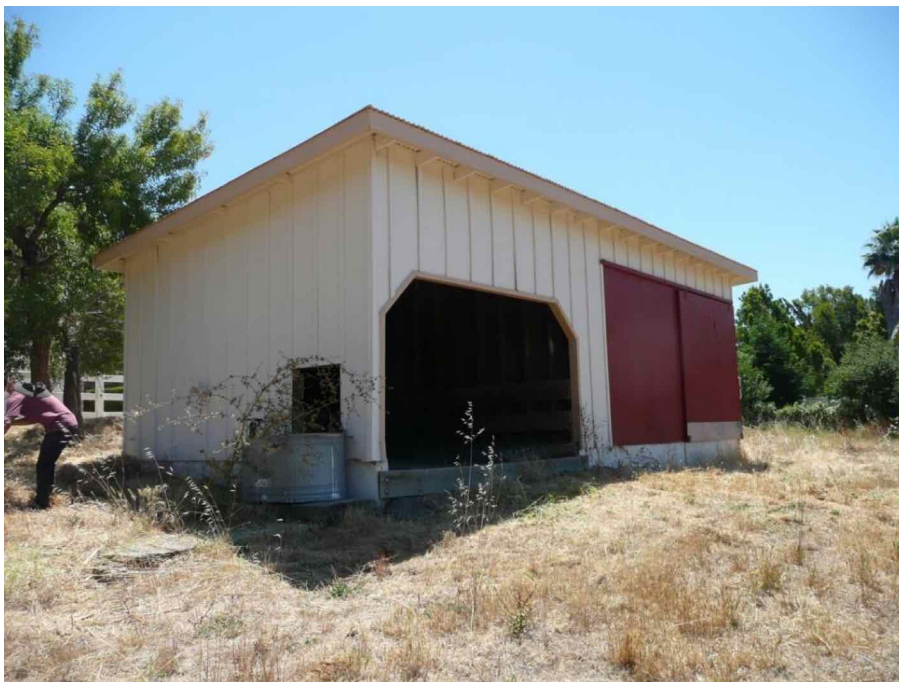
North and west elevations of contemporary horse tack building, facing southeast.
