Appendix

G

**Operation and
Maintenance
Detail**

This appendix details the tasks and costs of operation and maintenance of the trail system.

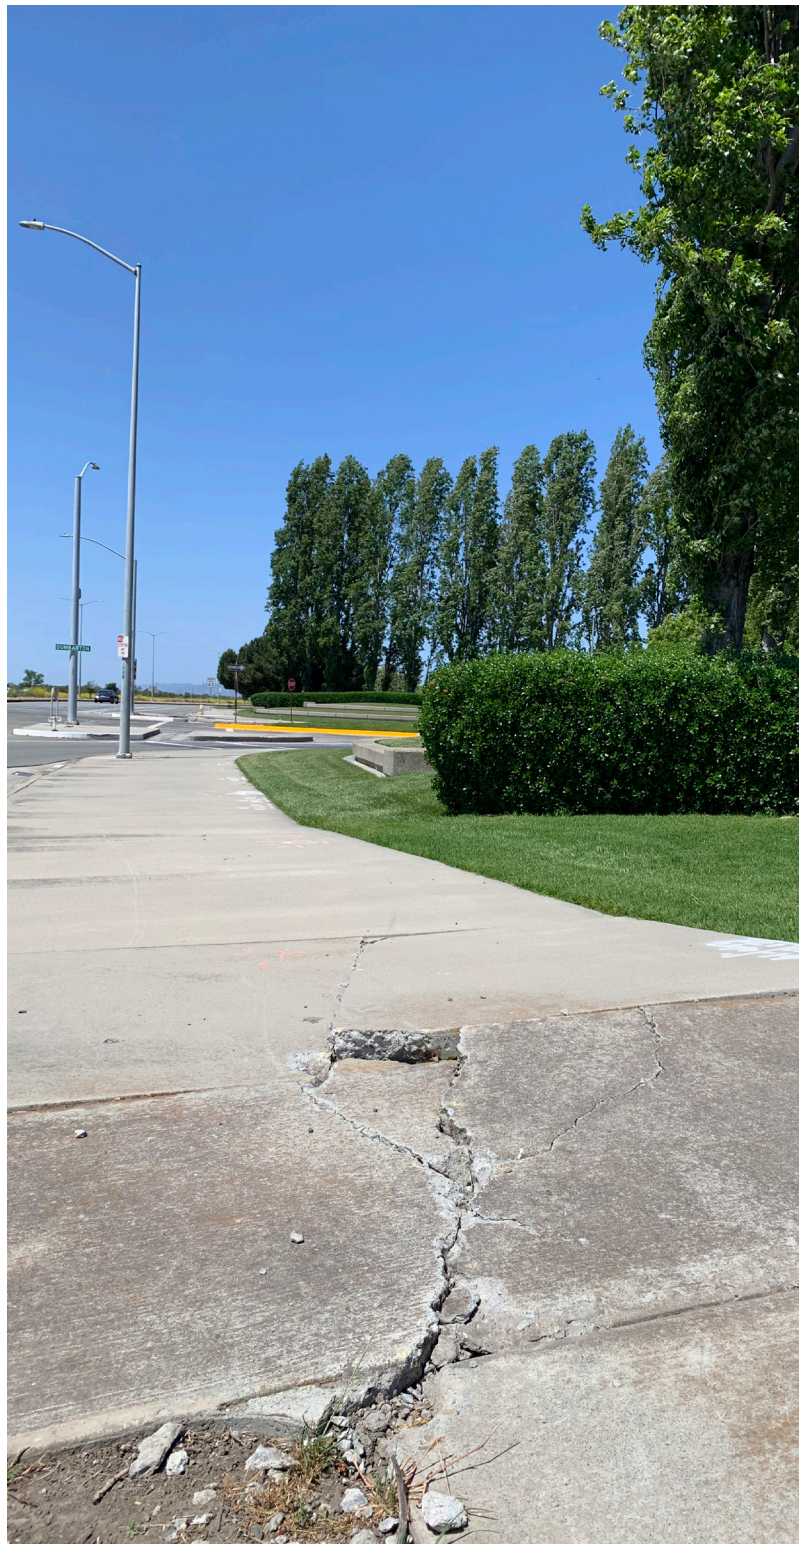
Damaged sidewalk on Paseo Padre Parkway near Dumbarton Circle
