# **Fremont Adult School**

## **Existing Conditions Summary**

January 2019

Prepared by Alta Planning + Design

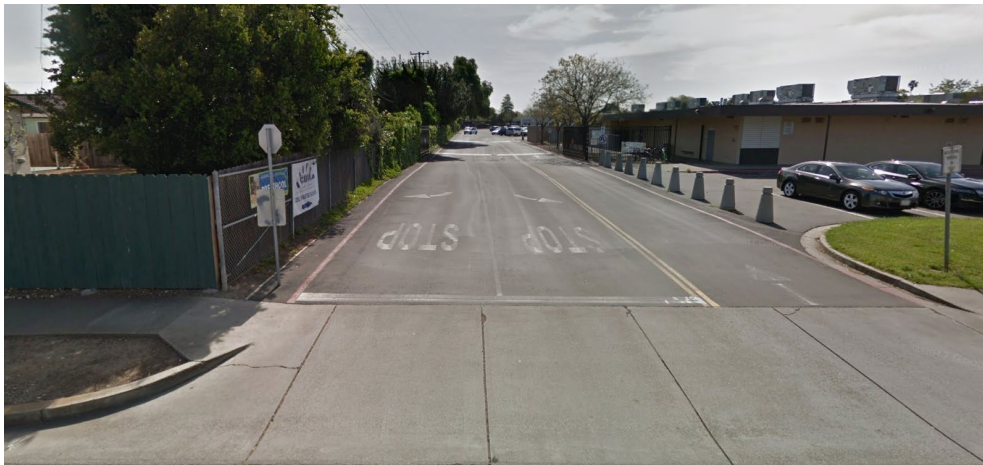
### 2. Calaveras Avenue and East Entrance

- ◆ Most people driving to the Fremont Adult School access the north parking lot through the North Entrance. Many turn left on Calaveras Avenue from Logan Drive and take a left into this entrance.
  - Cars sometimes back up while queuing to turn left. Participants observed the queue of cars grew up to five cars long.
- ◆ The driveway is currently two-way, with one lane going into the lot and a left-turn and right-turn lane exiting the lot.
- ◆ The neighboring property to the north has a fence at the edge of their property that impedes visibility of cars exiting the school.
  - Participants observed cars had to roll forward past the stop bar and into the sidewalk to see oncoming traffic.

*One entry lane and a left and right turn exit lanes at East Entrance.*

- 2 Calaveras Avenue/East Entrance**  
- Install high visibility crosswalk across staff parking lot and install curb ramps.  
- Stripe previous right turn lane as no parking zone to improve sight lines when exiting.

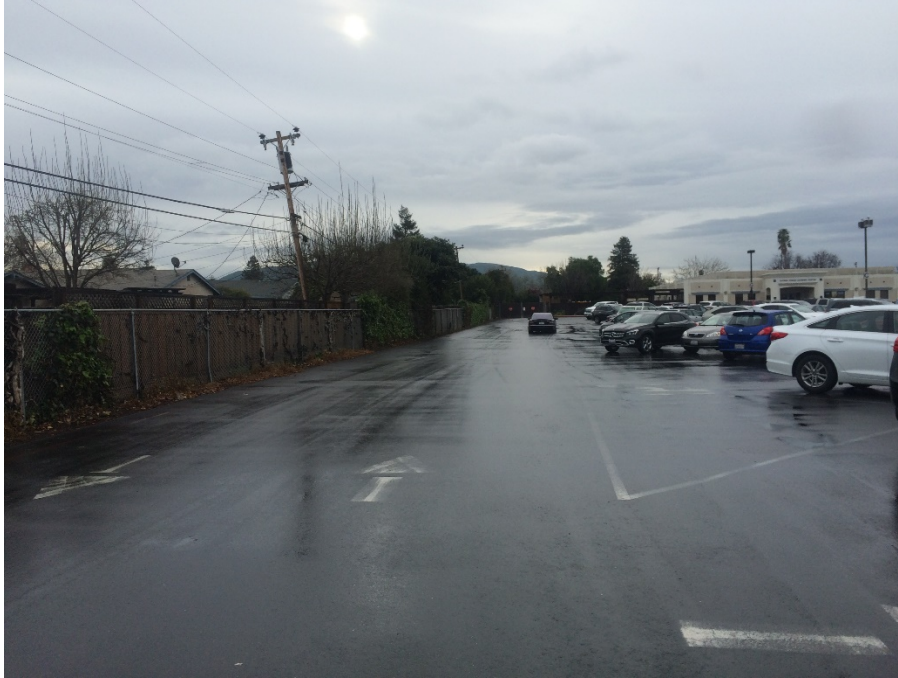
### 3. East Parking Lot

- ◆ Drivers were observed traveling slower in areas with existing speed humps, but increased speed in the straightaways in the north side of the lot without them.

*Past the speed humps in the North Parking Lot, cars were observed speeding.*

- Improve pedestrian pathway adjacent to school building.
- 3 North Parking Lot**  
- Install speed humps on eastern straightaway to slow vehicle traffic.

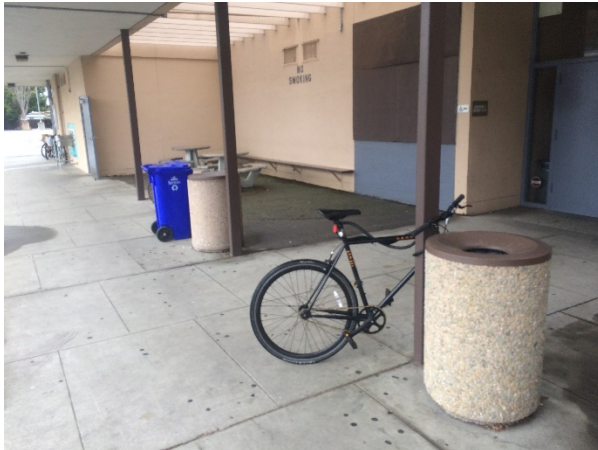
- ◆ The main bike rack on campus is located next to a shed within the North Parking lot. This bike rack was empty on the day of observation.
- ◆ Participants observed bikes locked to railings and signposts at different locations throughout campus.

*Left: Bikes were observed locked to poles and signposts.*

- 4 On Campus Bike Parking**  
- Install secure bike parking in visible locations.
- 5 Central Walkway**  
- Consider widening central walkway to create a multi-use path for people walking and biking to be able to access the rear buildings with greater separation from cars.

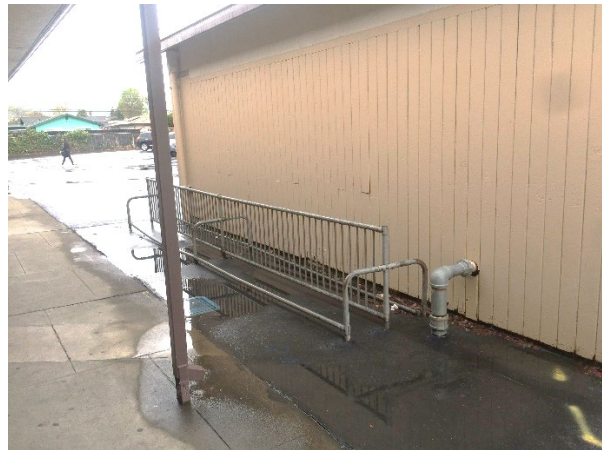
*Right: The largest bike rack is located behind a shed in the North Parking Lot.*

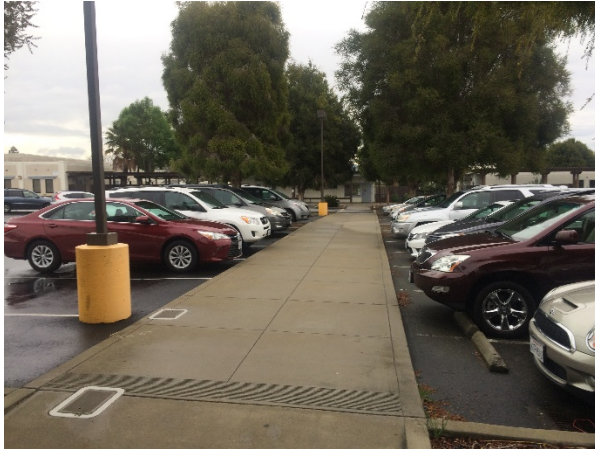
- ◆ People walking to the buildings toward the east of the campus were observed using the central walkway that divides the North and South Parking Lots.
- ◆ The two crosswalks connecting the central median to the buildings are marked as high visibility crossings, but not raised. One participant noted that they observe people backing up through the crosswalk.

*Left: Central Walkway connects front and rear buildings.*

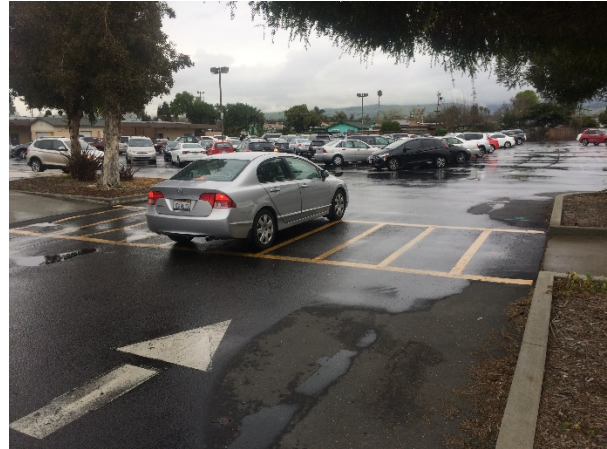
*Right: The two crosswalks that currently connect pedestrians using the central walkway between front to rear buildings.*

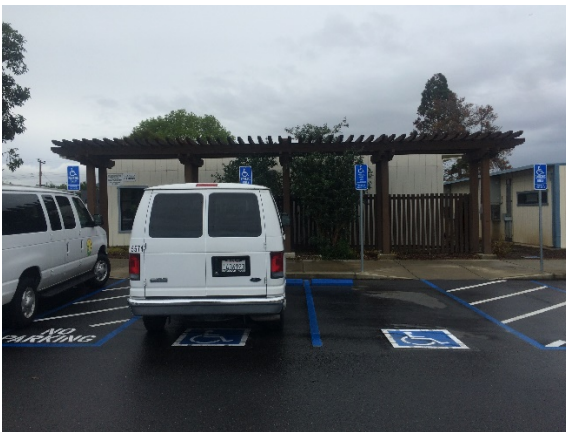
- ◆ The buildings for the Adults with Disabilities Program are next to Fremont Unified Young Adult Program that works with youth with disabilities. Both programs have a high need for designated accessible parking spaces for students who have special mobility needs.
- ◆ Attendees noted that accessible parking spaces were often full when needed, and vans with students have a greater to walk.

*Left: The accessible parking shared with the Adults with Disabilities Program and Young Adult Program.*

- 6 South Boundary of Parking Lot**  
- Designate accessible parking spots for exclusive use by the Adults with Disabilities program, and the Young Adults Program, respectively.

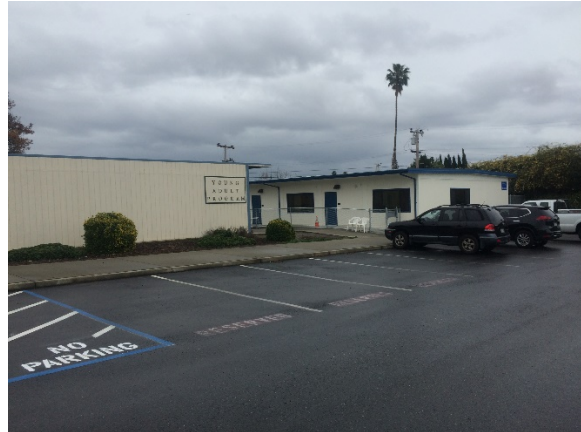
*Right: Parking spots in front of Young Adults Program.*

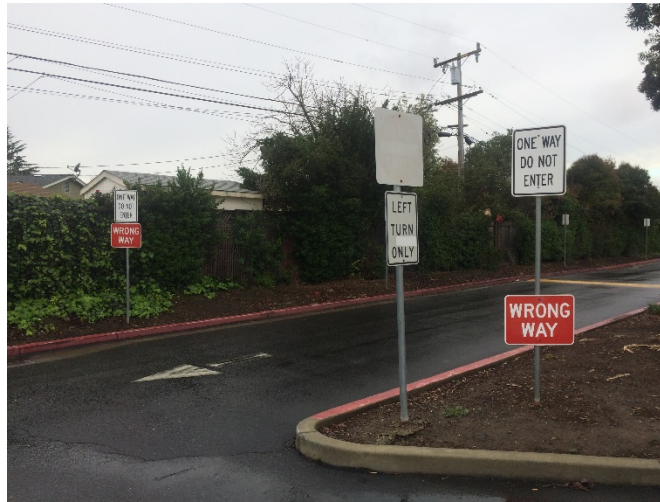
## 7. South Parking Lot

- ◆ The South Entrance is mainly one way, except for vehicles entering and exiting the Custodial Parking lot.

*The exit to the South Parking Lot.*

- 7 South Parking Lot**  
- Consider converting parking spaces alongside building to be angled and converting drive aisle to be one way, with pavement arrow legends.

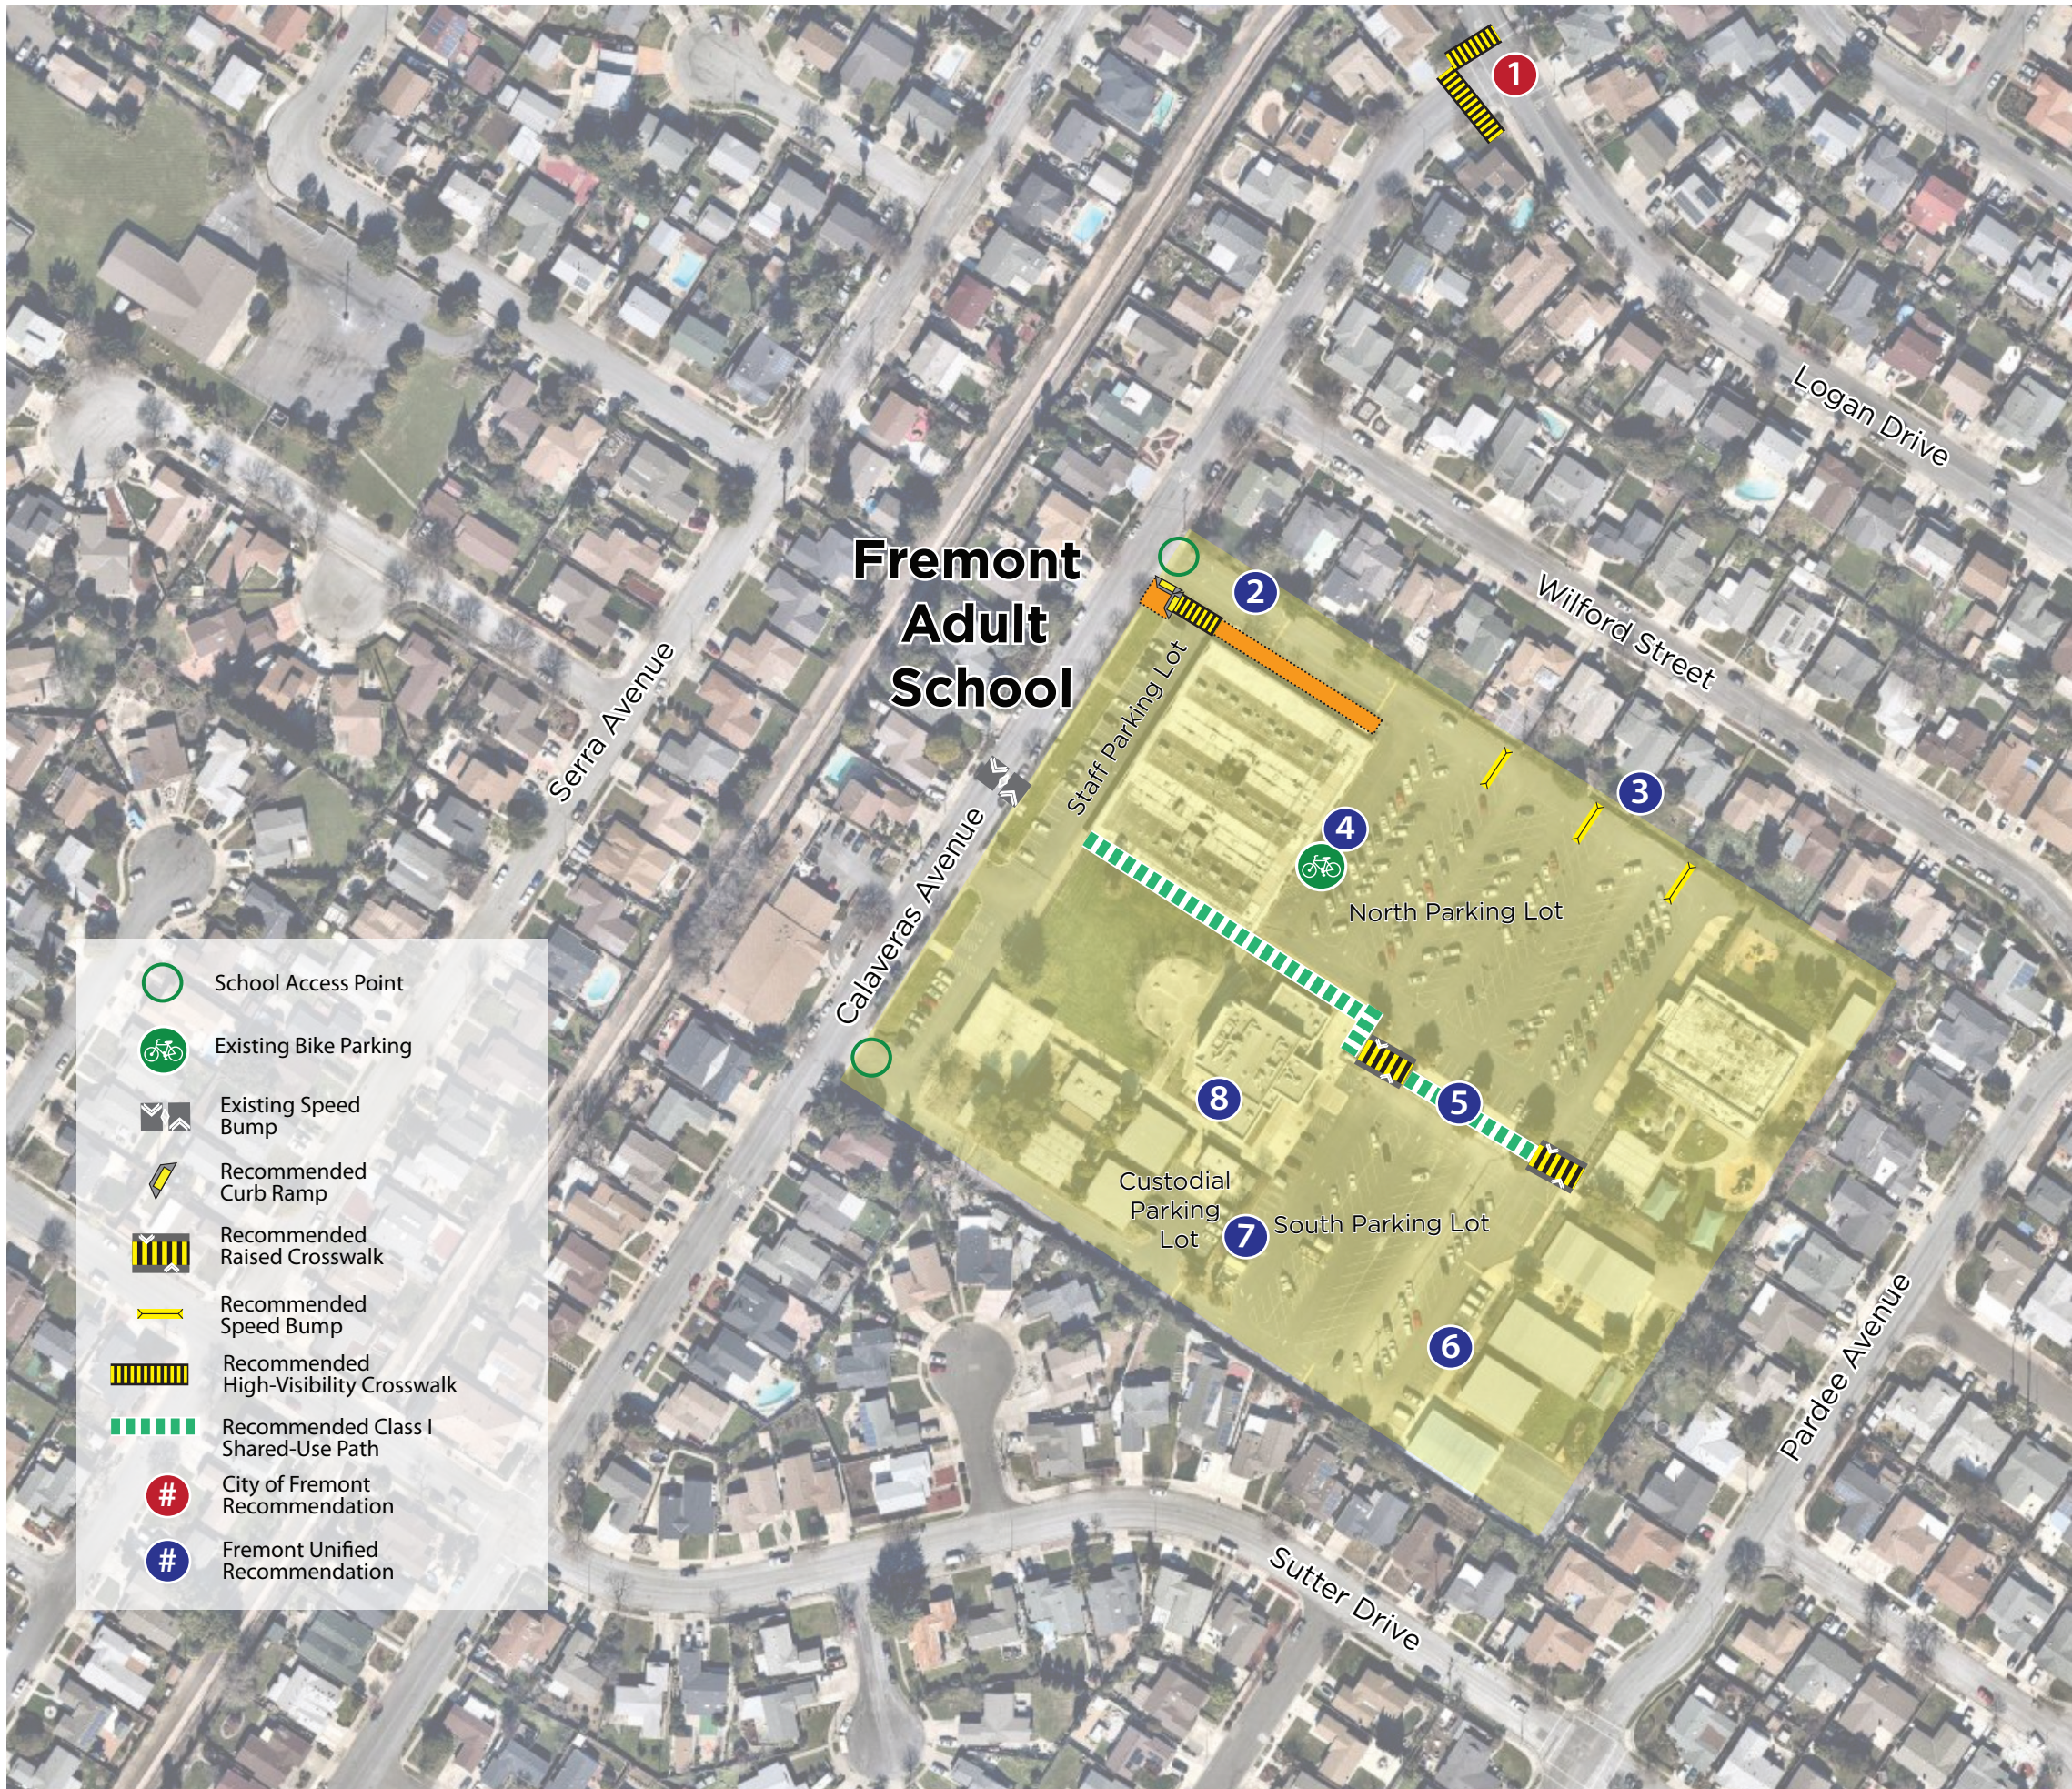
## Safe Routes to Schools Improvement Plan

- 1 Logan Drive/Calaveras Avenue**  
- Replace transverse crosswalks with high visibility crosswalks on the east and south approach of the Logan Drive/ Calaveras Avenue intersection.

- 8 Campus-wide**  
- Replace and install signage and wayfinding signs to provide clear guidance to people walking, biking and driving of various buildings or destinations on-site. Also, at driveway entrances install signage directing visitors to on-site visitor parking.
