**Grimmer School**  
**Fremont School Traffic Safety Assessment**  
**Technical Memo**

November 2017

Prepared by Alta Planning + Design

# Grimmer Elementary School

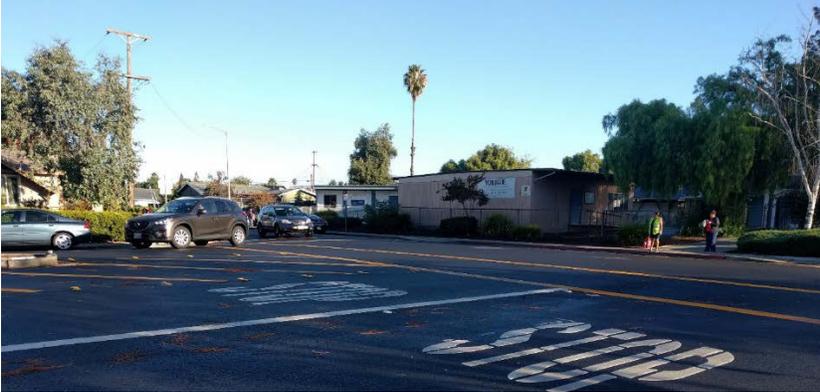
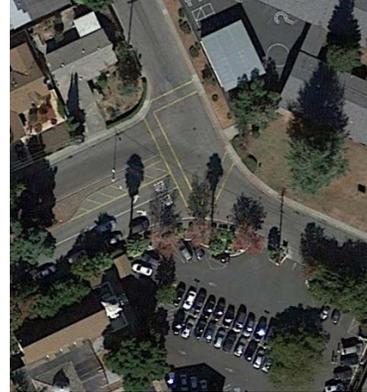
- ◆ This intersection had a high volume of pedestrian and vehicle activity during the drop-off period. Students and parents were seen walking from Delaware Drive, the northern approach of Newport Drive, and from the Vedic Dharma Samaj Fremont Hindu Temple parking lot to cross at this intersection.
- ◆ The approach from Delaware Drive is too wide given current vehicle turning needs. A former left turn pocket has become yellow crosshatched area, but may still be confusing for drivers. In addition, the right hand lane widens to nearly 30 feet in front of the crosswalk, encouraging vehicle speeding.

*Long crossing distance and excessive pavement across Delaware Drive at the Newport Drive and Delaware Drive intersection.*

- 3 Delaware Drive/Newport Drive**
  - Construct curb extensions at all approaches to shorten crossing distance and increase pedestrian visibility
  - Conduct a stop sign warrant study for an all-way stop at the Delaware Drive/Newport Drive intersection

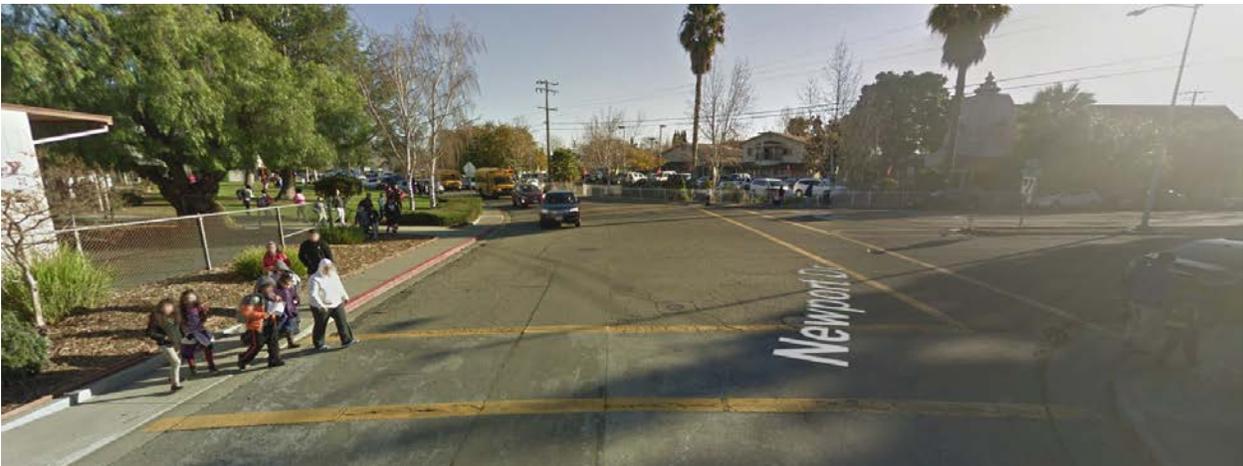
- ◆ Currently this intersection is a one-way stop, with a stop sign posted on the median and right-hand side of Delaware Drive. The right-side stop sign is obscured by trees and hedges. Pedestrian visibility at the intersection is hindered by parked cars.
- ◆ There is a transverse crosswalk at each approach. A crossing guard was at this location, and at intervals would pause vehicular traffic from all approaches to let pedestrians cross.
- ◆ There is a transverse crosswalk at each approach. A crossing guard was at this location, and at intervals would pause vehicular traffic from all approaches to let pedestrians cross.

*View of students crossing Newport Drive and Delaware Drive intersection looking east.*

- Trim vegetation and move stop sign on Delaware Drive to increase visibility of sign from the road
- 4 Charleston Way/Continental Drive**
  - Install a yellow transverse crosswalk across Continental Drive at Charleston Way

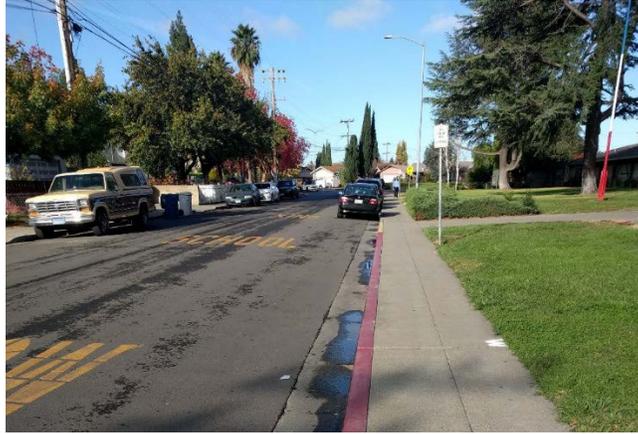
- ◆ Newport Drive in front of the school property is narrow, with one narrow lane in each direction.

*View of narrow Newport Drive from school property looking west.*

- ◆ During the drop-off period, Newport Drive in front of the school was backed-up with cars from the Newport Drive and Delaware Drive intersection. This back-up made it difficult for cars and buses parked on the curb to exit and also difficult for cars to exit the adjacent Temple parking lot.

- 4 Newport Drive**
  - Consider painting a red curb along Newport Drive in front of the school property
- 5 Drop Off Loop**
  - Consider removing "No Left Turn" and "Right Turn Only" signs from the parking loop exit to encourage vehicle flow away from the Delaware Drive/Newport Drive intersection

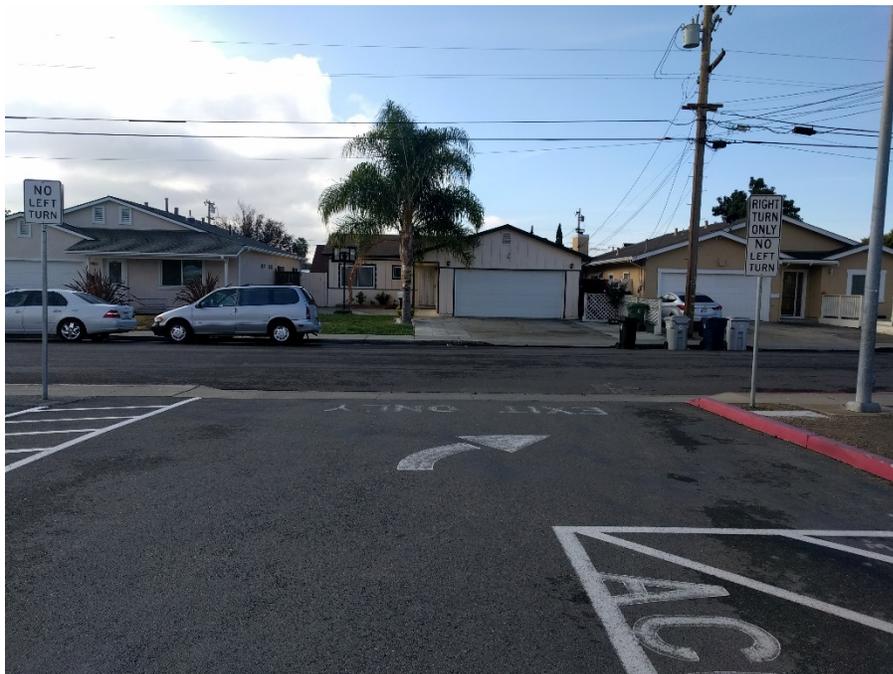
- ◆ The drop-off loop was not heavily used in the morning by parents. Staff indicated that it was more highly used in the afternoon.
- ◆ There is currently a “No Left Turn” sign at the exit of the drop-off loop. Some cars ignored this sign. Vehicles that turned right out of the parking lot would add to the back-up on Newport Drive from the Newport Drive and Delaware Drive intersection.

*No Left Turn and Right Turn Only signs visible from the drop-off loop exit.*

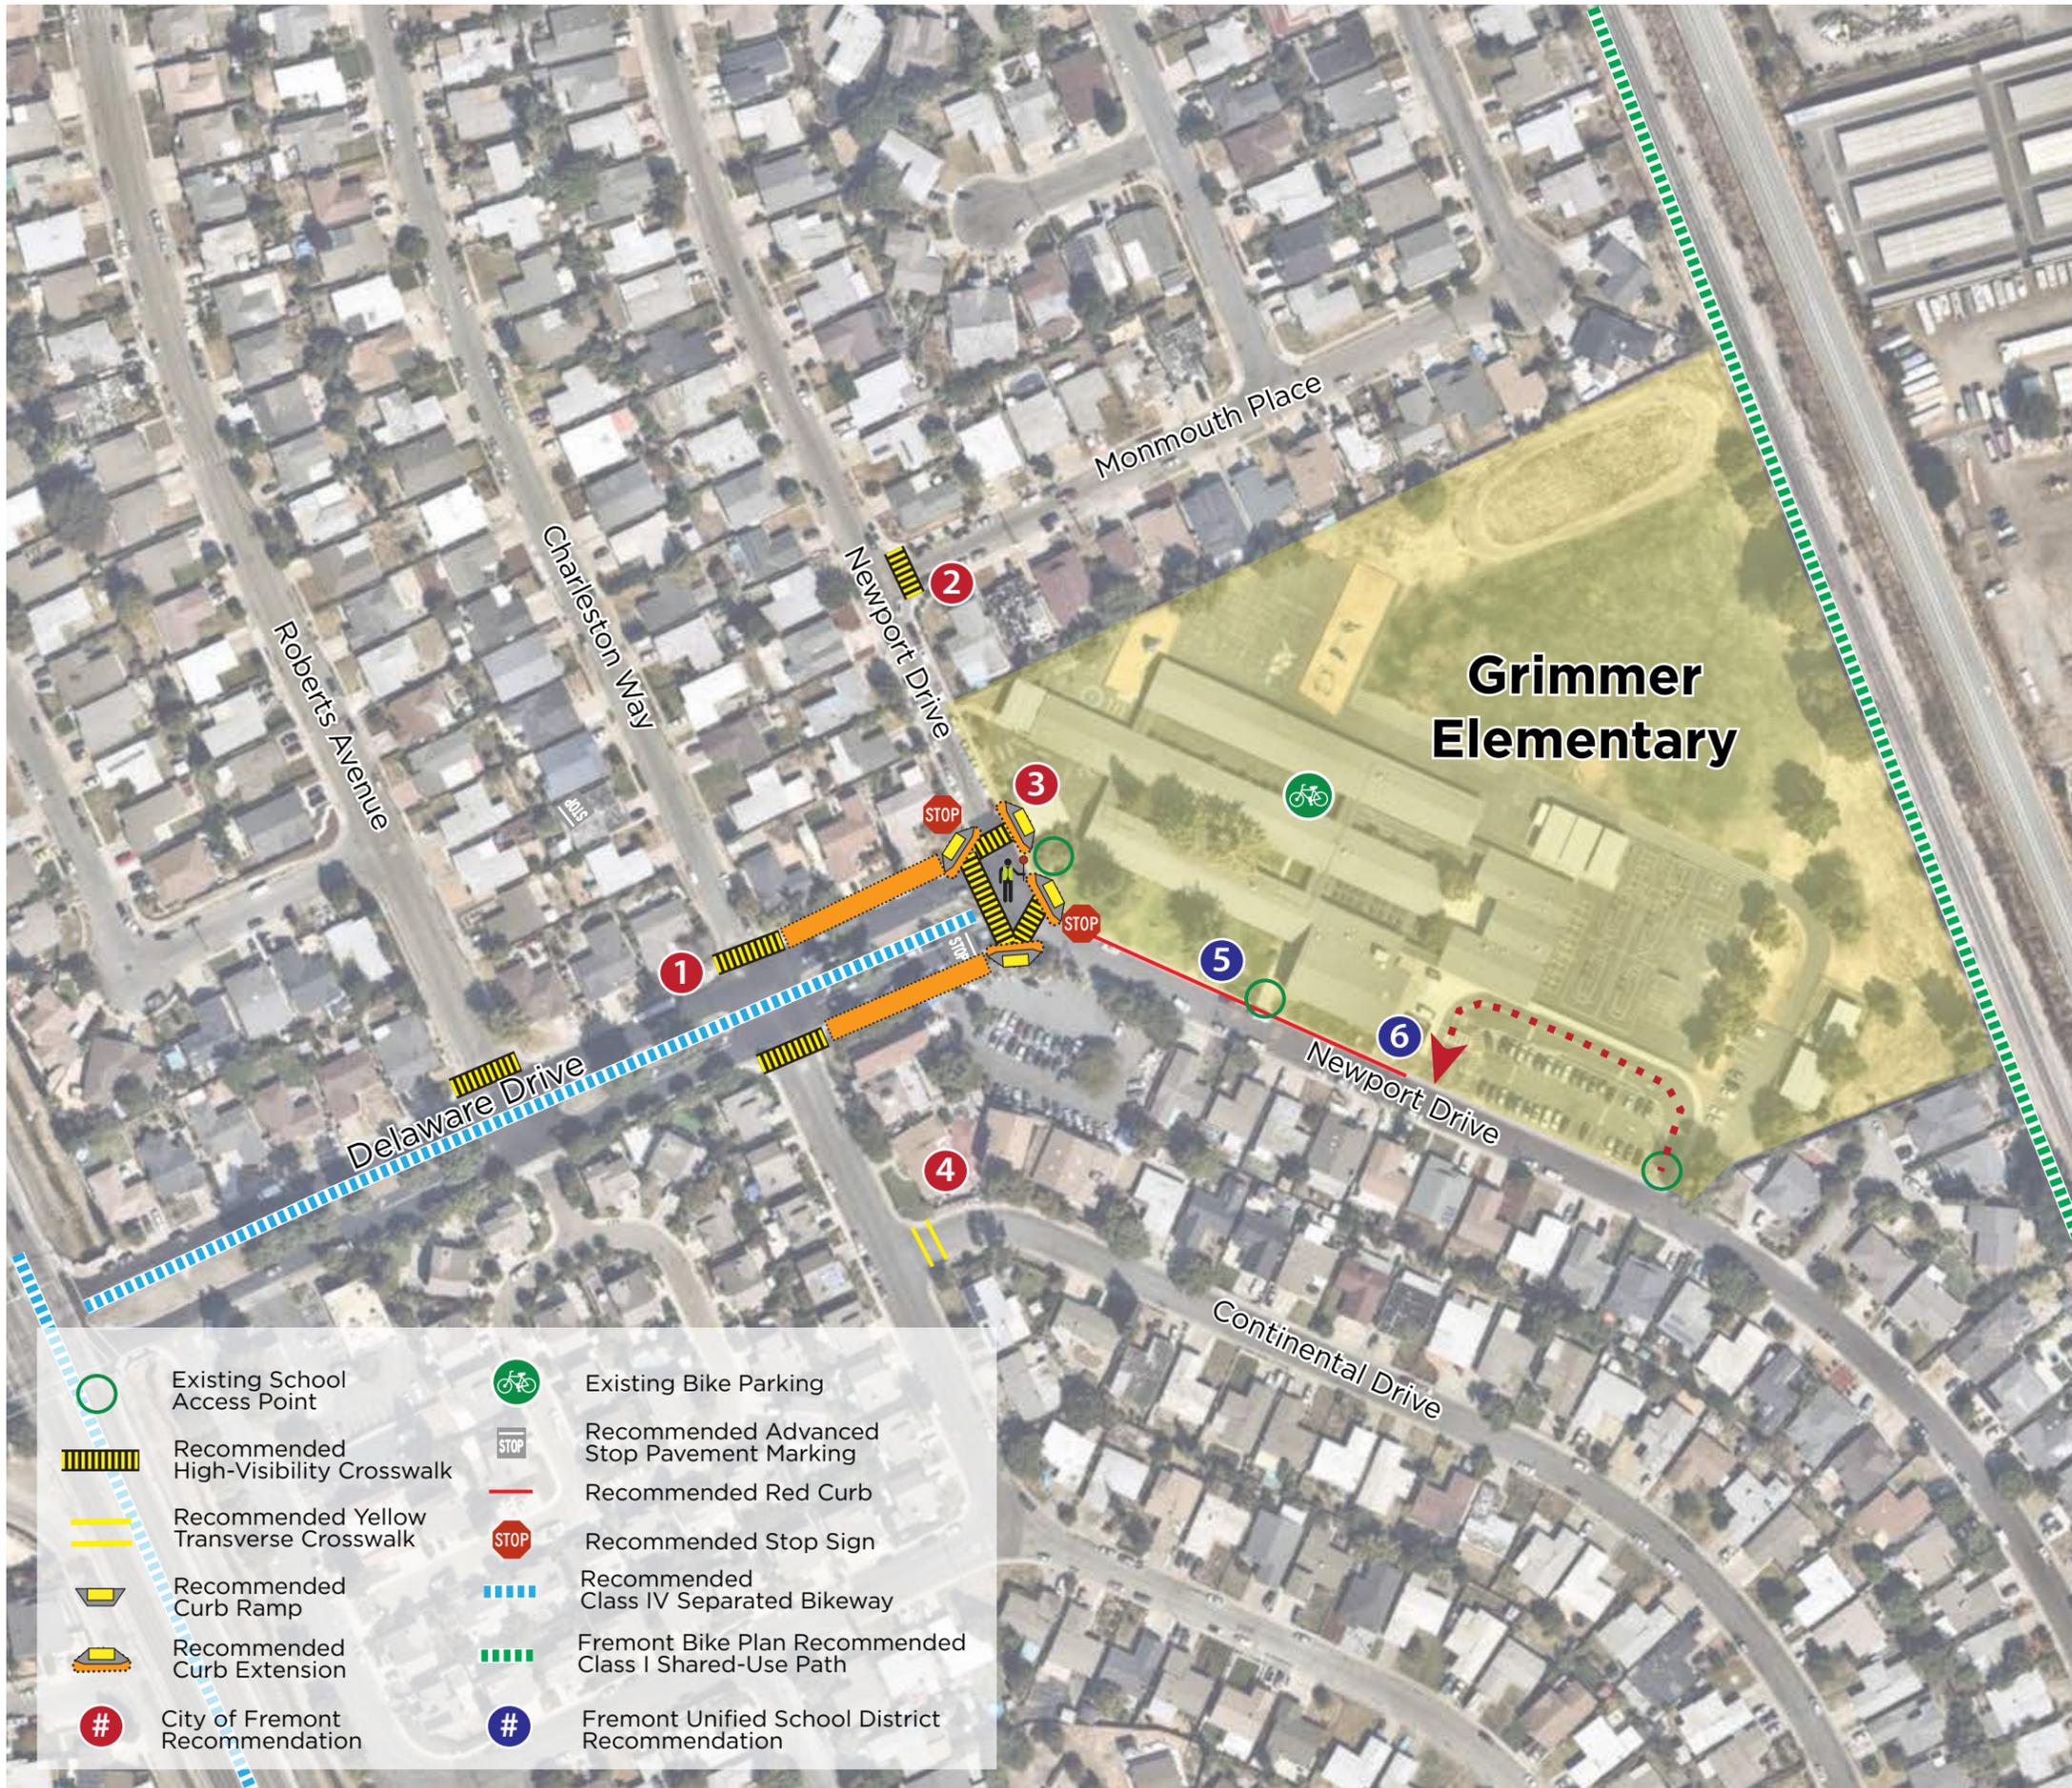
## Safe Routes to Schools Improvement Plan

- 1 Delaware Drive**
  - Replace transverse crosswalks on Delaware Avenue across Charleston Way and Roberts Avenue with high visibility crosswalks
  - Consider widening sidewalks between Newport Drive and Charleston Way to accommodate for higher pedestrian flow

- Consider removing one travel lane in each direction and installing Class IV separated bikeways on Delaware Drive
- 2 Newport Drive/Monmouth Place**
  - Install high visibility crosswalk across Monmouth Place at the intersection with Newport Drive
