Parkmont Elementary School Existing Conditions Summary

Prepared by Alta Planning + Design

Parkmont Elementary School

A School Safety Assessment (SSA) was conducted at Parkmont Elementary School during the morning arrival on Wednesday, March 21, 2018. The assessment was attended by representatives from the City of Fremont, Alta Planning + Design, and Parkmont Elementary staff.

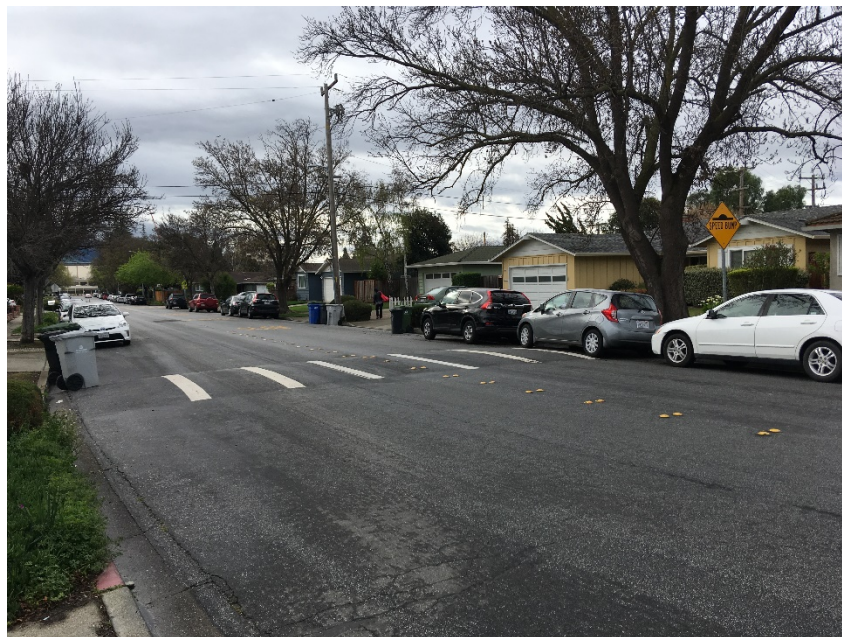
1. Parkside Drive

- ◆ Many parents turn off Mowry Avenue to access Parkside Drive and the east drop-off loop.
 - Vehicles were backed up on Parkside Drive, at one point near the intersection of Mowry Avenue and Parkside Drive.
- ◆ Some parents were observed parking on Parkside Drive or in nearby parking lots and walking with their students to campus. Two cars unloaded students while waiting in traffic on Parkside Drive.
- ◆ There is a speed hump near the east drop-off loop that has non-CA MUTCD compliant striping.

Speed hump with non-CA MUTCD compliant striping.

- 1 Parkside Drive School Frontage**
- Restripe the two speed humps along Parkside Drive school frontage with CA MUTCD compliant striping.
- 2 Parkside Drive/Acacia Street**
- Install curb extensions on each corner of the intersection to shorten crossing distances across Parkside Drive.
- Install high visibility crosswalks across north, east, and south approaches.
- 3 Parkside Drive/Bronson Street**
- Install high visibility crosswalk across Bronson Street.
- 4 Parkside Drive/Country Drive**
- Install advance yield signs and pavement markings on Parkside Drive approaches.
- Install "No Stopping Anytime" signs on Country Drive approaching Parkside Drive to obtain 20' clear space.
- 5 West Drop-off Loop**
- Consider extending white curb for drop-off curb further towards exit to allow for more cars to drop off at the same time.

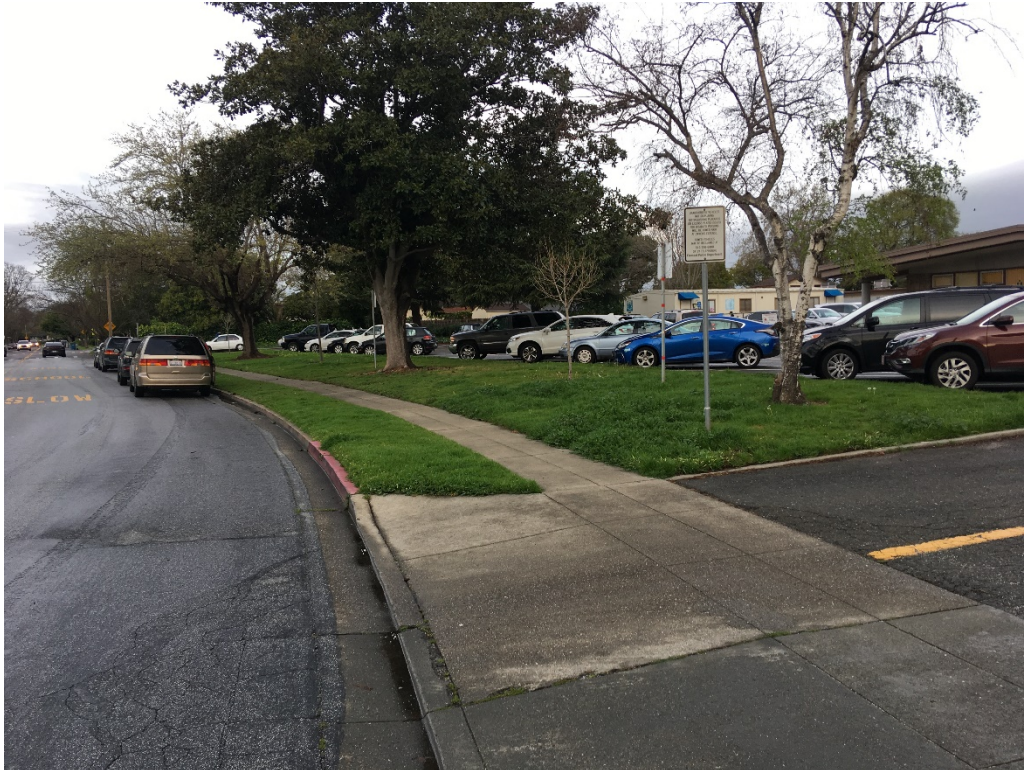
2. Parkside Drive School Frontage

- ◆ Parking is allowed on both sides of Parkside Drive in front of the school. Assessment participants observed teachers using this area for parking, as well as a few parents parking and walking with their students to school. Some parents parked on the opposite curb from the school and crossed with their children.
 - There is low volume of through traffic due to the two drop-off loops that direct traffic away from the school's frontage.

Parents and teachers were observed parking along the school frontage.

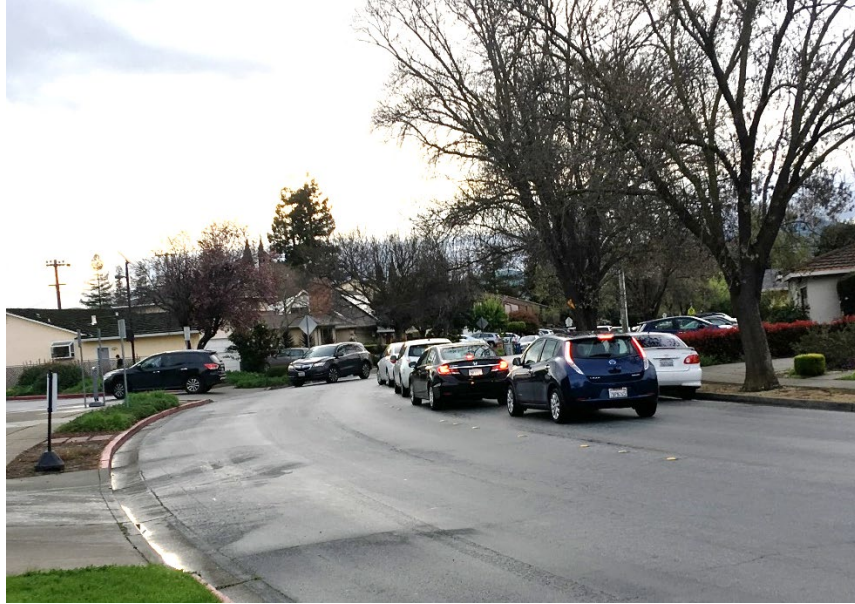
3. East Drop-off Loop

- ◆ Families driving are instructed to take a right turn into this loop and then a left out of the loop; parents mainly adhered to the rule. A parent volunteer with student volunteers helped open doors as a valet to facilitate an efficient drop off flow.

Vehicles waiting to turn into the east drop-off loop also delays through traffic.

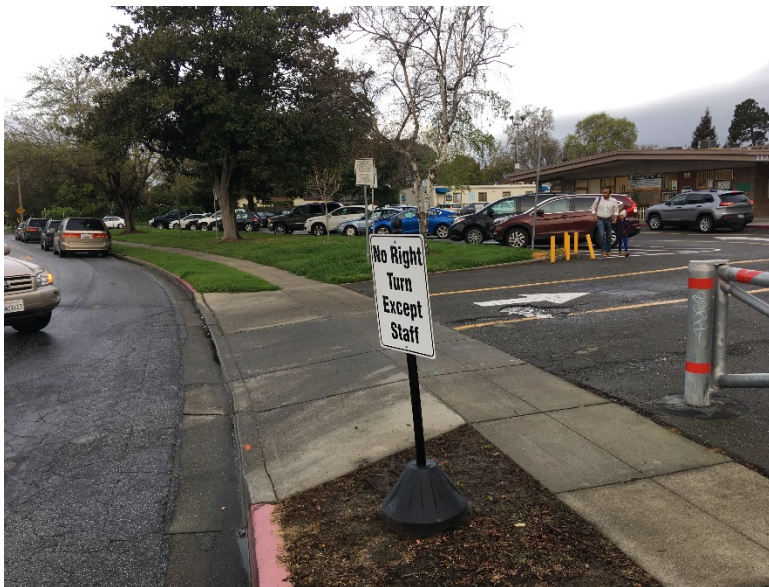
4. West Drop-off Loop

- ◆ Parents are instructed to take a left into this loop and a right turn out of the loop, which they mainly adhered to. There is a part of the curb that is designated for loading and unloading, and a volunteer parent and student were present to help open doors of unloading vehicles.
- ◆ The entrance to a staff parking lot reduces the frontage available for loading and unloading in this loop.

The west drop-off loop instructs families that there are no right turns into the loop.

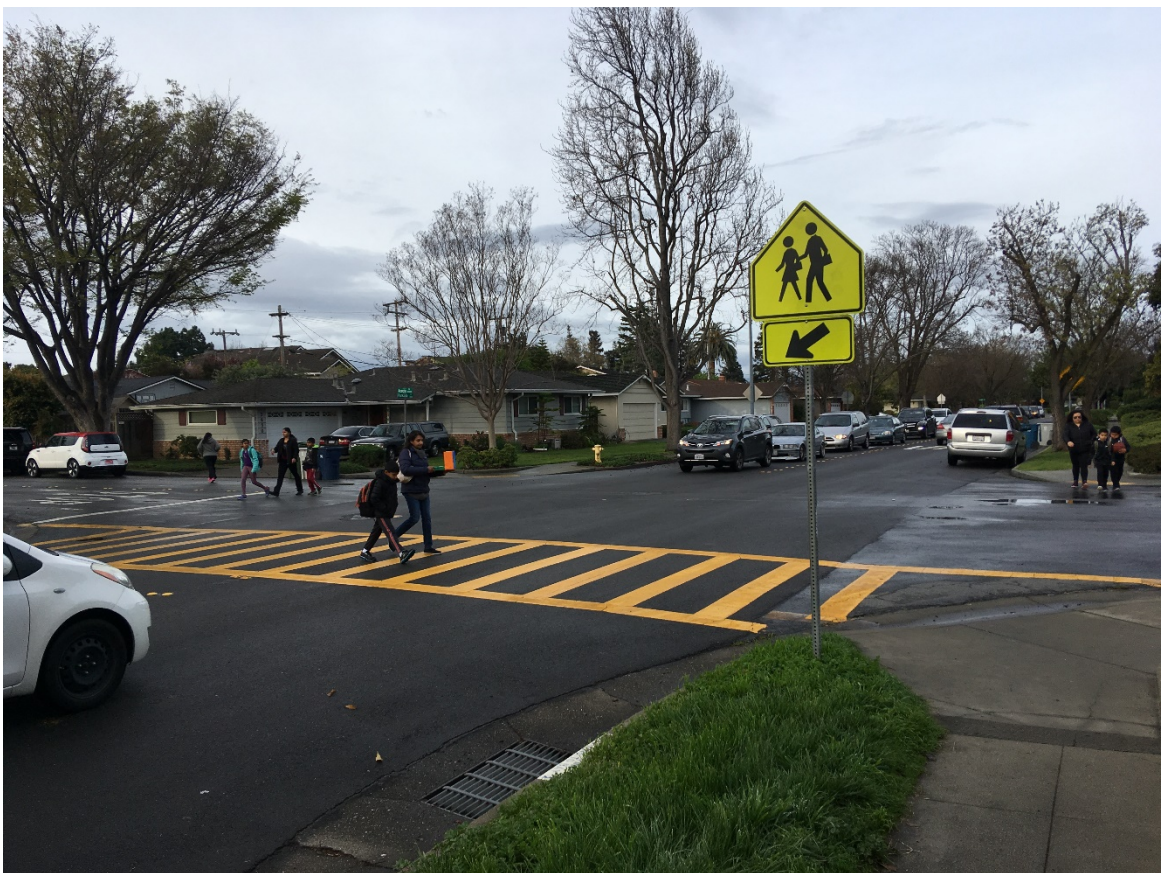
5. Parkside Drive/Acacia Street

- ◆ Families walking use the Parkside Drive/Acacia Street intersection to cross. There is currently only one transverse crosswalk, across Parkside Drive (east approach). The principal indicated that sometimes there is a crossing guard at this location, but there was no one present on the day of the assessment.
- ◆ With high volumes of students and parents crossing on foot, cars sometimes backed up at all approaches.
- ◆ SSA Participants noted that parents would park alongside Parkside Drive and Acacia Street on either side of the intersection to walk with their children to school.
- ◆ There are parking restrictions on the curbs on Parkside Drive closest to the school.
- ◆ On all corners, vehicles were observed parking close to the curb cuts, and this reduced visibility of those crossing on foot.

Families walk on the crosswalk across Acacia Street at the Acacia Street/Parkside Drive intersection.
