Walters Jr. High School

Existing Conditions Summary

January 2019

Prepared by Alta Planning + Design

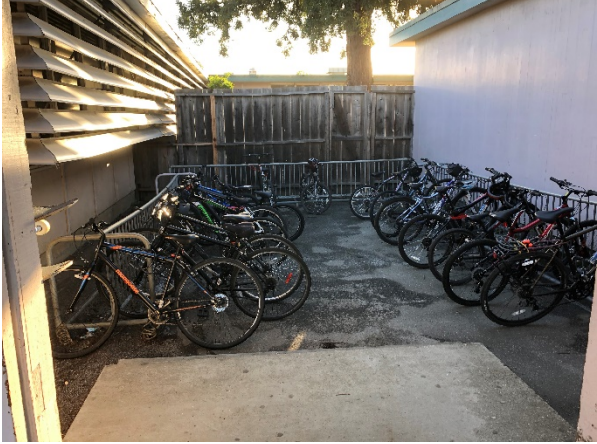
<p>How do school and transit buses interact with the school?</p>	<p>School buses have their own driveway/drop-off area separated from parent pick-up and drop-off.</p> <p>There is little transit use at Walters Junior High.</p>
<p>Does the school have special pick-up/drop-off policies/procedures?</p>	<p>The school has a drop-off loop for private vehicles, a loop for buses, and a path (part paved, part dirt) for access from the rear of the school from Bidwell Drive.</p>

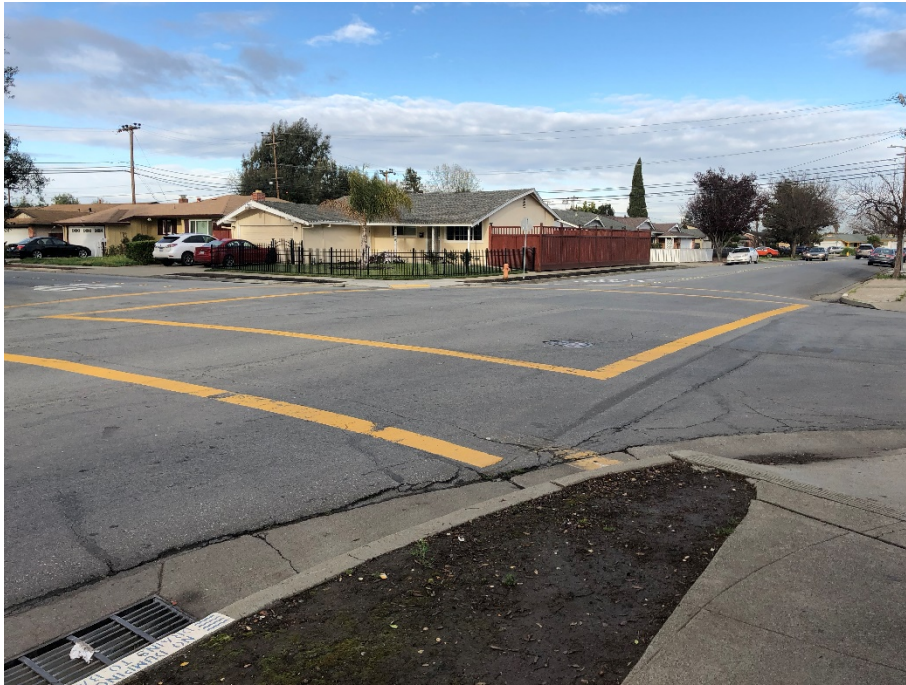
2. Sundale Drive/Logan Drive

- ◆ This intersection is currently all-way stop controlled.
- ◆ Assessment participants reported that this is a very busy intersection during pick-up and drop-off periods in all directions.

- ◆ It was observed that rolling stops (not completely stopping at a stop sign) were very common at this intersection.
- ◆ The high volume of vehicular traffic causes many conflicts with both pedestrians and bicyclists traveling through this intersection.
- ◆ Walters school staff reported that more pedestrians cross at the Logan Drive/Sundale Drive intersection than at the Logan Drive/Sloan Street intersection.
- ◆ Walk audit participants also observed that some cars failed to yield, not waiting for pedestrians.

The intersection of Sundale Drive and Logan Drive.

- 1 Sundale Drive/Logan Drive**
 - Refresh/install new advance stop markings (with stop bar) at all intersection approaches.
 - Upgrade existing yellow transverse crosswalks to yellow high visibility crosswalks.

- Install curb extensions at the two eastern corners.
- 2 Sloan Street/Logan Drive**
 - Install a curb extension on the eastern, school side, of the existing crossing. This would improve pedestrian visibility for cars traveling along Logan Drive and exiting the driveway.

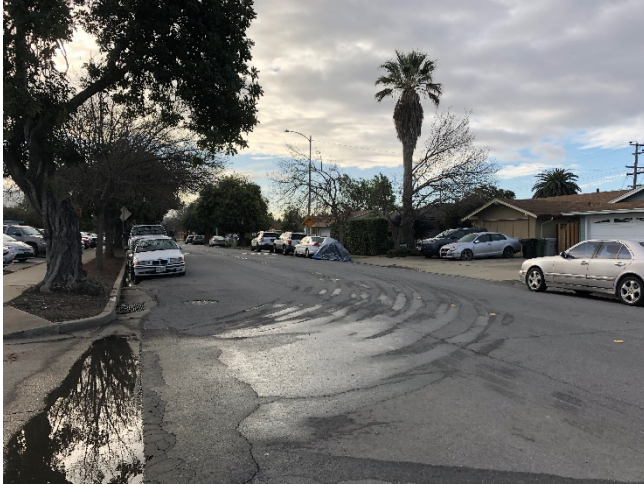
- ◆ Logan Drive is the primary north-south corridor near school and serves as the primary point of access for the majority of students, families, and staff.
- ◆ During both pick-up and drop-off periods, traffic on Logan Drive can back-up, limiting available roadway for through movements.
- ◆ Curb space between the two drop-off loop driveways is used for pick-up and drop-off.
- ◆ School staff reported that midblock crossings, by both students and families, occurs regularly across Logan Drive.
- ◆ Participants observed that cars will speed along Logan Drive if there isn't a back-up of cars.
- ◆ Walters staff also reported that cars will regularly perform U-turns on Logan Drive, especially from the curbside drop-off.

Left: Looking east from the bus loop exit driveway along Logan Drive.

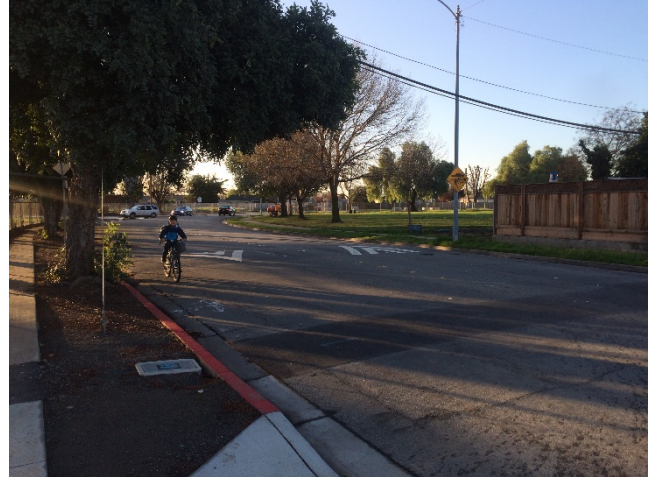
Right: Looking east from the parent drop-off loop driveway exit on Logan Drive.

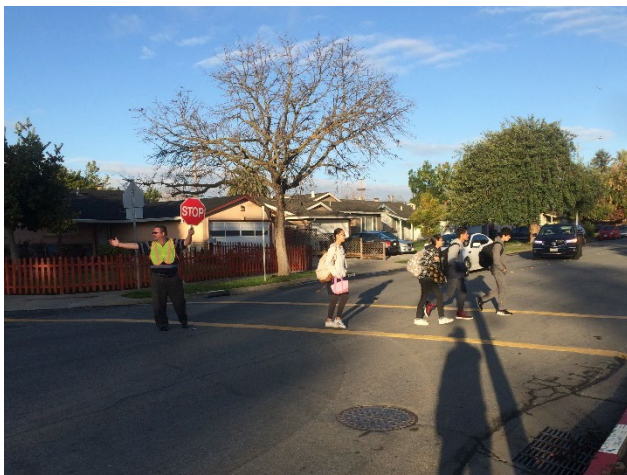
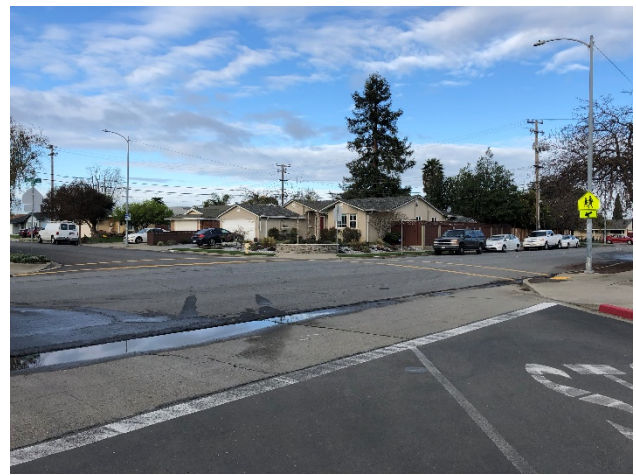
4. Logan Drive/Sloan Street

- ◆ Logan Drive/Sloan Street is an uncontrolled T-intersection with two marked transverse crossings.
- ◆ This is a highly used crossing location for pedestrians.
- ◆ A crossing guard serves this intersection during the morning arrival period, but not in the afternoon.
- ◆ Assessment participants reported that the crosswalk across Logan Drive can be hard to see for some drivers as they can be looking into direct sunlight as they approach; reducing their visibility of potential pedestrians and bicyclists.
- ◆ There is a relatively high number of pedestrians that walk along Sloan Street to get to/from Walters.
- ◆ There is an existing “School Zone” sign on light pole 1864. There is a “School Assembly B” sign at the crosswalk.

Left & Right: The Logan Drive crossing at the Sloan Street intersection.

- Upgrade both existing transverse crossings to high visibility crosswalks.
 - Install advance yield markings and signs on Logan Avenue approaches.
 - Install a stop sign at the Sloan approach of this intersection.

- Trim vegetation along Sloan Street to increase sign visibility.
 - Install School Assembly D sign on Sloan Street in advance of the crosswalk.
- 3 Nelson Street/Logan Drive**

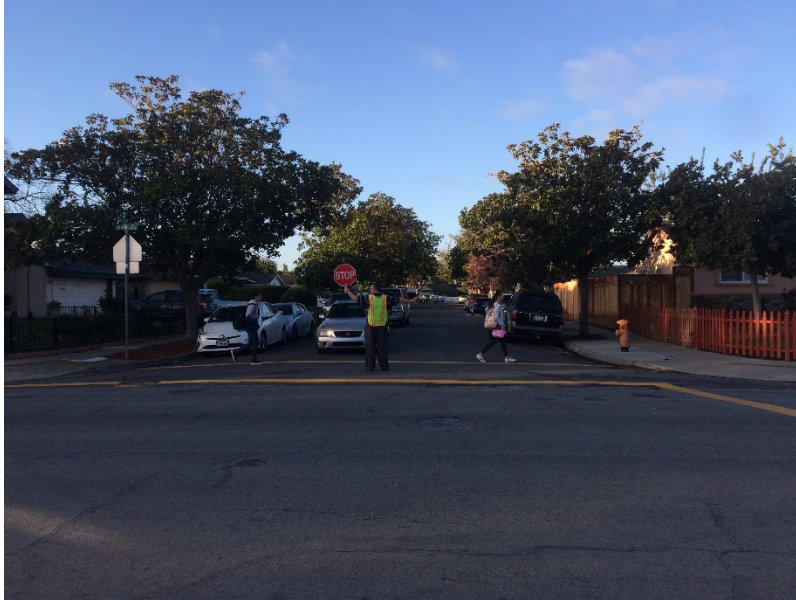
The crossing guard crossing students across Sloan Street.

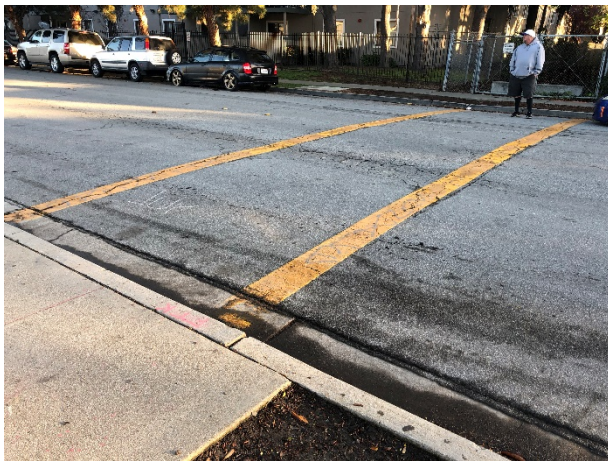
- ◆ Bidwell Drive is located at the back of the school, separated from campus by a row of single-family houses.
- ◆ There is a paved path that leads to campus from the sidewalk to the fields. Once reaching the field, it transitions to an unpaved dirt path.
- ◆ This area is monitored by two staff members in the morning who help students cross an existing transverse crossing. The location is only staffed during the morning arrival period.
- ◆ Those staff members reported that cars will sometimes not yield to pedestrians and that some parents will stop at the crosswalk, without pulling over, and drop their child off.
- ◆ This crosswalk does not have curb ramps on either side.

- ◆ Cars were observed parking very close to the crosswalk, and school staff reported that this parking behavior is normal and that cars have previously parked in the crosswalk itself. The curbs are not painted red and there are no “No Parking” signs.

Top Left: The transverse crossing across Bidwell Drive, with a school staff member.

- Upgrade existing transverse crosswalk to high visibility crosswalk.
 - Install curb extensions on both sides of the crosswalk to increase pedestrian visibility and keep parked cars further away.

- Install "No Stopping" signs around the crosswalk.
 - Install School Assembly B sign for southbound traffic at the Bidwell Drive crossing.
 - Update the existing advance crossing signs to School Zone or School Assembly D signs.

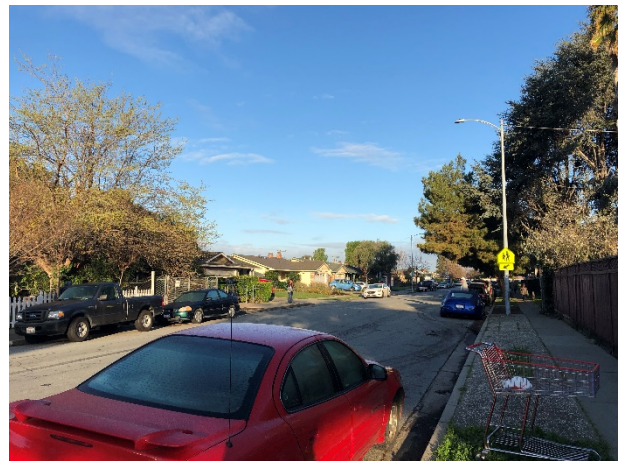
- ◆ The crossing of Tehama Avenue is not marked and there are no curb ramps at this intersection.
- ◆ There are outdated advance crossing warning signs on the light pole near 4448 Bidwell and 4319 Bidwell. Additionally, there is only an “Assembly B” sign for westbound traffic at the crosswalk.

Top Right: Looking west towards the Bidwell Drive crossing.

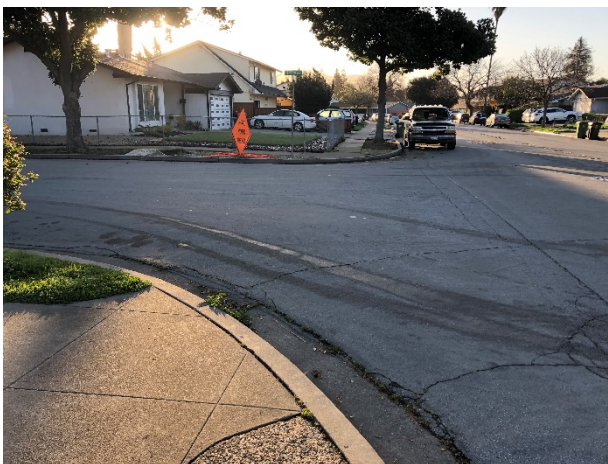
Bottom Left: The unmarked crossing and missing curb ramps at the Tehama Ave. intersection.

- Install a high visibility crosswalk across Tehama Avenue
 - Curb ramps should be installed with the crosswalk.
- 5 Bidwell Drive**
 - LONG TERM: As a part of the school's expansion, formalize the dirt path connecting Bidwell Drive to the campus by upgrading it to a more weather resistant material (asphalt, decomposed granite, etc.).

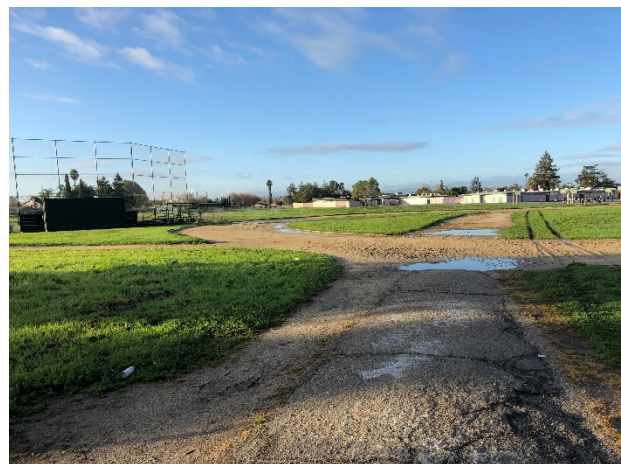
- ◆ Students were observed walking on both sides of Bidwell Drive to reach the school access gate.
- ◆ The path through the school fields is dirt and does not handle water well. This results in puddles and mud through the path.

Bottom right: The field path was muddy and full of puddles after a recent rain.

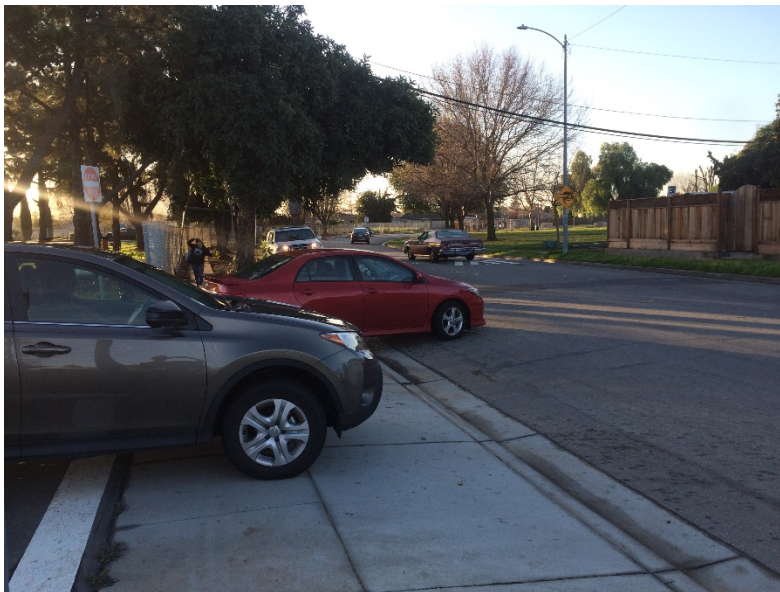
8. Drop-off Loop

- ◆ The parent drop-off loop has two exit lanes, allowing for cars to more quickly exit the loop, regardless of left or right turn.
- ◆ School staff reported that the loop generally flows fairly well.

Cars exiting the parent drop-off loop (two marked lanes).

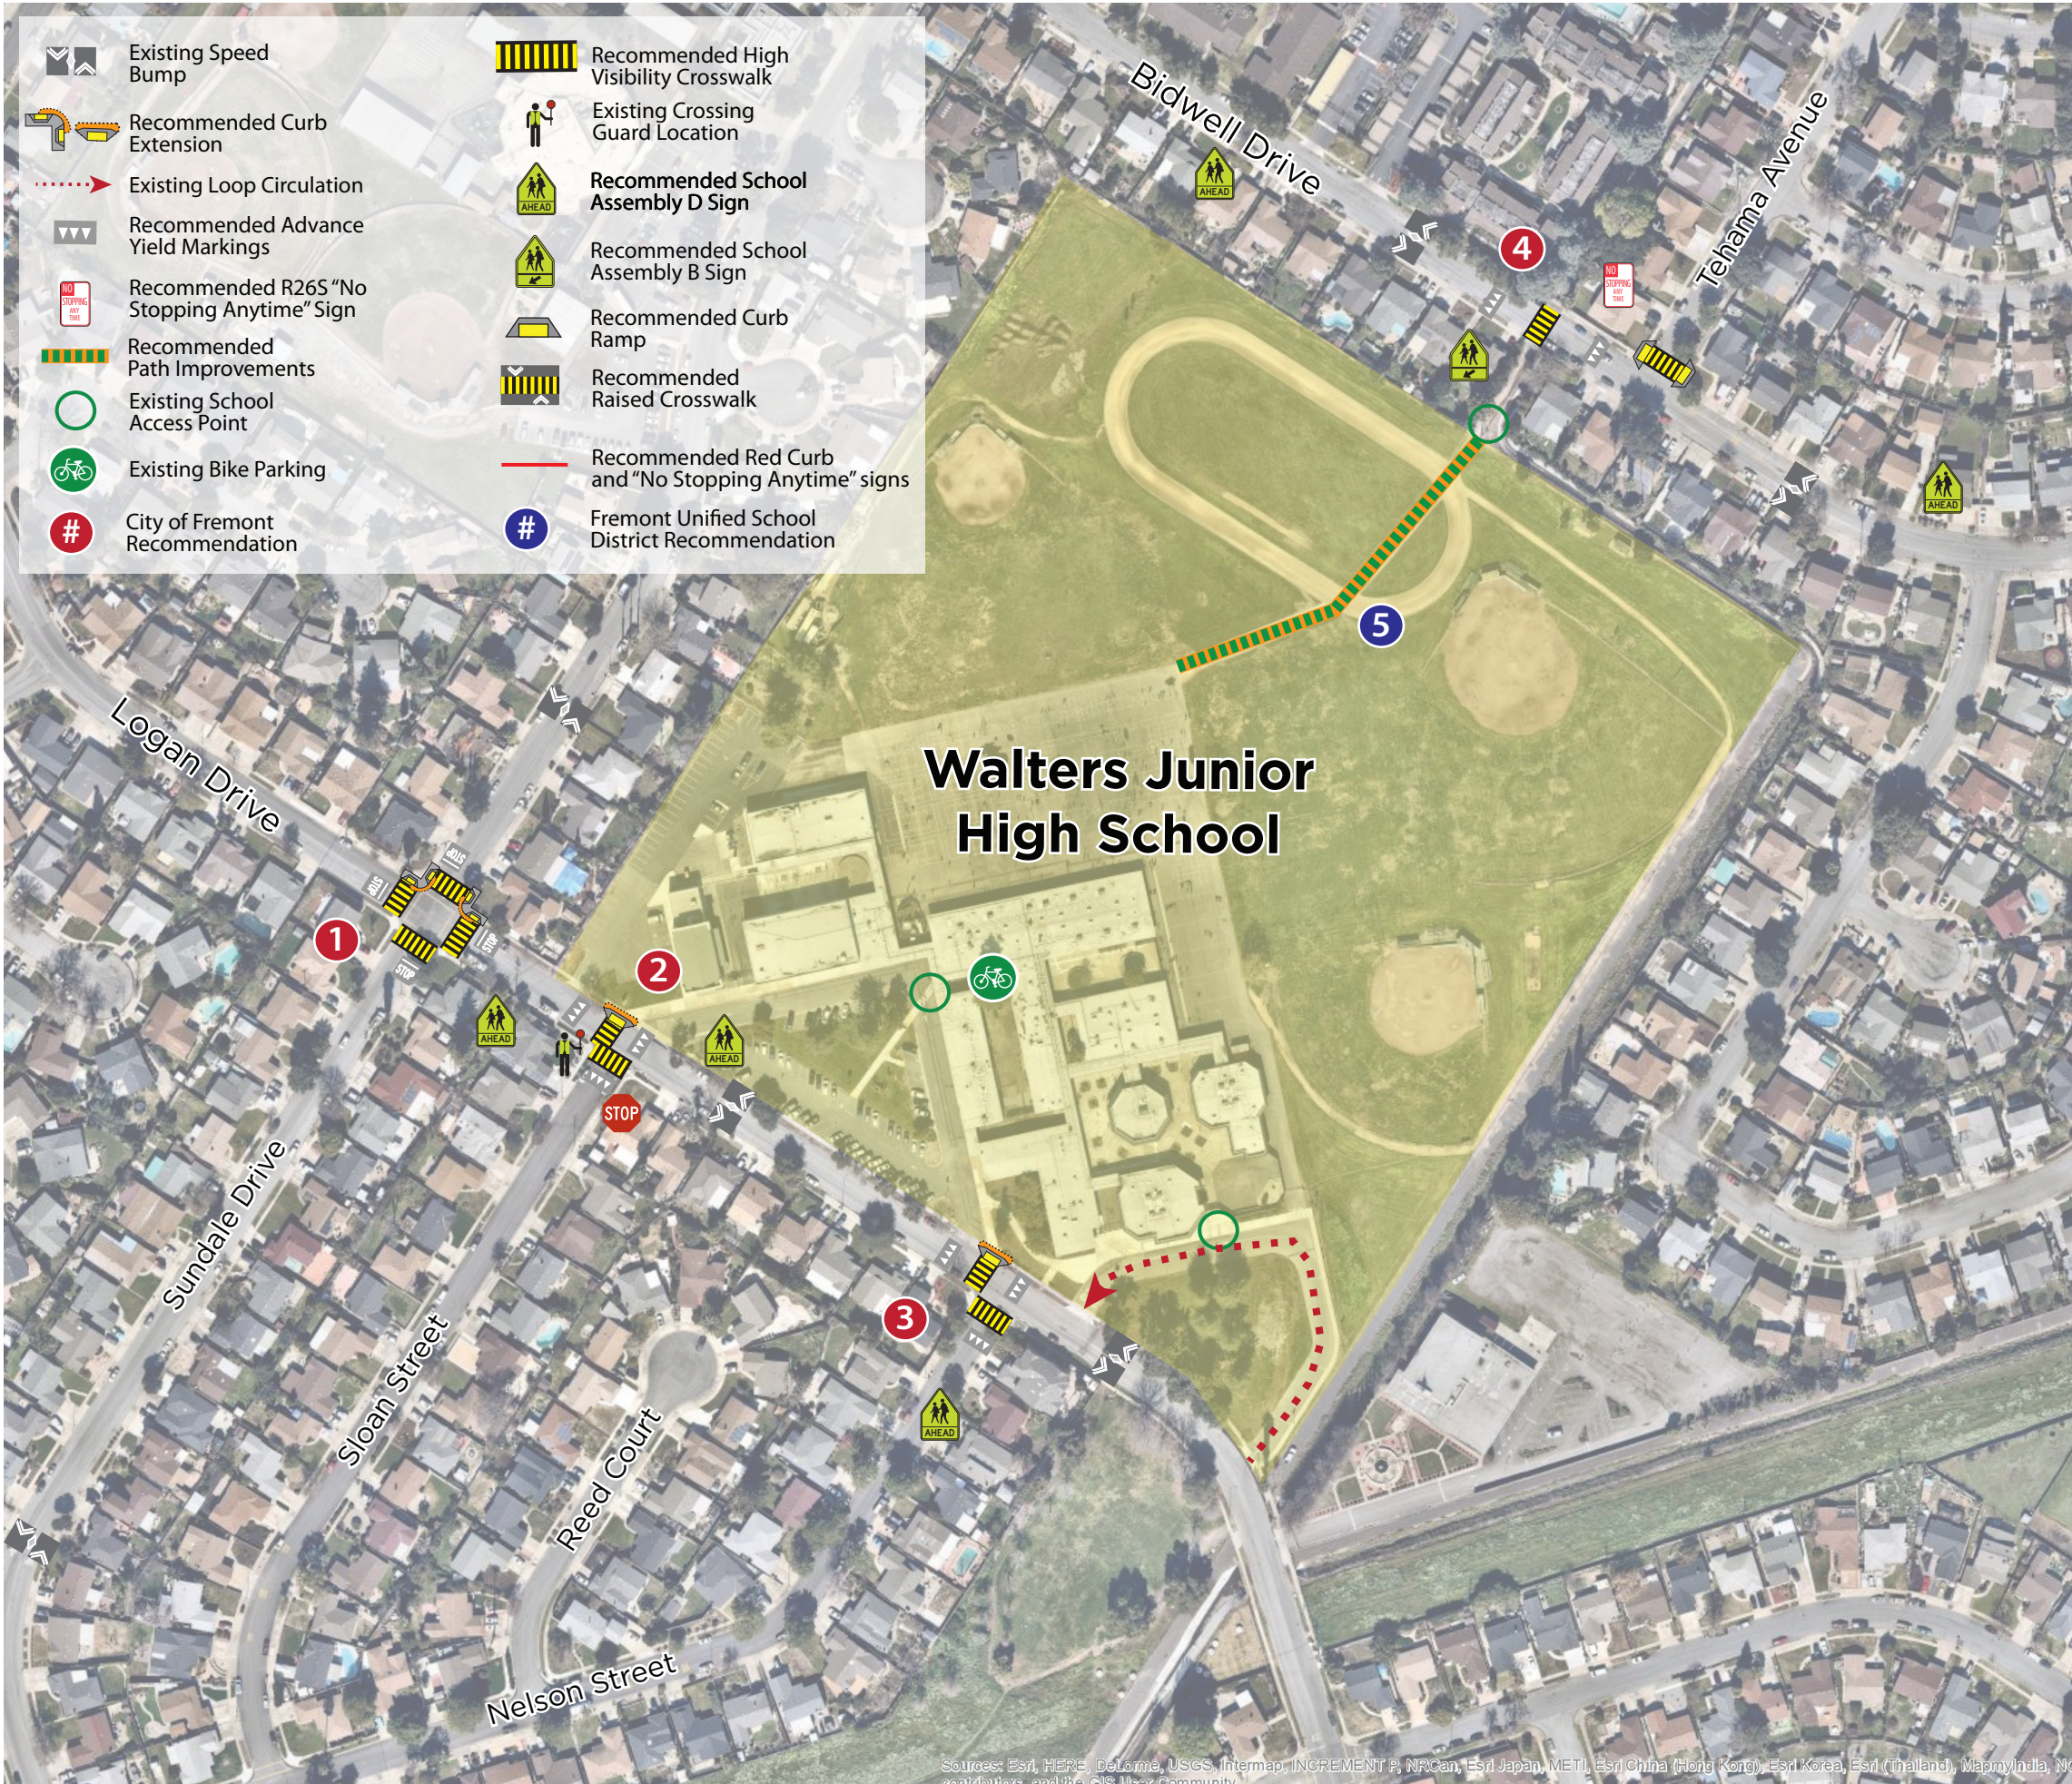
Safe Routes to Schools Improvement Plan

- Install curb extensions on the school side of the Logan Drive crossing to increase the visibility of pedestrians at both crossings.
 - Upgrade both crosswalks to high visibility crosswalks.

- Install advance yield markings at all approaches.
 - Install School Assembly D signs on Nelson Street in advance of the crosswalk.
- 4 Bidwell Drive**
