## CONDITIONS ASSESSMENT & TREATMENT RECOMMENDATIONS

RODRIGUES FARMHOUSE PROPERTY  
41948 MISSION BOULEVARD, FREMONT  
APN 513-450-4-2  
CITY OF FREMONT PROJECT #: PLN2018-0013  
[17267]

PREPARED FOR:  
CITY OF FREMONT

JANUARY 24, 2018

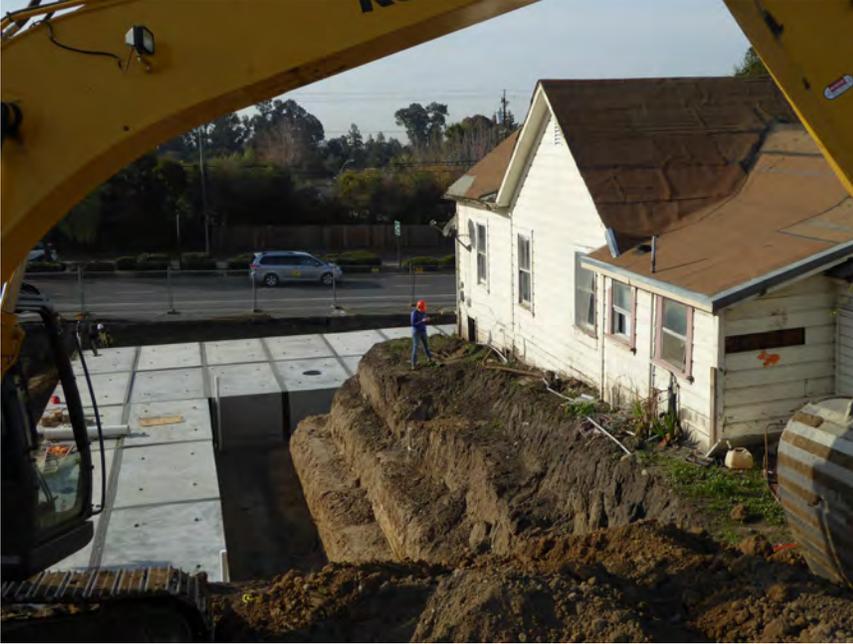
Owing to the adjacent construction of a landscaped bioswale and nearby homes, the site characteristics of the Rodrigues Farmhouse are in poor condition, per the definition above. In addition to the demolition of the shed-and-storage building, all remnants of the house yard have been removed to allow for digging and a construction drive.

Image 4 - View along the south side of the farmhouse, to the west.

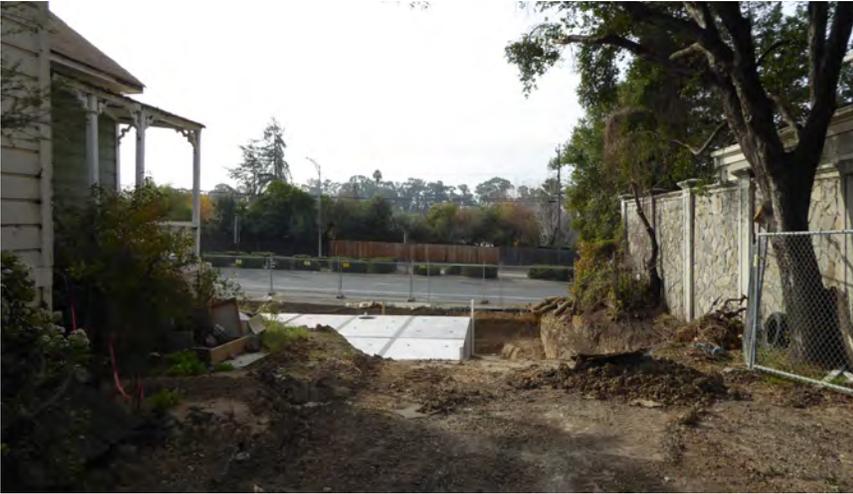
Image 5 - View along the north side of the farmhouse, to the west.

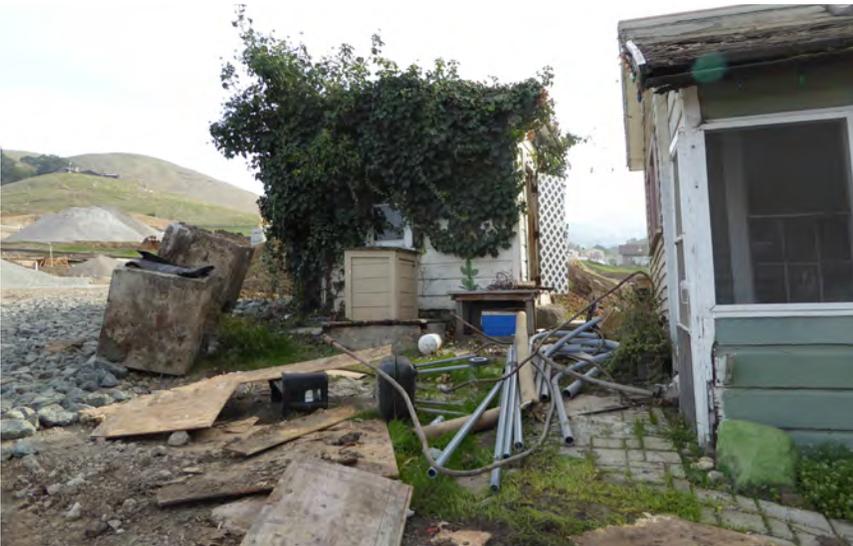
Image 6 - View along the east side of the farmhouse, to the south.

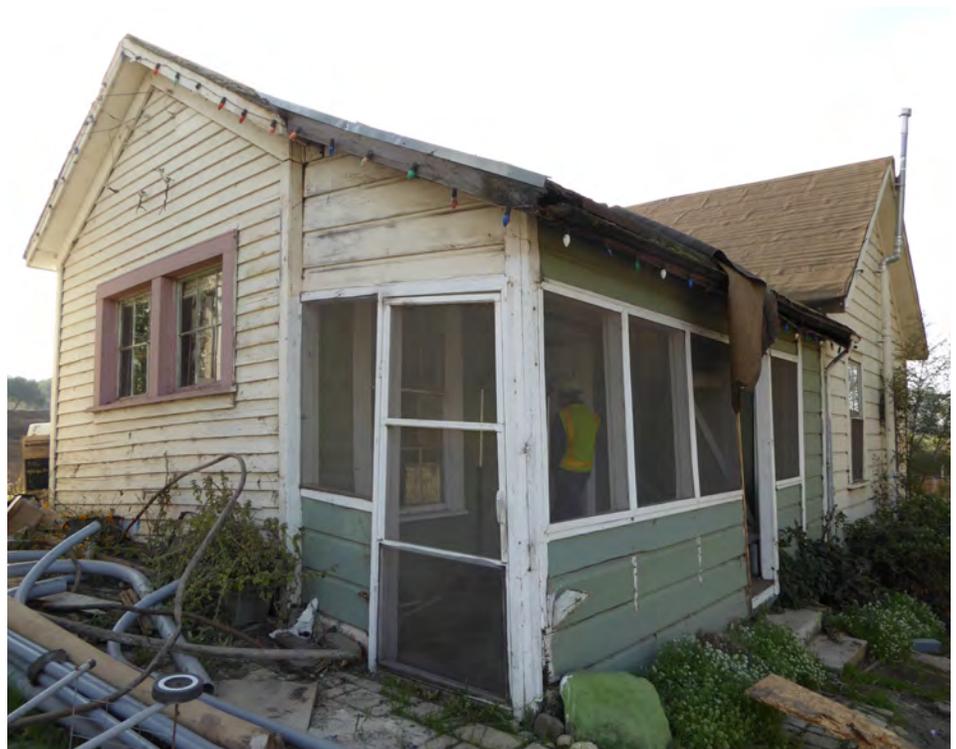
The open porch and screen porch are each in poor condition.

Image 15 - (prior page, top left) The open porch.

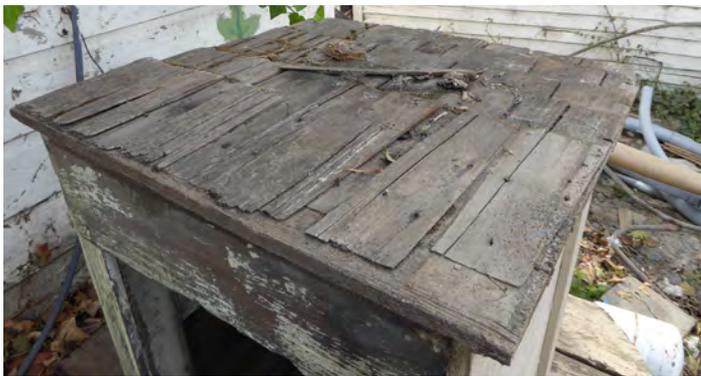
Image 31 - (middle left) The roof of the pumphouse.

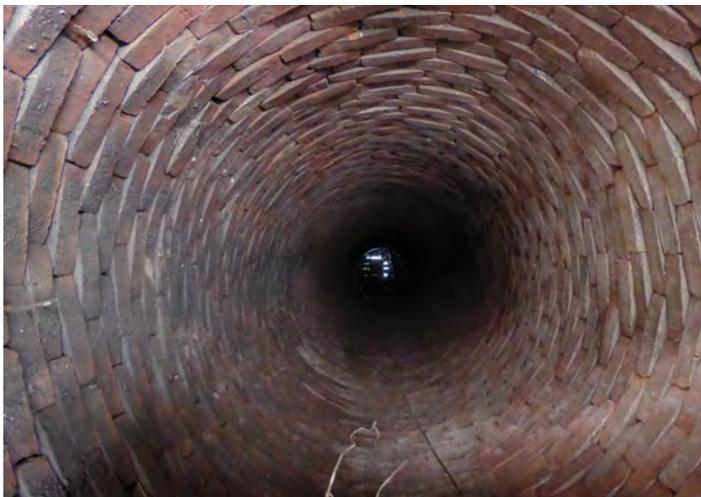
Image 32 - (bottom left) The brick well below the pumphouse.

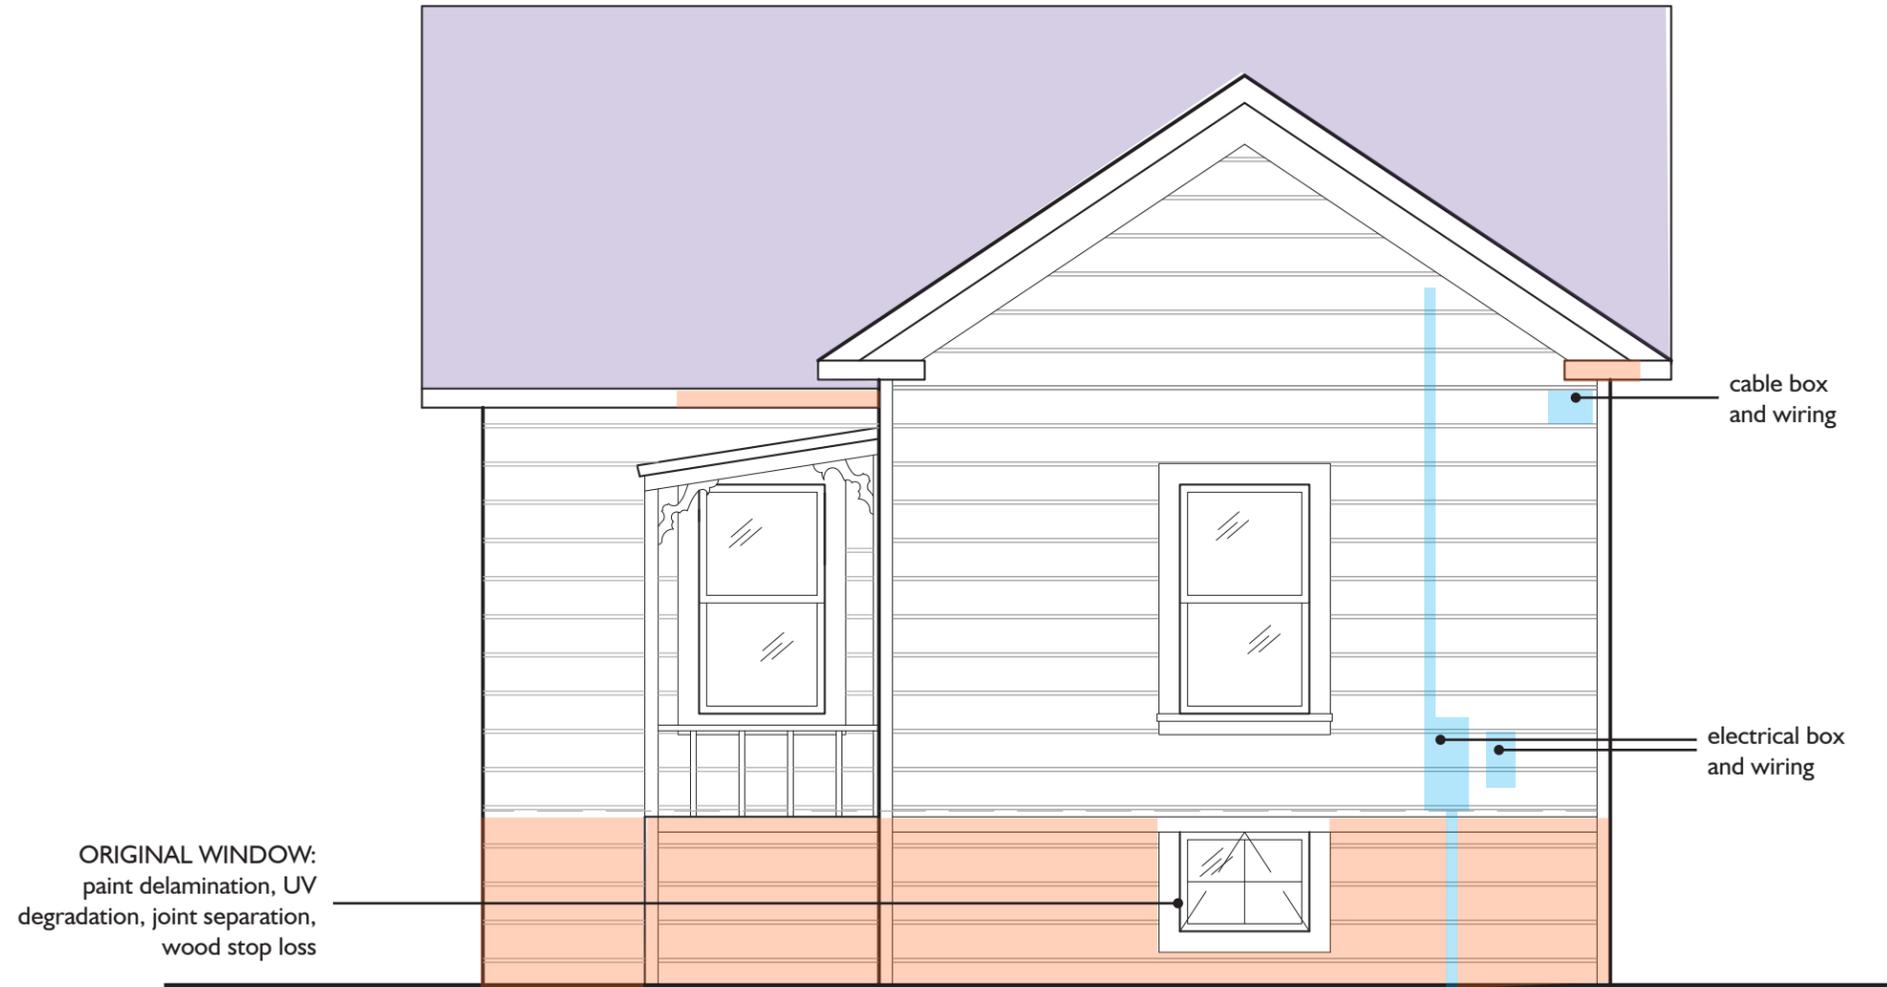
3 EXISTING WEST ELEVATION

- SIDING REQUIRING REPLACEMENT
- ROOFING REQUIRING REPLACEMENT
- ADDED INSTALLATION

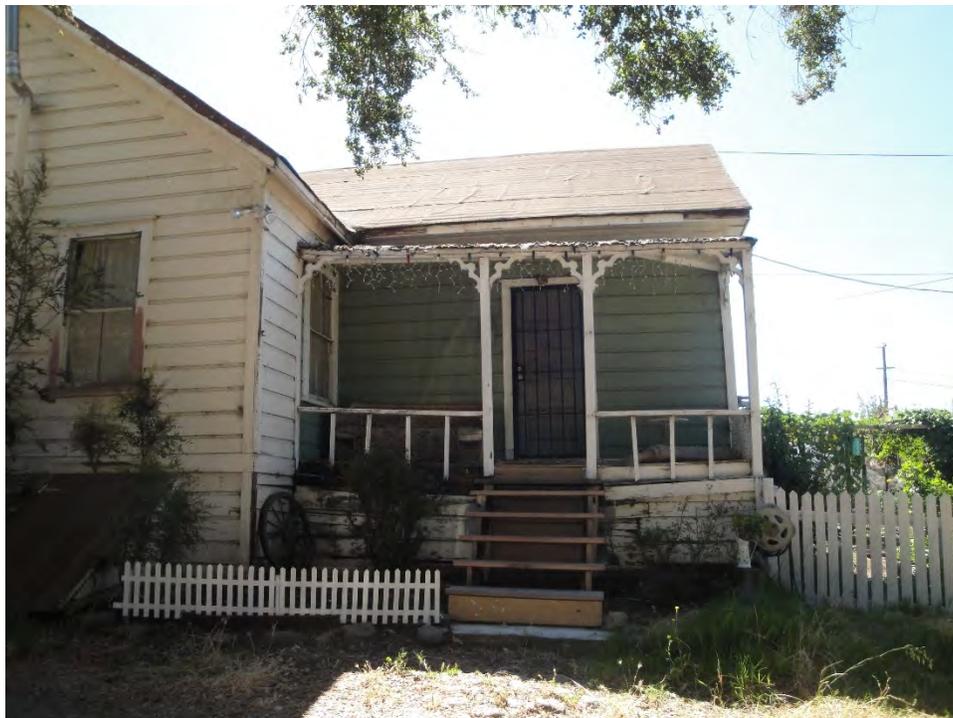
Detail of the front porch on the west façade of the farmhouse, view east (ARG, July 2016)

Response: Due to its poor condition, the front porch will be reconstructed. Although this will result in the loss of original building fabric, the porch will be replaced in kind and replicate its existing construction material, form, and detailing, including the jigsaw brackets.

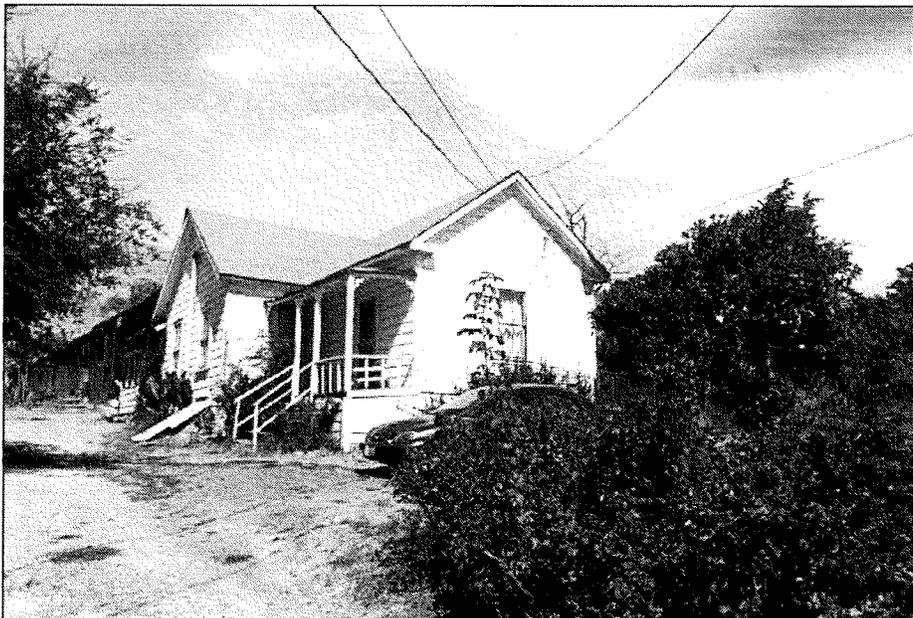
P5b. Description of Photo: Front view from SW

The building was built in ca. 1895. The surviving older buildings on the property appear to be largely intact. The stair railing and porch balustrade of the house's front porch have been replaced with 2x4's. The outhouse door appears to be new. The shed appears intact.

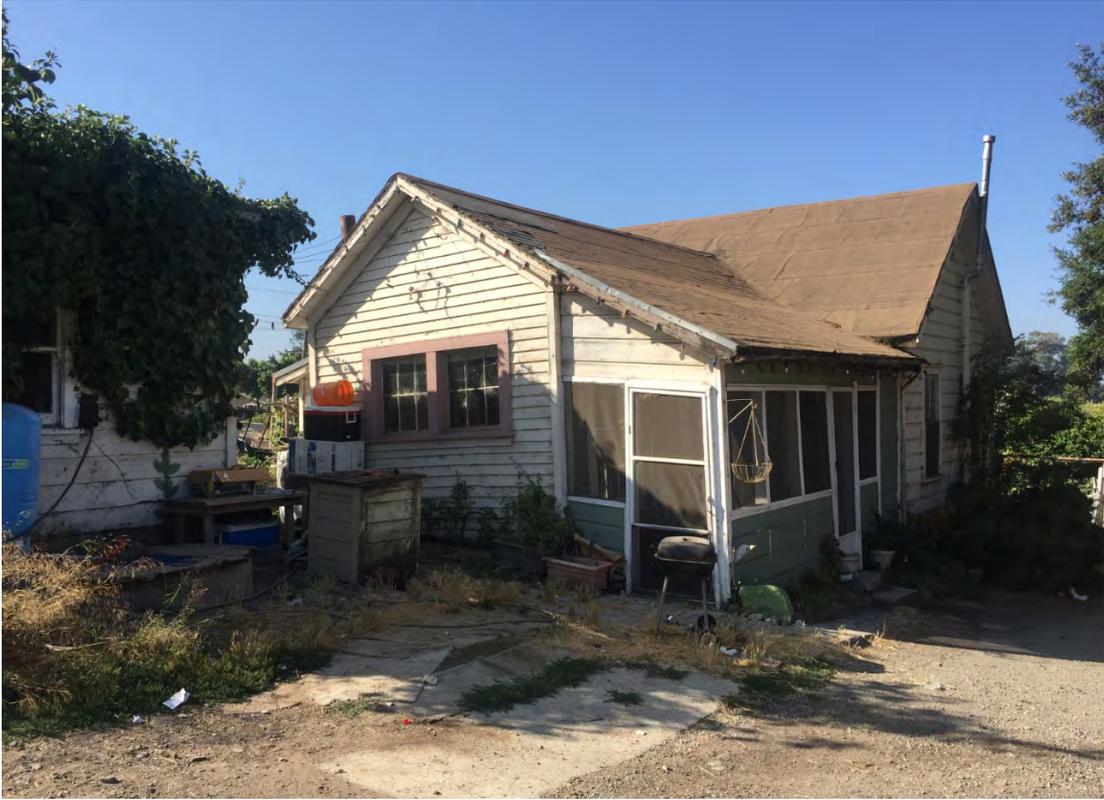
Picture #1

At your request, we conducted a site visit to Rodrigues House (one story single family house) located at 41948 Mission Blvd., Fremont, CA 94539 (Picture #1) with Mr. Tregoning on 07/27/17 to observe the existing structural condition and below are what we found:

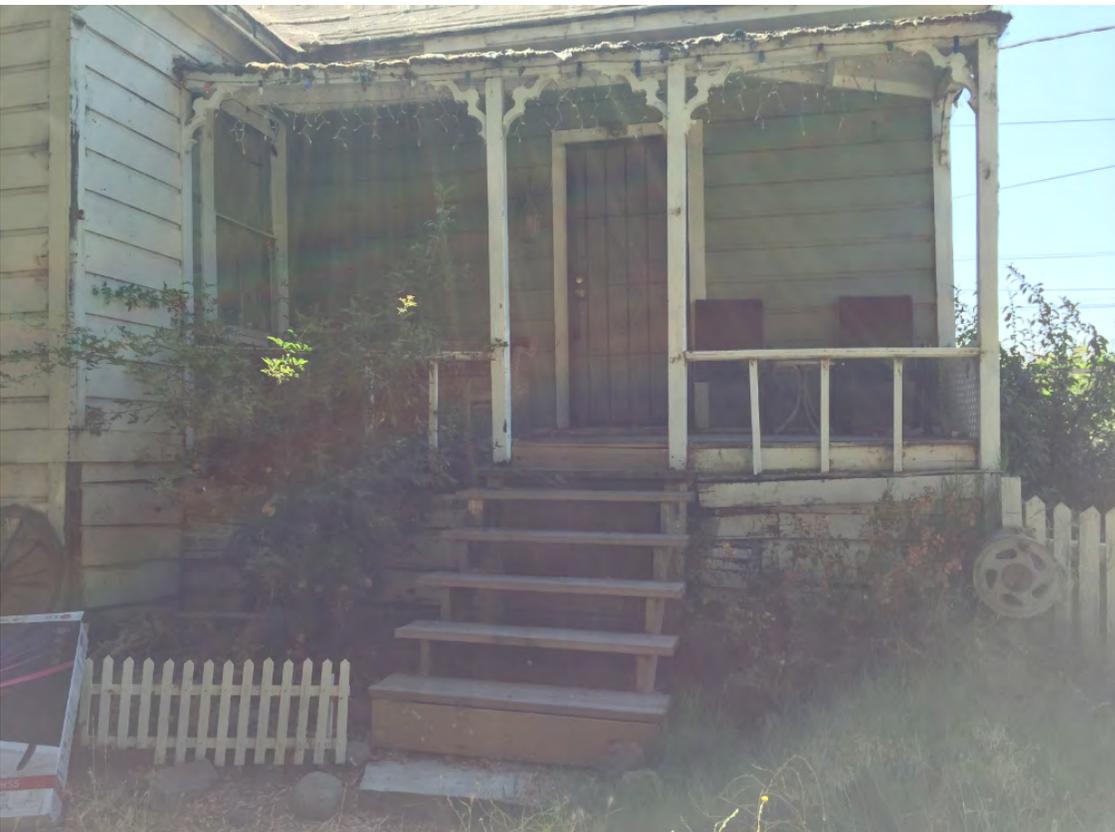
Picture #4

3. Front porch: In general the front porch seems to be in very bad condition from both safety and structural stand points (Pictures #4 and #5).

We recommend to demolish the front porch area and to re-build it with the same raised floor

framing and roof systems to match the original on new properly designed concrete foundation.

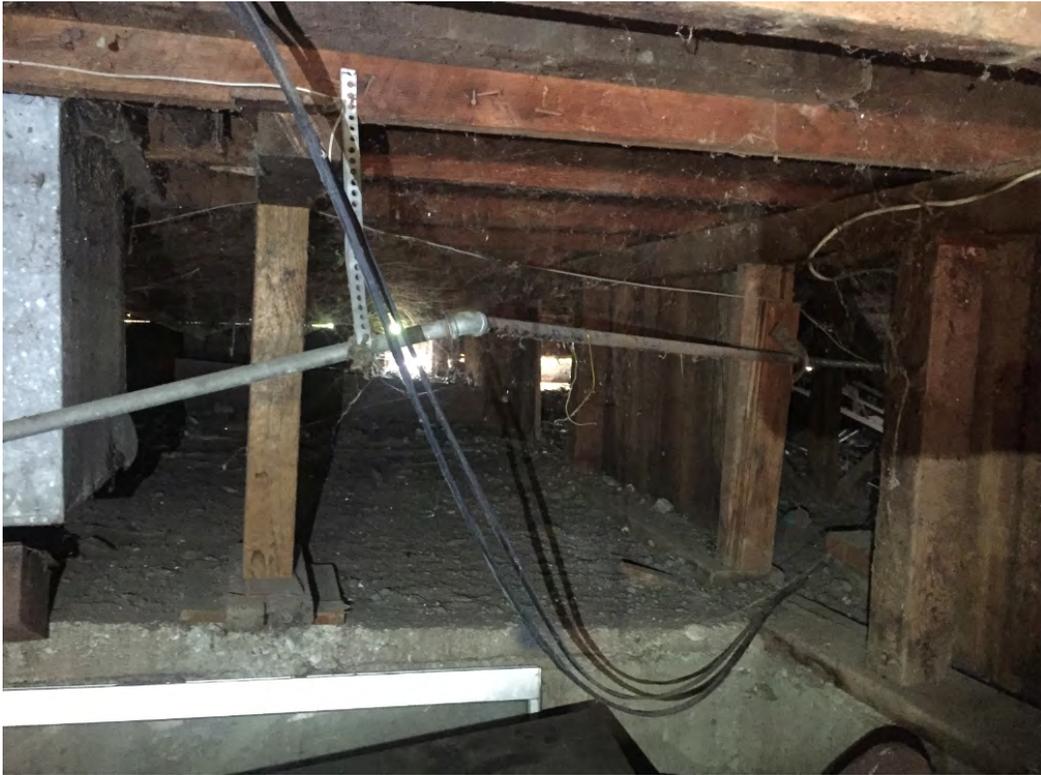
Picture #6

4. Anchor Bolts and Footings: During the time of the site visit, we could not find any anchor bolts nor any concrete footings. There are concrete low retaining walls around the small basement area where we went down to do the observation. There are some bearing posts sitting on these low retaining walls without any hardware connection (Picture #7). There are also some concrete piers supporting the bearing posts but without any hardware connection and proper installation (Picture #8).

We recommend that the properly designed concrete foundation to be added to support the entire house. Lateral resisting system (shear walls) also to be added along with the proper shear transfer connection to transfer lateral forces from the roof diaphragms to shear walls to floor diaphragms and to new concrete foundation.
